U. S. NUCLEAR REGULATORY COMMISSION

Report No. 50-461/85032(DRP)

Facility Name: Clinton Power Station

Inspection Conducted: May 29 through July 9, 1985

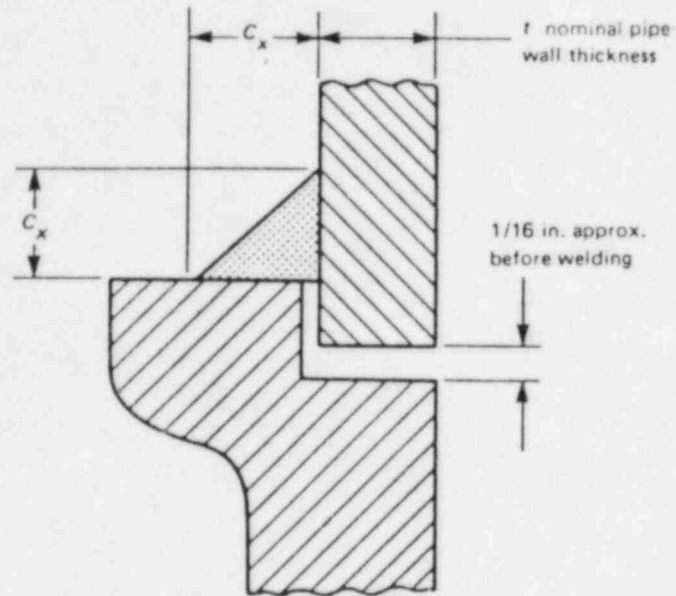
Attachment: Figure 1-A
and 1-B of Fig. NB-4427-1,
Fillet Weld Dimensions

- (1) ASME Code (refer to Figure 1-A attached): The code specifies that the piping will be withdrawn approximately $1/16$ " from the socket bottom prior to welding. The code was not specific on the angularity of the piping.
- (2) BAP 2.6, Instrumentation, Section 5.6.1(e) states "for socket weld joint an approximate $1/16$ " gap shall be maintained between the end of the pipe and the bottom of the socket."

The inspector observed approximately 150 instrumentation piping installations. The piping had various angularities to eliminate the need to bend the piping for fit up. In one case, the angularity was approximately 10 degrees (Figure 1-B attached).

At the request of the inspector, the fitting in Figure 1-B (see attached) was radiographed and full piping engagement into the socket was verified. The inspector questioned whether piping with an angularity of 10 degrees or greater could bind within the socket and thereby induce excessive stresses on the weld resulting in cracking, a condition similar to weld cracking if the piping is fully engaged at the socket bottom when welded.
