RADIOLOGIC AND ENGINEERING ASSESSMENT

DOE ID NO.: GJ-03089-RS  
ADDRESS: 1745 ORCHARD AVENUE

SEPTEMBER 1985

URANIUM MILL TAILINGS REMEDIAL ACTION PROJECT OFFICE

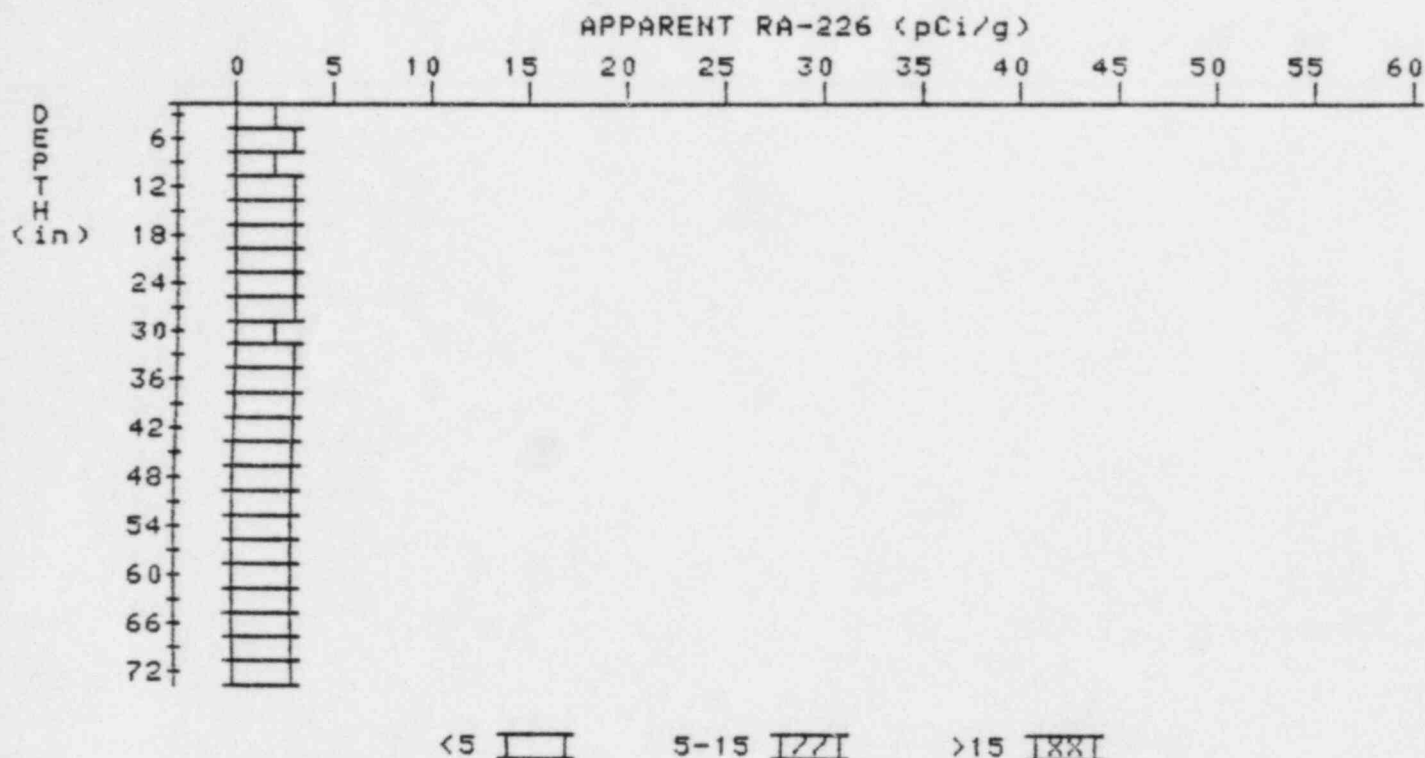
HOLE NUMBER: 1

LOCATION: 141212

Depth (in)	Apparent Radium-226 (pCi/g) Undeconvolved	Apparent Radium-226 (pCi/g) Deconvolved
3	2.2	2.2
6	2.5	2.9
9	2.6	2.4
12	2.8	3.2
15	2.8	2.8
18	2.8	2.8
21	2.8	2.6
24	2.9	3.1
27	2.9	3.1
30	2.8	2.4
33	2.9	3.1
36	2.9	2.9
39	2.9	2.9
42	2.9	2.7
45	3.0	3.0

48	3.1	3.5
51	3.0	2.8
54	3.0	3.2
57	2.9	2.7
60	2.9	2.9
63	2.9	2.9
66	2.9	2.7
69	3.0	3.4
72	2.9	2.9

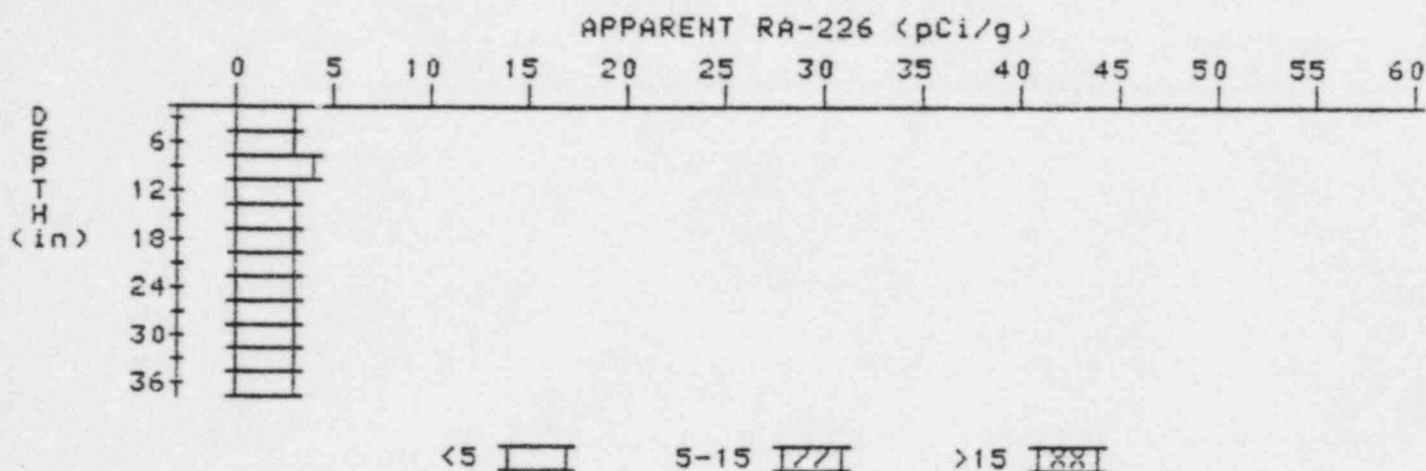
HOLE NUMBER: 5

LOCATION: 180210

Depth (in)	Apparent Radium-226 (pCi/g) Undeconvolved	Apparent Radium-226 (pCi/g) Deconvolved
3	2.7	2.7
6	3.1	3.5
9	3.3	3.7
12	3.3	3.5
15	3.2	3.0
18	3.2	3.4
21	3.1	2.9
24	3.1	2.9
27	3.2	3.4
30	3.2	3.4
33	3.1	2.7
36	3.2	3.2

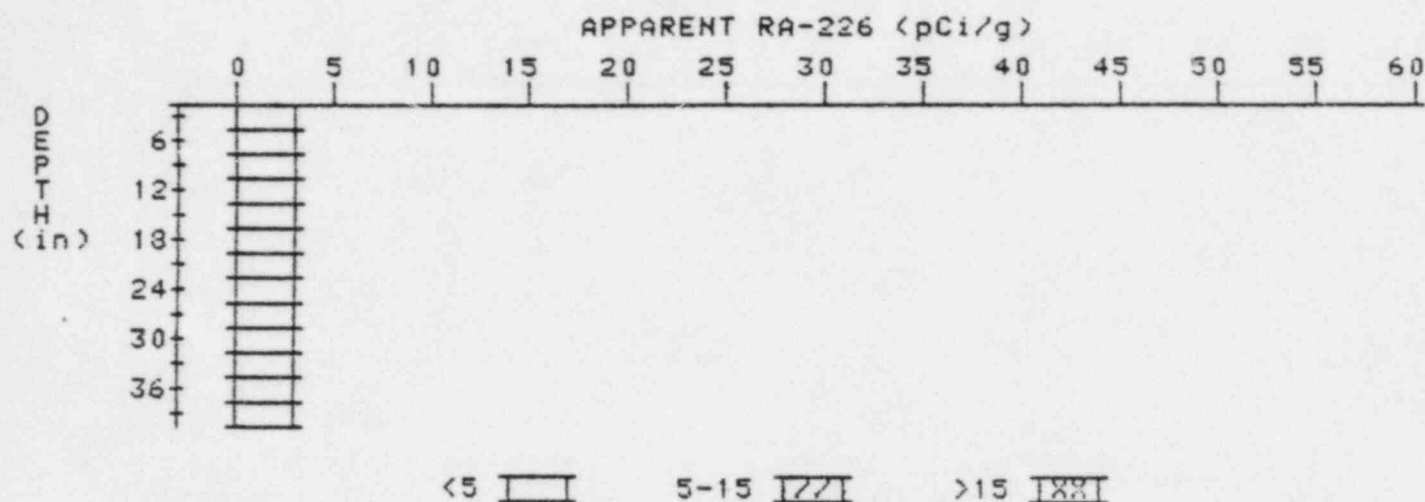
HOLE NUMBER: 6

LOCATION: 190230

Depth (in)	Apparent Radium-226 (pCi/g) Undeconvolved	Apparent Radium-226 (pCi/g) Deconvolved
3	2.6	2.6
6	2.9	3.3
9	3.0	3.2
12	3.0	3.0
15	3.0	3.2
18	2.9	2.7
21	2.9	2.5
24	3.1	3.5
27	3.1	2.9
30	3.2	3.4
33	3.2	3.2
36	3.2	3.4
39	3.1	3.1

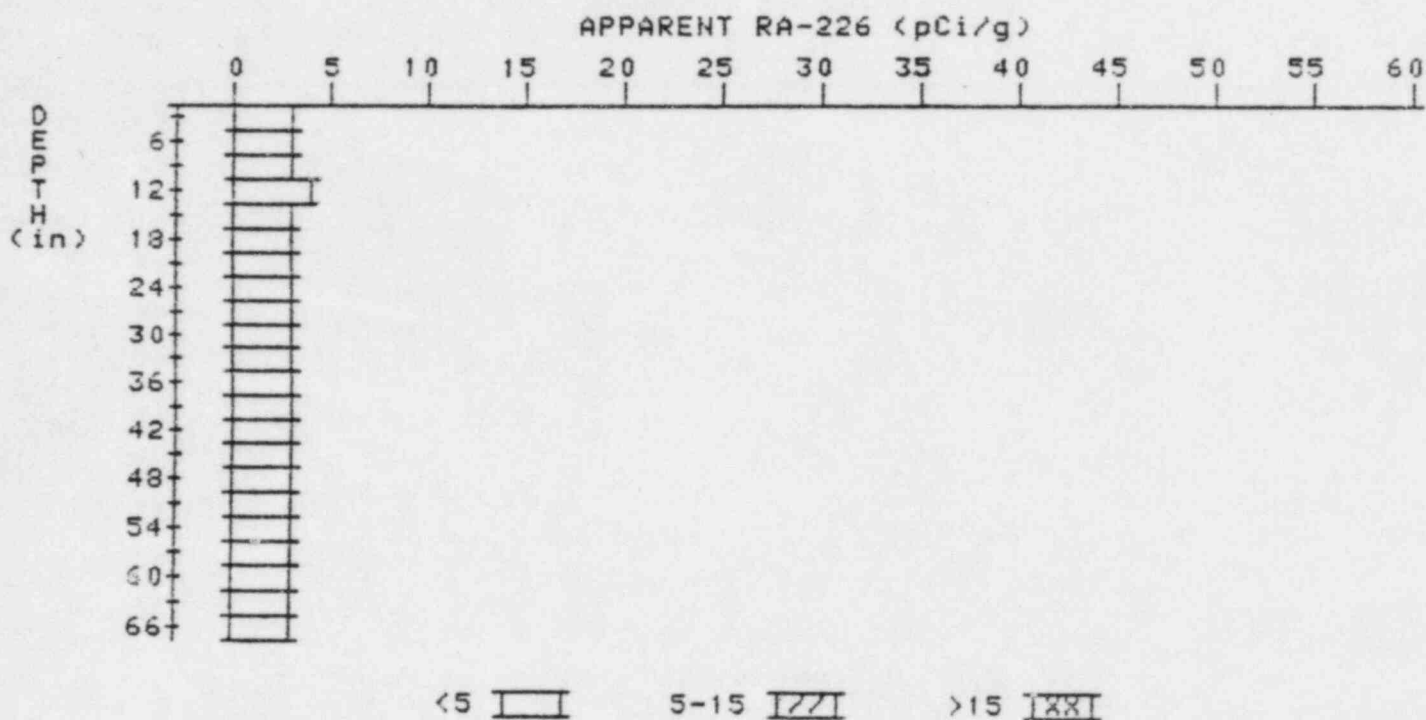
HOLE NUMBER: 7

LOCATION: 197201

Depth (in)	Apparent Radium-226 (pCi/g) Undeconvolved	Apparent Radium-226 (pCi/g) Deconvolved
3	2.7	2.7
6	3.0	3.4
9	3.1	3.1
12	3.2	3.6
15	3.1	2.9
18	3.1	3.1
21	3.1	3.1
24	3.1	3.1
27	3.1	3.1
30	3.1	3.1
33	3.1	3.1
36	3.1	3.1
39	3.1	3.1
42	3.1	3.1
45	3.1	3.3
48	3.0	2.8

51	3.0	2.8
54	3.1	3.3
57	3.1	3.1
60	3.1	3.1
63	3.1	3.1
66	3.1	3.1
