RADIOLOGIC AND ENGINEERING ASSESSMENT

DOE ID NO.: GJ-01354-CS
ADDRESS: 1710 NORTH 12TH STREET

SEPTEMBER 1985

BENDIX FIELD ENGINEERING CORPORATION
P.O. Box 1569
Grand Junction, Colorado 81502

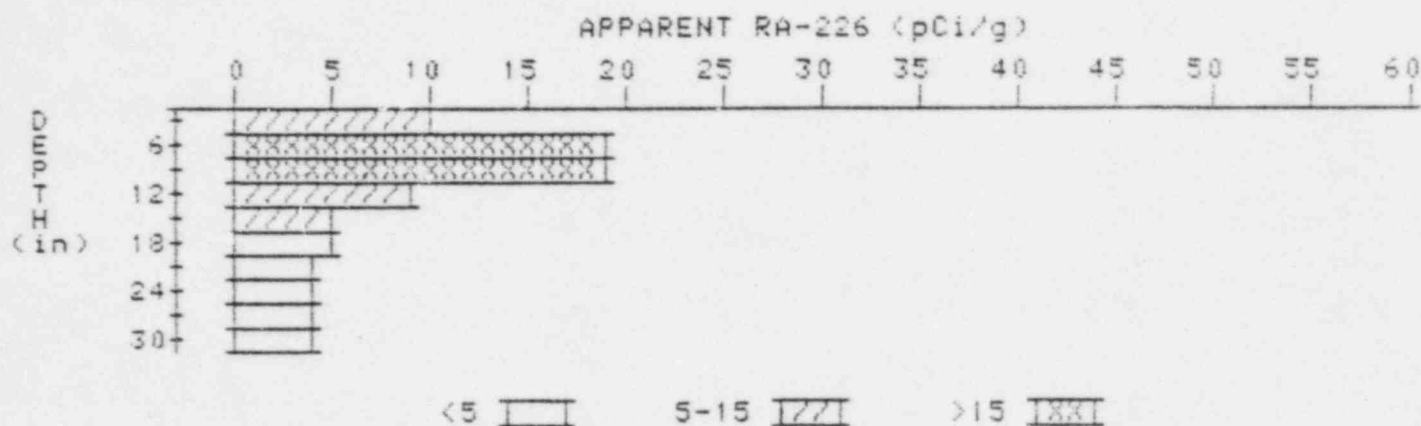
HOLE NUMBER: 6

LOCATION: 132226

Depth (in)	Apparent Radium-226 (pCi/g) Undeconvolved	Apparent Radium-226 (pCi/g) Deconvolved
3	9.7	9.7
6	13.1	19.1
9	13.1	18.6
12	10.0	9.1
15	7.4	5.4
18	5.9	4.8
21	5.0	4.3
24	4.5	4.1
27	4.2	4.0
30	4.0	4.0

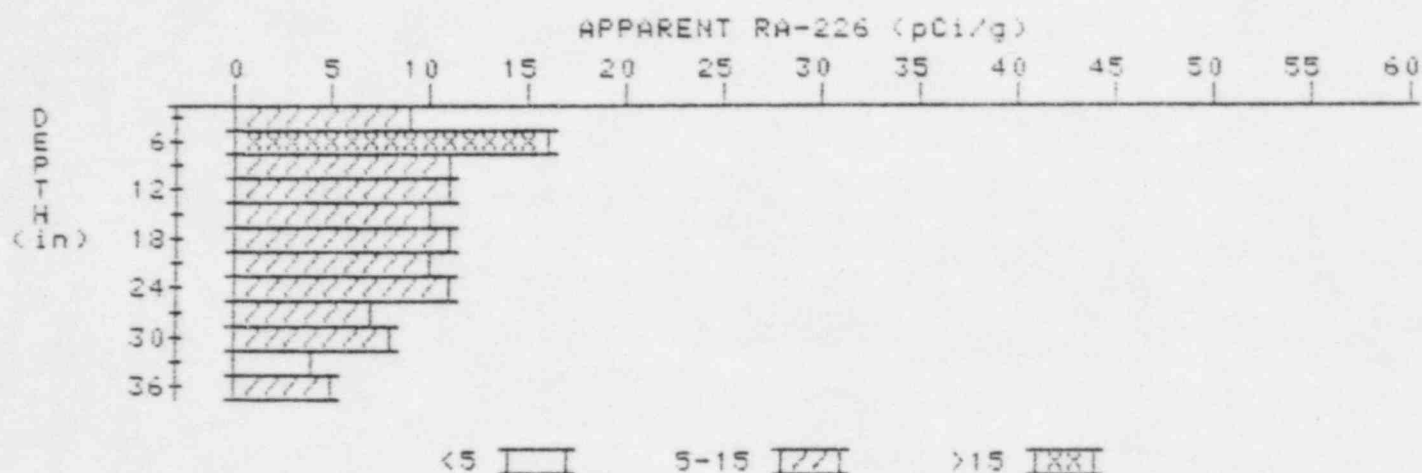
HOLE NUMBER: 9

LOCATION: 134200

Depth (in)	Apparent Radium-226 (pCi/g) Undeconvolved	Apparent Radium-226 (pCi/g) Deconvolved
3	9.4	9.4
6	11.6	16.2
9	11.2	11.4
12	10.7	10.5
15	10.3	9.6
18	10.3	11.0
21	9.9	10.3
24	9.3	10.9
27	7.8	6.6
30	7.0	7.9
33	5.7	4.5
36	5.1	5.1

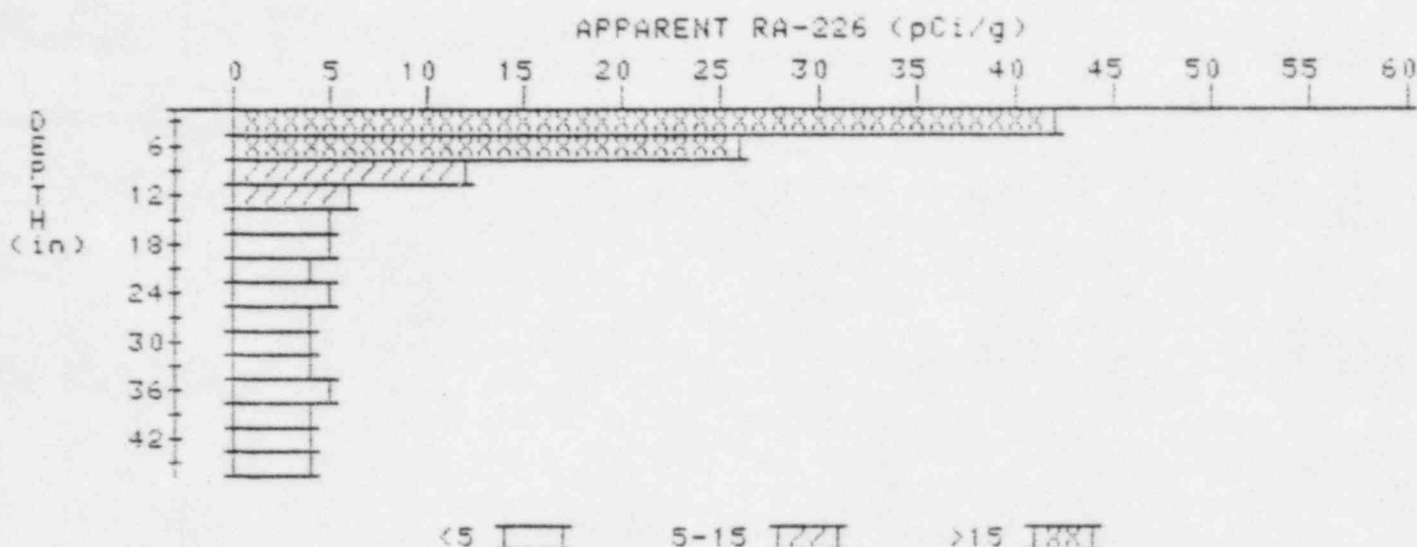
PROPERTY NUMBER: GJ-01354-CS
HOLE NUMBER: 11
LOCATION: 135240

Depth (in)	Apparent Radium-226 (pCi/g) Undeconvolved	Apparent Radium-226 (pCi/g) Deconvolved
3	42.4	42.4
6	29.5	25.9
9	18.6	11.7
12	11.6	5.6
15	8.0	4.8
18	6.2	5.0
21	5.1	3.9
24	4.7	4.7
27	4.3	3.9
30	4.1	3.6
33	4.2	4.4
36	4.2	4.6
39	4.0	4.0
42	3.8	3.8
45	3.6	3.6

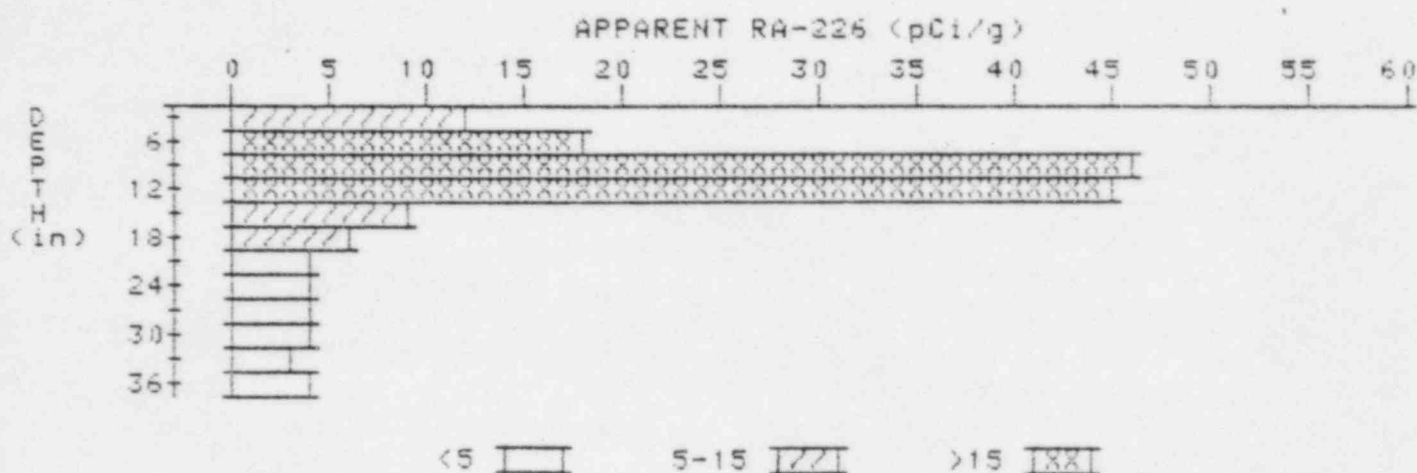
PROPERTY NUMBER: GJ-01354-CS
HOLE NUMBER: 13
LOCATION: 138222

Depth (in)	Apparent Radium-226 (pCi/g) Undeconvolved	Apparent Radium-226 (pCi/g) Deconvolved
3	11.5	11.5
6	19.4	17.6
9	28.3	45.7
12	27.4	44.8
15	16.7	8.7
18	10.5	5.7
21	7.0	3.8
24	5.3	3.5
27	4.6	4.1
30	4.2	4.0
33	3.9	3.2
36	4.0	4.0

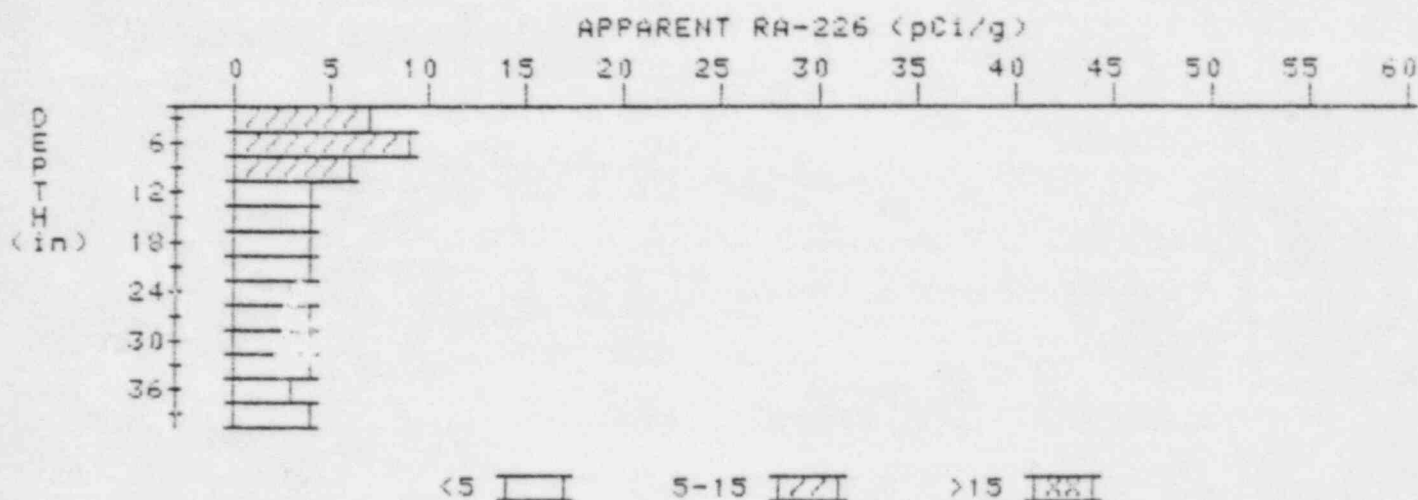
PROPERTY NUMBER: GJ-01354-CS
HOLE NUMBER: 14
LOCATION: 138226

Depth (in)	Apparent Radium-226 (pCi/g) Undeconvolved	Apparent Radium-226 (pCi/g) Deconvolved
3	6.9	6.9
6	7.1	9.2
9	6.1	6.1
12	5.1	4.2
15	4.6	4.4
18	4.2	3.7
21	4.1	4.3
24	3.9	3.4
27	4.0	4.2
30	4.0	4.2
33	3.9	3.9
36	3.8	3.4
39	3.9	3.9

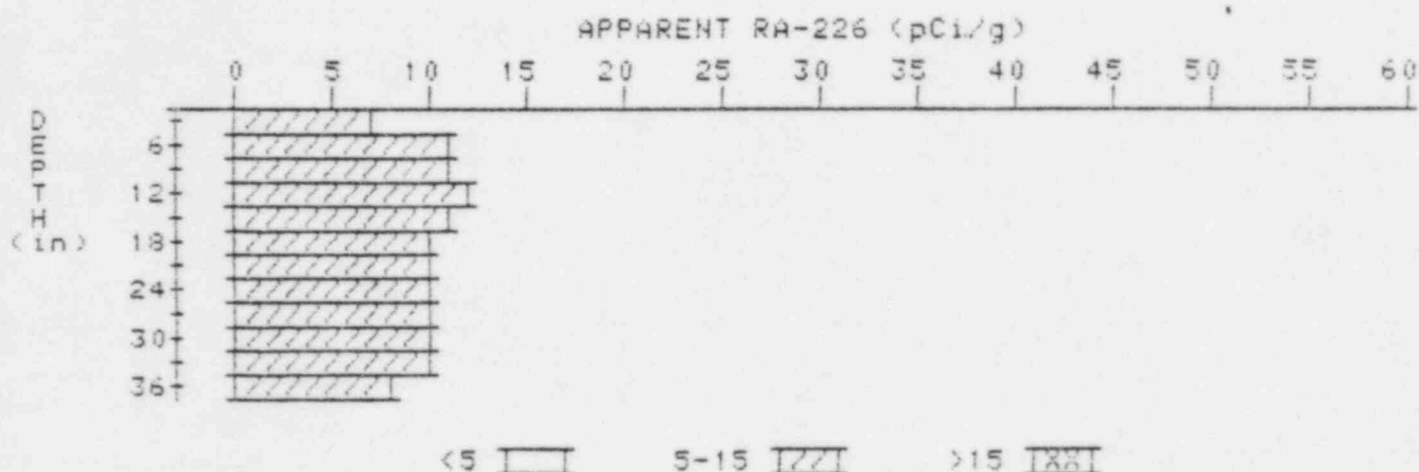
HOLE NUMBER: 32

LOCATION: 180199

Depth (in)	Apparent Radium-226 (pCi/g) Undeconvolved	Apparent Radium-226 (pCi/g) Deconvolved
3	6.5	6.5
6	9.0	11.5
9	10.1	11.2
12	10.6	11.7
15	10.5	11.0
18	10.1	9.6
21	10.0	9.6
24	10.1	10.5
27	10.0	10.4
30	9.7	10.1
33	9.2	10.1
36	8.2	8.2
