RADIOLOGIC AND ENGINEERING ASSESSMENT

DOE ID NO.: GJ-02193-RS
ADDRESS: 443 NORTH 18TH STREET

SEPTEMBER 1985

BENDIX FIELD ENGINEERING CORPORATION
P.O. Box 1569
Grand Junction, Colorado 81502

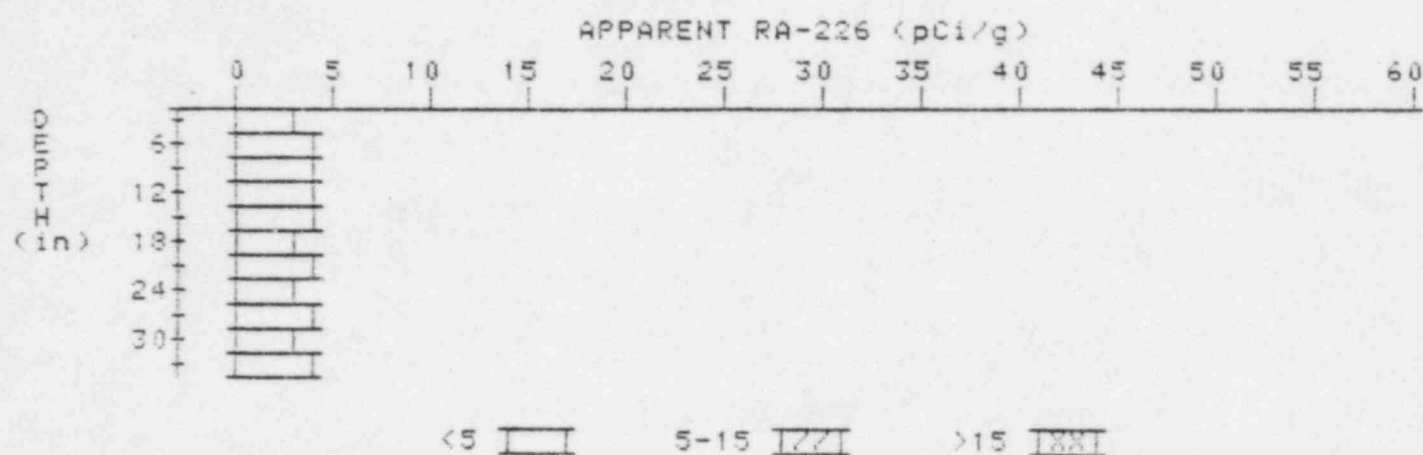
HOLE NUMBER: 1

Depth (in)	Apparent Radium-226 (pCi/g) Undeconvolved	Apparent Radium-226 (pCi/g) Deconvolved
3	3.3	3.3
6	3.5	3.7
9	3.6	3.8
12	3.6	3.6
15	3.6	3.6
18	3.6	3.4
21	3.7	4.1
24	3.6	3.2
27	3.7	4.1
30	3.6	3.4
33	3.6	3.6

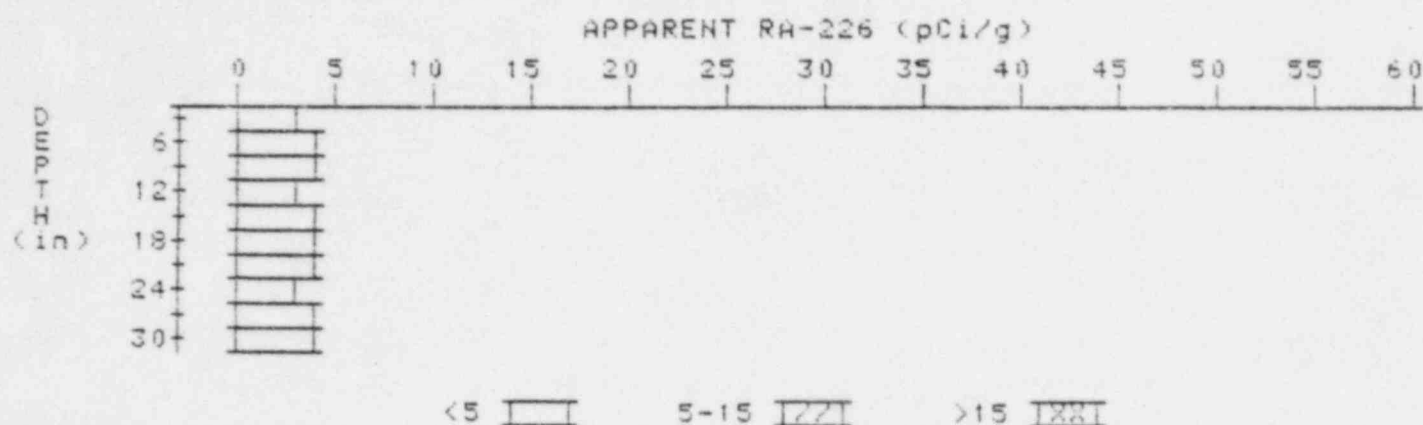
HOLE NUMBER: 2

Depth (in)	Apparent Radium-226 (pCi/g) Undeconvolved	Apparent Radium-226 (pCi/g) Deconvolved
3	3.2	3.2
6	3.5	3.9
9	3.6	3.8
12	3.6	3.4
15	3.7	3.9
18	3.7	3.5
21	3.8	4.3
24	3.6	3.2
27	3.6	3.6
30	3.6	3.6

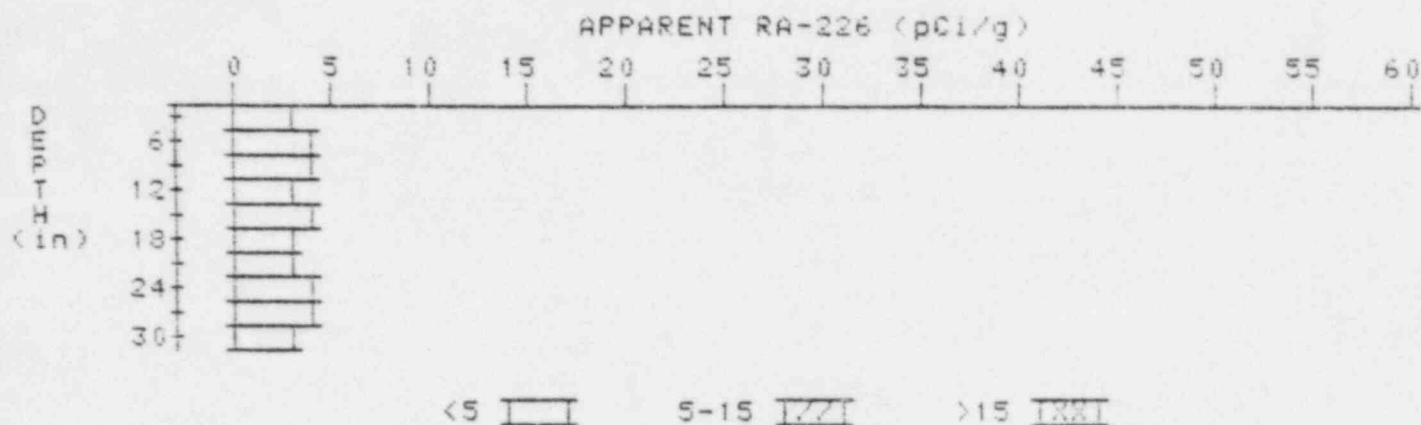
HOLE NUMBER: 4

Depth (in)	Apparent Radium-226 (pCi/g) Undeconvolved	Apparent Radium-226 (pCi/g) Deconvolved
3	3.1	3.1
6	3.5	4.0
9	3.6	3.8
12	3.6	3.4
15	3.7	4.2
18	3.5	3.1
21	3.5	3.3
24	3.6	4.0
27	3.5	3.5
30	3.4	3.4

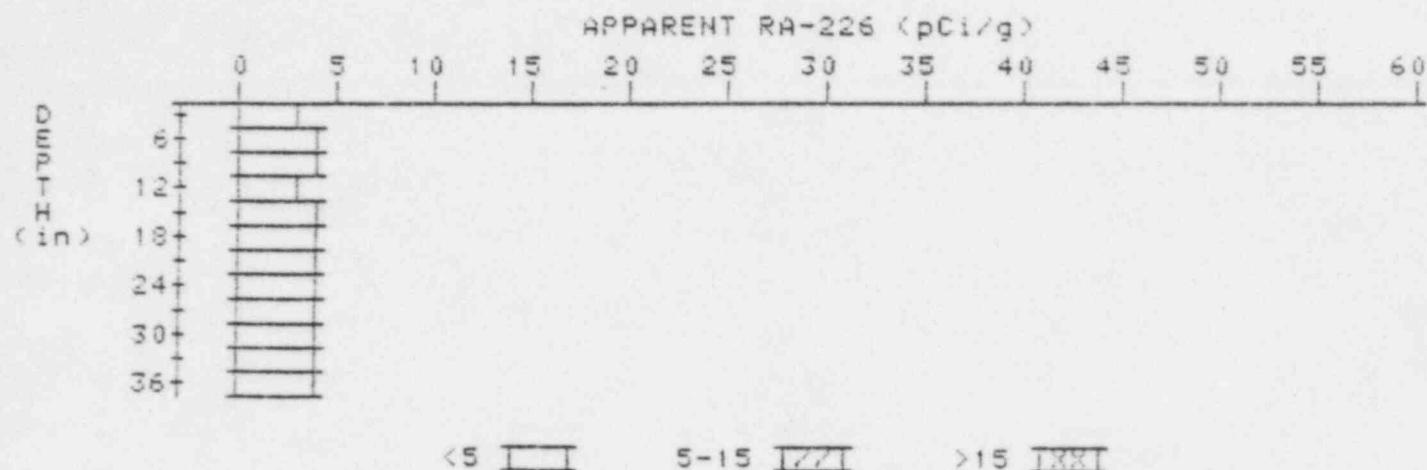
HOLE NUMBER: 5

Depth (in)	Apparent Radium-226 (pCi/g) Undeconvolved	Apparent Radium-226 (pCi/g) Deconvolved
3	3.3	3.3
6	3.5	3.7
9	3.6	3.8
12	3.6	3.4
15	3.7	3.7
18	3.8	4.0
21	3.8	3.8
24	3.8	3.8
27	3.8	3.8
30	3.8	4.0
33	3.7	3.7
36	3.6	3.6

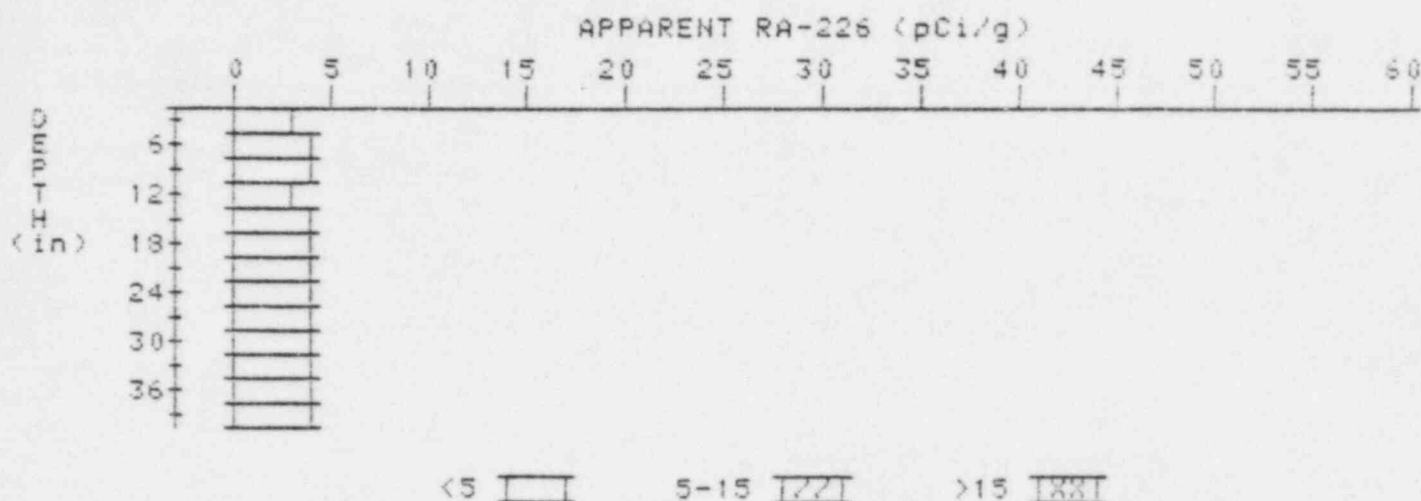
HOLE NUMBER: 6

Depth (in)	Apparent Radium-226 (pCi/g) Undeconvolved	Apparent Radium-226 (pCi/g) Deconvolved
3	3.3	3.3
6	3.5	3.7
9	3.6	3.8
12	3.6	3.4
15	3.7	3.9
18	3.7	3.7
21	3.7	3.7
24	3.7	3.7
27	3.7	3.7
30	3.7	3.7
33	3.7	3.7
36	3.7	3.9
39	3.6	3.6
