RADIOLOGIC AND ENGINEERING ASSESSMENT

DOE ID NO.: GJ-13359-RS
ADDRESS: 713 CENTAURI DRIVE

AUGUST 1985

URANIUM MILL TAILINGS REMEDIAL ACTION PROJECT OFFICE

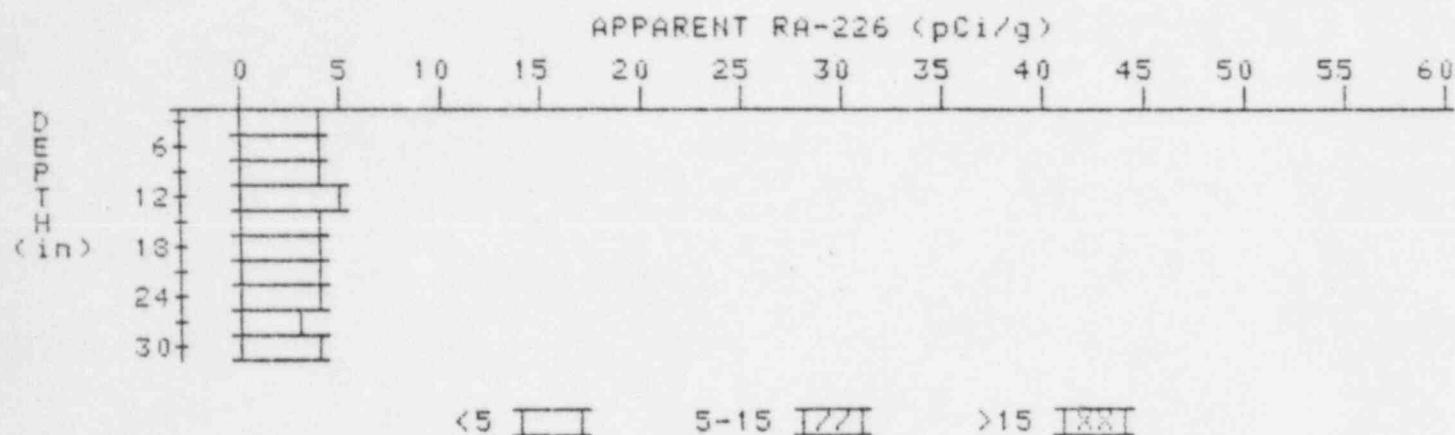
PROPERTY NUMBER: GJ-13359-RS
HOLE NUMBER: 9
LOCATION: 117220

Depth (in)	Apparent Radium-226 (pCi/g) Undeconvolved	Apparent Radium-226 (pCi/g) Deconvolved
3	3.8	3.8
6	3.9	3.9
9	4.0	4.0
12	4.1	4.6
15	3.9	3.5
18	3.9	4.3
21	3.7	3.5
24	3.6	3.6
27	3.5	3.1
30	3.6	3.6

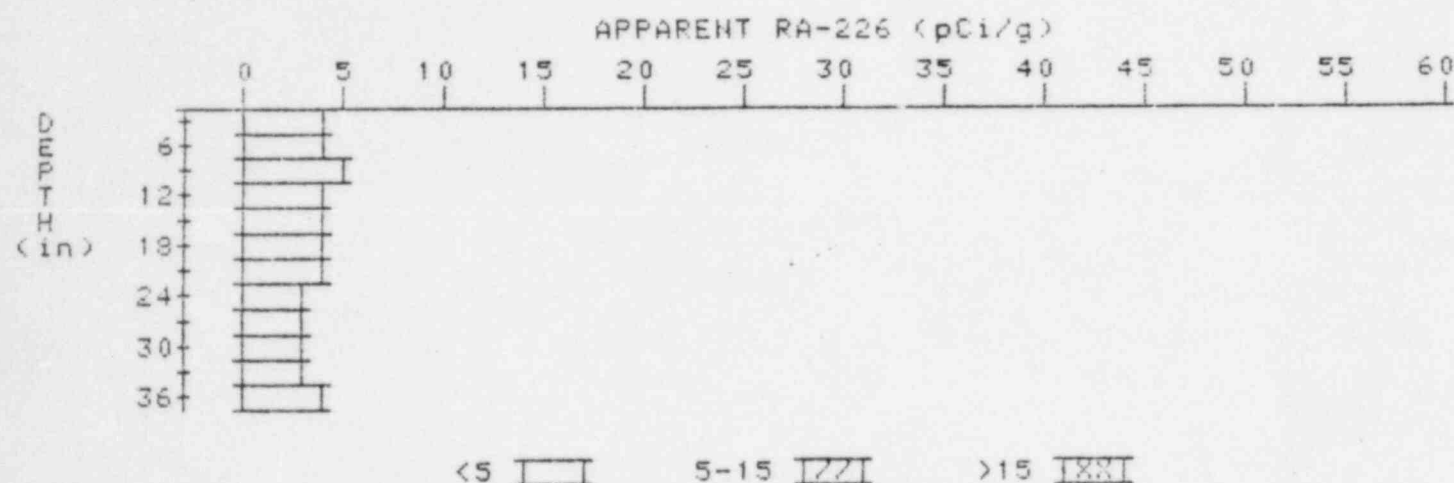
PROPERTY NUMBER: GJ-13359-RS
HOLE NUMBER: 10
LOCATION: 117240

Depth (in)	Apparent Radium-226 (pCi/g) Undeconvolved	Apparent Radium-226 (pCi/g) Deconvolved
3	3.5	3.5
6	3.7	3.5
9	4.0	4.7
12	3.9	3.7
15	3.9	4.3
18	3.7	3.5
21	3.6	3.8
24	3.4	3.0
27	3.4	3.4
30	3.4	3.4
33	3.4	3.2
36	3.5	3.5

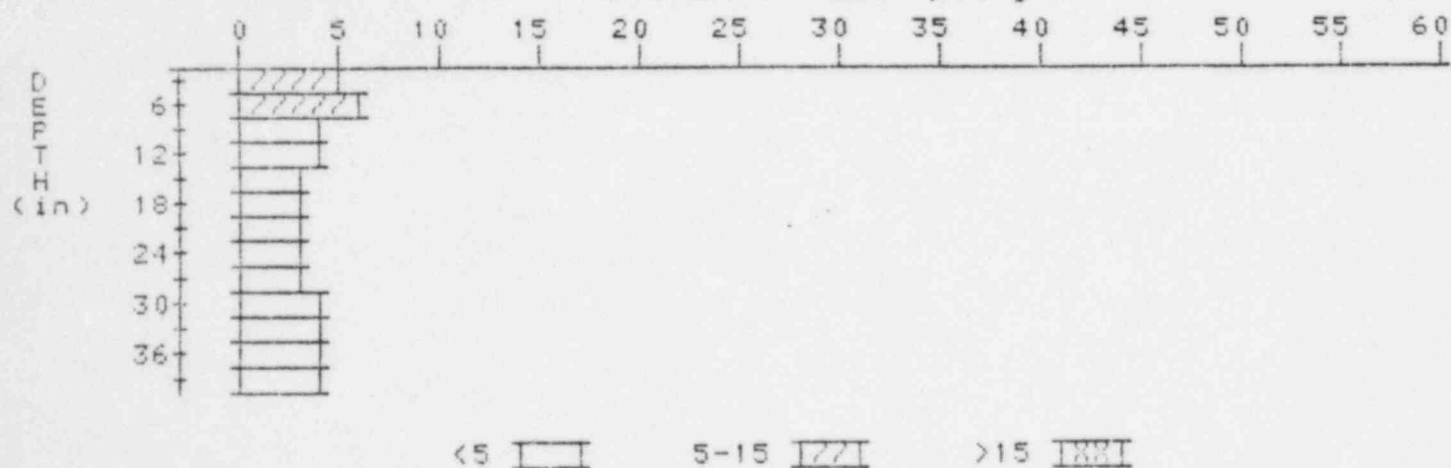
LOCATION: 120270

Depth (in)	Apparent Radium-226 (pCi/g) Undeconvolved	Apparent Radium-226 (pCi/g) Deconvolved
3	5.1	5.1
6	4.9	5.6
9	4.3	3.9
12	3.9	3.7
15	3.6	3.4
18	3.4	3.4
21	3.2	2.7
24	3.3	3.3
27	3.4	3.4
30	3.5	3.5
33	3.6	3.6
36	3.7	3.7
39	3.8	3.8

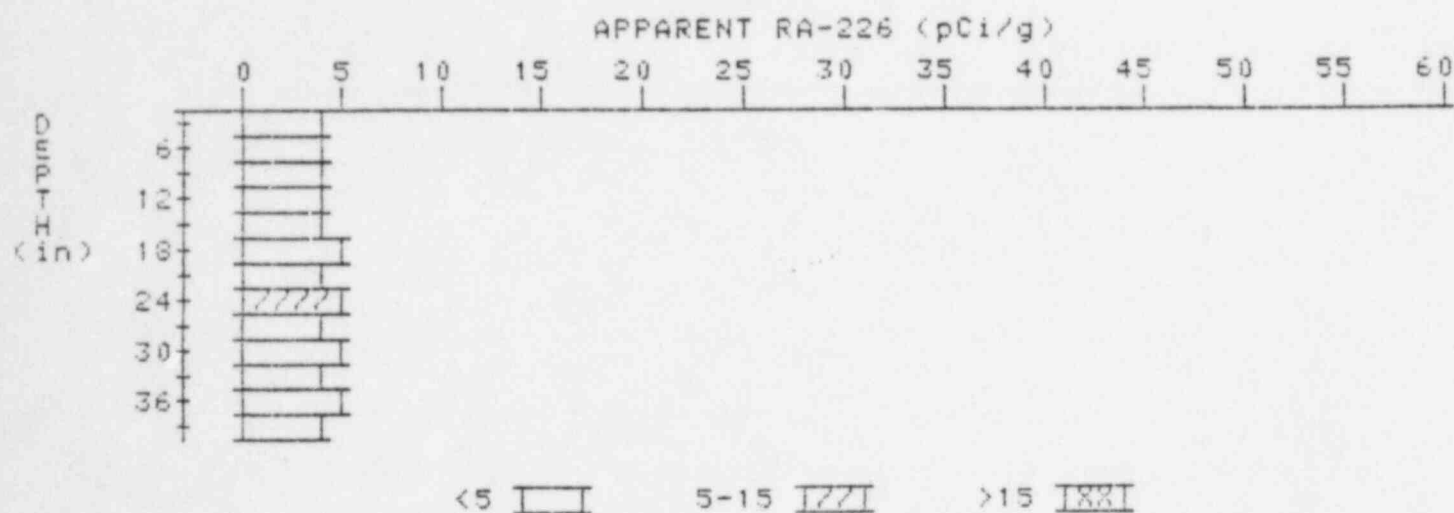
LOCATION: 174258

Depth (in)	Apparent Radium-226 (pCi/g) Undeconvolved	Apparent Radium-226 (pCi/g) Deconvolved
3	3.5	3.5
6	3.8	4.0
9	4.0	4.2
12	4.1	4.1
15	4.2	4.0
18	4.4	4.6
21	4.5	4.3
24	4.7	5.4
27	4.5	4.1
30	4.5	4.7
33	4.4	4.4
36	4.3	4.7
39	4.0	4.0

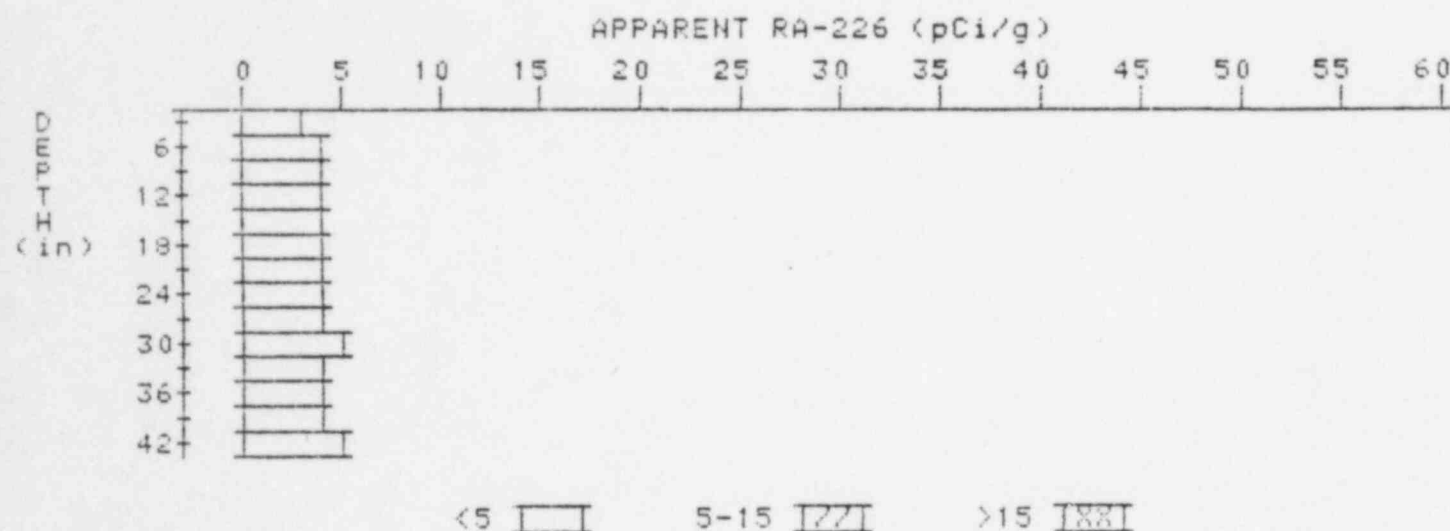
LOCATION: 205295

Depth (in)	Apparent Radium-226 (pCi/g) Undeconvolved	Apparent Radium-226 (pCi/g) Deconvolved
3	3.3	3.3
6	3.5	3.5
9	3.7	3.7
12	3.9	4.1
15	4.0	4.2
18	4.0	4.0
21	4.0	3.6
24	4.2	4.4
27	4.3	4.3
30	4.4	4.6
33	4.4	4.4
36	4.4	4.4
39	4.4	4.2
42	4.5	4.5

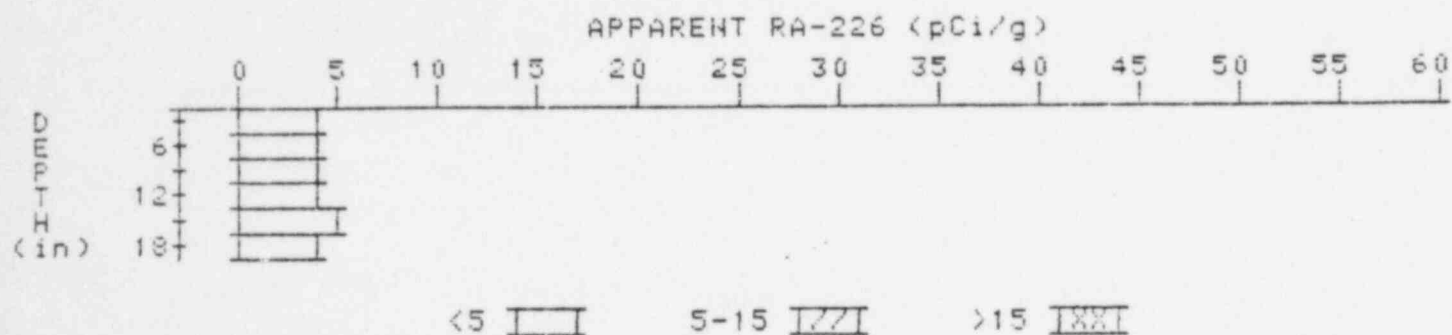
LOCATION: 210292

Depth (in)	Apparent Radium-226 (pCi/g) Undeconvolved	Apparent Radium-226 (pCi/g) Deconvolved
3	3.8	3.8
6	4.0	4.2
9	4.1	4.3
12	4.1	3.9
15	4.2	4.6
18	4.1	4.1

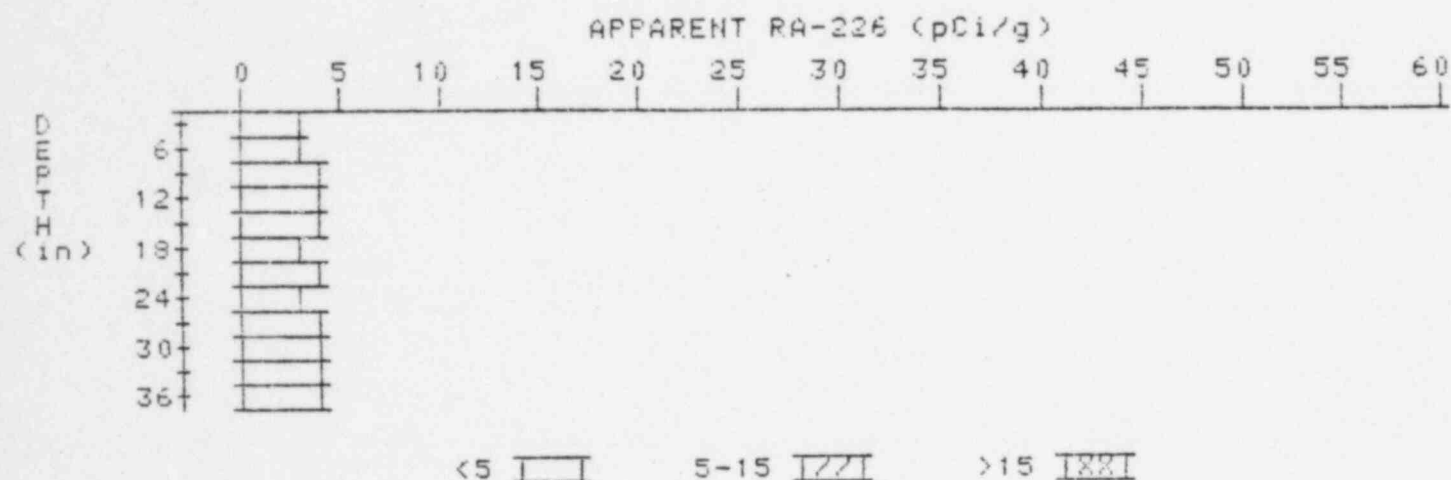
PROPERTY NUMBER: GJ-13359-RS
HOLE NUMBER: 23
LOCATION: 220175

Loc #	Grid Location	Depth (in.)	Meas. Type	In Situ Ra-226 (pCi/g)		Chem Ra-226 (pCi/g)	Comments
				Tot. Ct	Spectr.		
23	220175	06	TC	3.3		*	
		09	TC	3.5		*	
		12	TC	3.6		*	
		15	TC	3.7		*	
		18	TC	3.6		*	
		21	TC	3.6		*	
		24	TC	3.6		*	
		27	TC	3.7		*	
		30	TC	3.9		*	
		33	TC	4.0		*	
		36	TC	4.1		*	
24	221289	00	DS	10.8		*	Gas line
		24	DS	2.1		*	Next to flower bed
25	222275	00	DS	1.9		*	Flower bed
		03	TC	3.3		*	East foundation
		06	TC	3.5		*	
		09	TC	3.5		*	DC = 0 inches
		12	TC	3.6		*	
		15	TC	3.6		*	
		18	TC	3.6		*	
		21	TC	3.6		*	
		24	TC	3.5		*	
		27	TC	3.6		*	
		30	TC	3.6		*	
26	223281	00	DS	1.8		*	Flower bed
		06	DS	2.8		*	
27	231284	00	DS	6.4		*	Flower bed east of
		06	DS	1.8		*	primary structure
28	235280	00	DS	6.5		*	East lawn
		06	DS	1.8		*	
29	251283	00	DS	8.0		*	East lawn
		03	TC	7.5		*	
		06	TC	7.0		*	DC = 12 inches
		09	TC	5.9		*	Based on the
		12	TC	5.0		*	deconvolution graph
		15	TC	4.5		*	
		18	TC	4.2		*

Depth (in)	Apparent Radium-226 (pCi/g) Undeconvolved	Apparent Radium-226 (pCi/g) Deconvolved
3	3.0	3.0
6	3.3	3.5
9	3.5	3.7
12	3.6	3.6
15	3.7	4.1
18	3.6	3.4
21	3.6	3.6
24	3.6	3.4
27	3.7	3.5
30	3.9	4.1
33	4.0	4.0
36	4.1	4.1

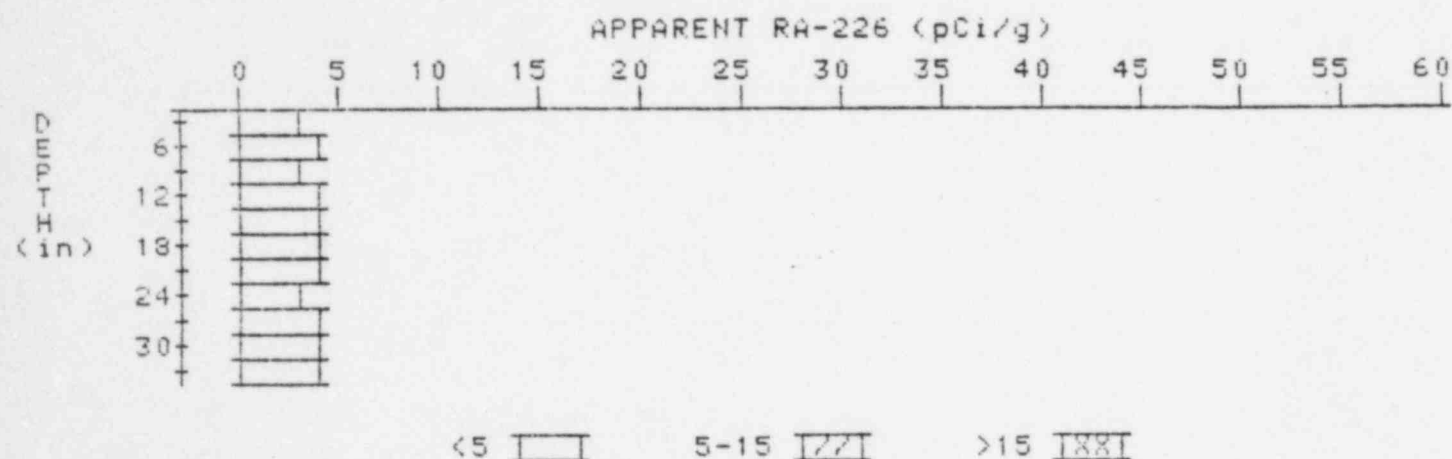
LOCATION: 222275

Depth (in)	Apparent Radium-226 (pCi/g) Undeconvolved	Apparent Radium-226 (pCi/g) Deconvolved
3	3.3	3.3
6	3.5	3.9
9	3.5	3.3
12	3.6	3.8
15	3.6	3.6
18	3.6	3.6
21	3.6	3.8
24	3.5	3.1
27	3.6	3.8
30	3.6	3.8
33	3.5	3.5
