RADIOLOGIC AND ENGINEERING ASSESSMENT

DOE ID NO.: GJ-10972-RS
ADDRESS: 304 TELLER AVENUE

AUGUST 1985

BENDIX FIELD ENGINEERING CORPORATION
P.O. Box 1569
Grand Junction, Colorado 81502

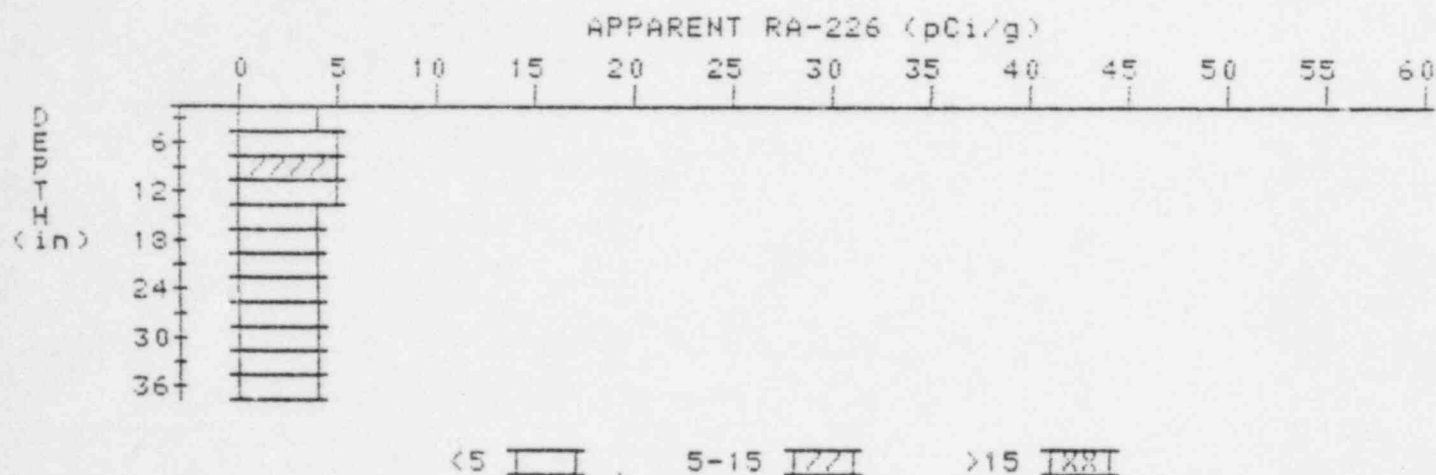
HOLE NUMBER: 2

Depth (in)	Apparent Radium-226 (pCi/g) Undeconvolved	Apparent Radium-226 (pCi/g) Deconvolved
3	4.4	4.4
6	4.6	4.8
9	4.7	5.2
12	4.5	4.5
15	4.3	4.1
18	4.2	4.2
21	4.1	3.9
24	4.1	4.1
27	4.1	4.1
30	4.1	4.1
33	4.1	4.1
36	4.1	4.1

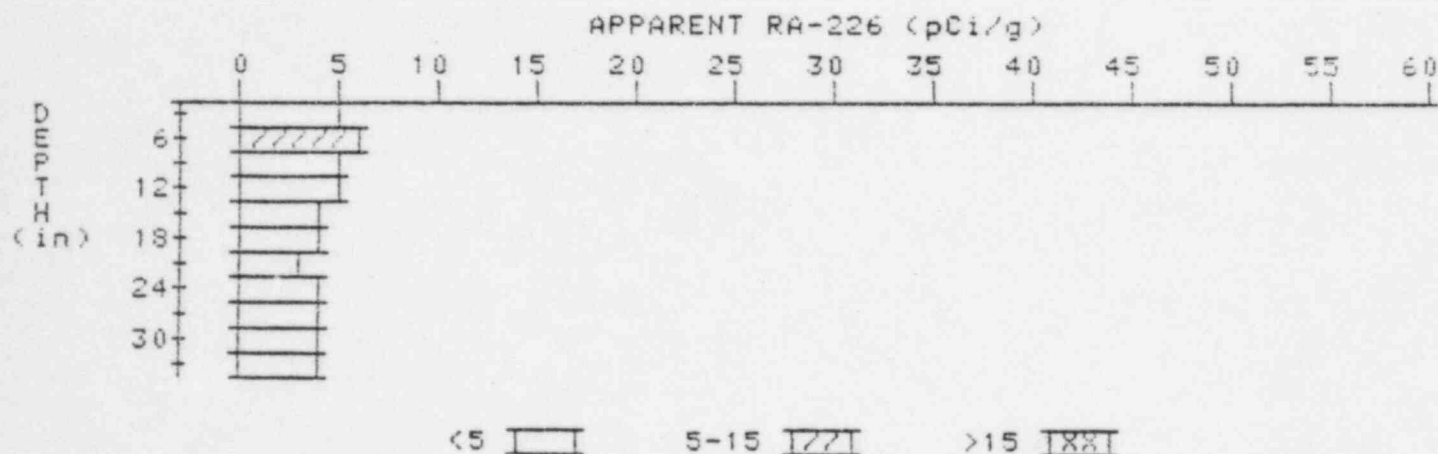
PROPERTY NUMBER: GJ-10972-RS
HOLE NUMBER: 3
LOCATION: 138208

Depth (in)	Apparent Radium-226 (pCi/g) Undeconvolved	Apparent Radium-226 (pCi/g) Deconvolved
3	4.7	4.7
6	5.0	5.9
9	4.3	5.0
12	4.5	4.5
15	4.2	3.8
18	4.1	4.3
21	3.9	3.4
24	4.0	4.4
27	3.9	3.7
30	3.9	3.9
33	3.9	3.9

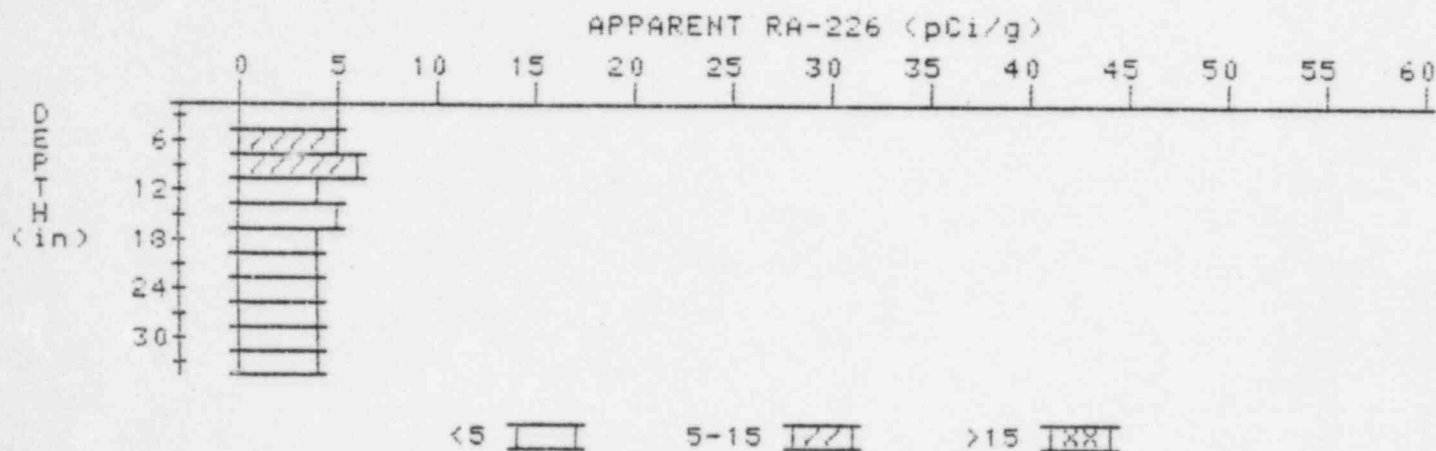
HOLE NUMBER: 8

Depth (in)	Apparent Radium-226 (pCi/g) Undeconvolved	Apparent Radium-226 (pCi/g) Deconvolved
3	4.7	4.7
6	4.9	5.3
9	4.9	5.6
12	4.5	3.8
15	4.5	4.9
18	4.3	4.3
21	4.1	3.7
24	4.1	4.3
27	4.0	4.0
30	3.9	3.5
33	4.0	4.0

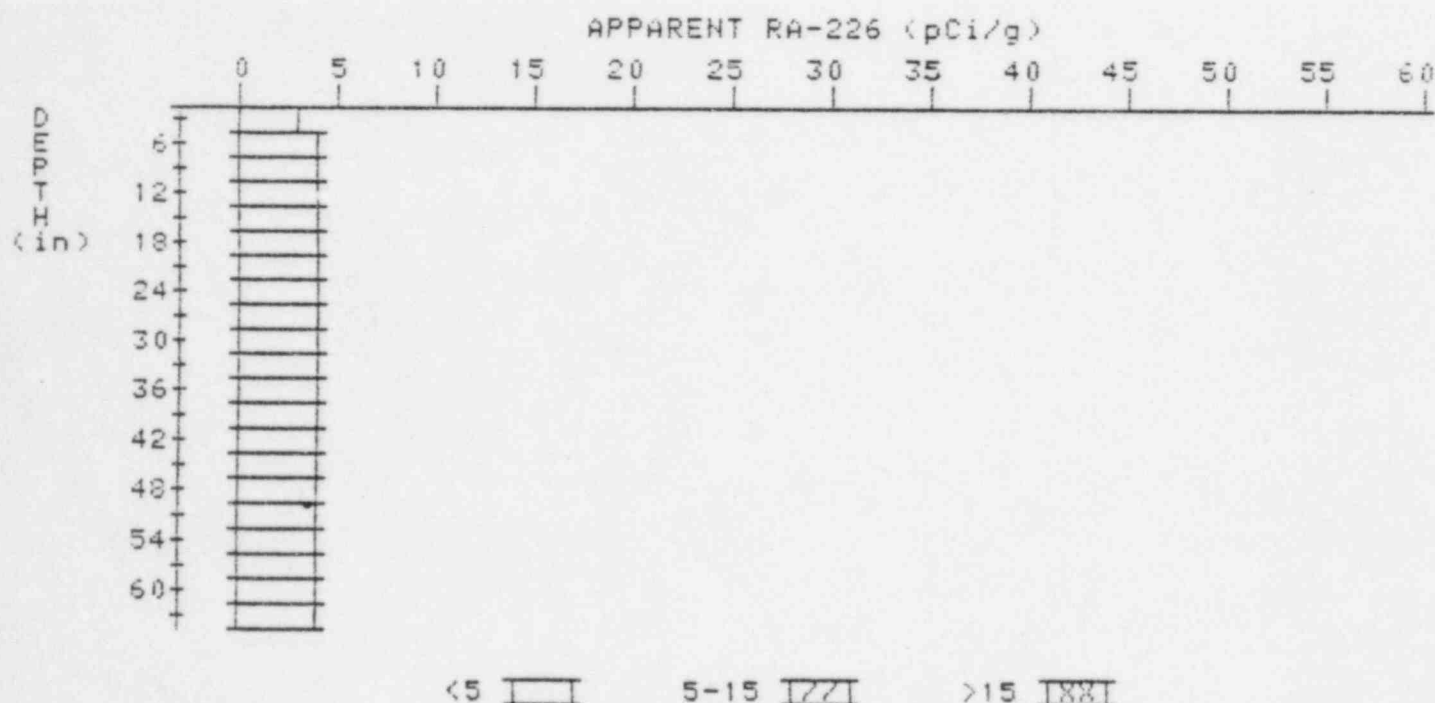
HOLE NUMBER: 18

Depth (in)	Apparent Radium-226 (pCi/g) Undeconvolved	Apparent Radium-226 (pCi/g) Deconvolved
3	3.3	3.3
6	3.5	3.7
9	3.6	3.6
12	3.7	3.7
15	3.8	4.0
18	3.8	3.8
21	3.8	3.8
24	3.8	3.6
27	3.9	4.1
30	3.9	3.9
33	3.9	4.1
36	3.8	3.6
39	3.8	3.8
42	3.8	3.6
45	3.9	4.3
48	3.8	3.6
51	3.8	3.8

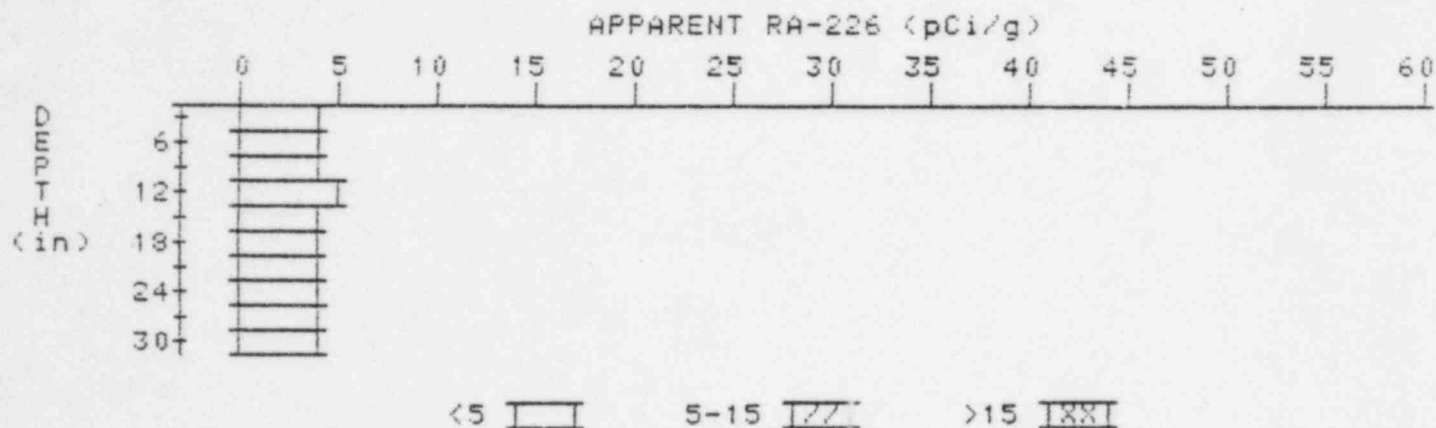
PROPERTY NUMBER: GJ-10972-RS
HOLE NUMBER: 20
LOCATION: 245208

Depth (in)	Apparent Radium-226 (pCi/g) Undeconvolved	Apparent Radium-226 (pCi/g) Deconvolved
3	4.4	4.4
6	4.4	4.4
9	4.4	4.4
12	4.4	4.6
15	4.3	4.1
18	4.3	4.3
21	4.3	4.5
24	4.2	4.4
27	4.0	3.6
30	4.0	4.0

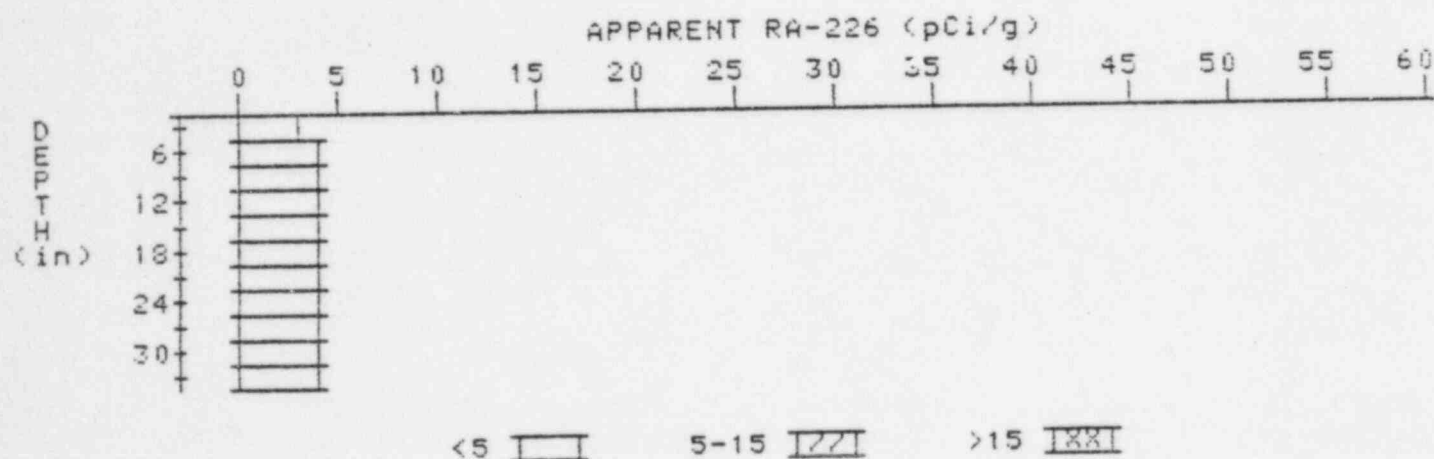
HOLE NUMBER: 22

Depth (in)	Apparent Radium-226 (pCi/g) Undeconvolved	Apparent Radium-226 (pCi/g) Deconvolved
3	3.2	3.2
6	3.5	3.9
9	3.6	3.6
12	3.7	3.7
15	3.8	4.0
18	3.8	3.8
21	3.8	3.8
24	3.8	3.8
27	3.8	4.0
30	3.7	3.7
33	3.6	3.6

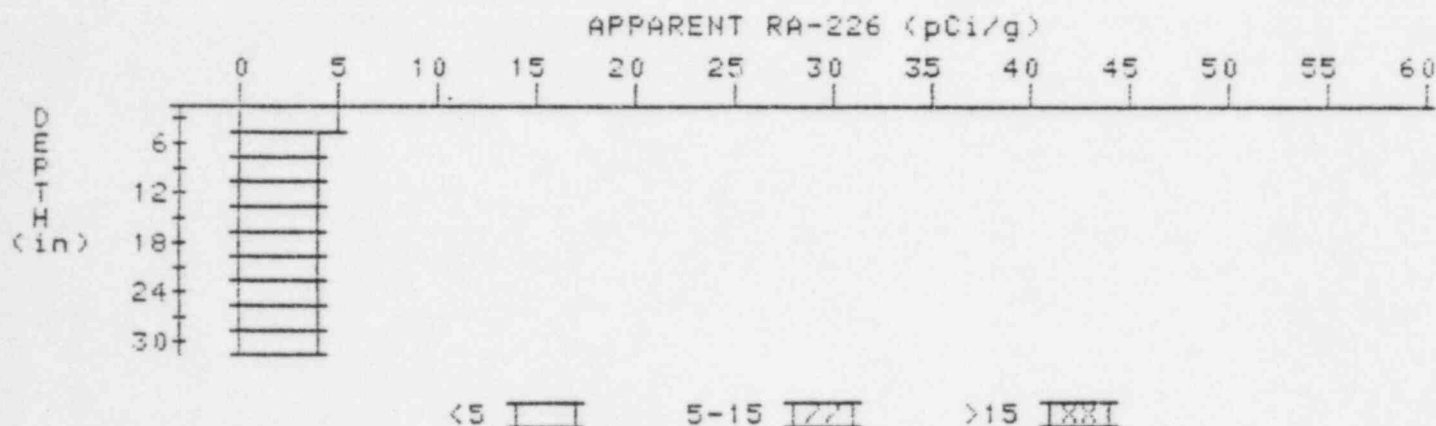
PROPERTY NUMBER: GJ-10972-RS
HOLE NUMBER: 32
LOCATION: 268255

Depth (in)	Apparent Radium-226 (pCi/g) Undeconvolved	Apparent Radium-226 (pCi/g) Deconvolved
3	4.8	4.8
6	4.4	3.9
9	4.3	4.3
12	4.2	4.0
15	4.2	4.4
18	4.1	4.1
21	4.0	3.8
24	4.0	4.0
27	4.0	4.2
30	3.9	3.9
