RADIOLOGIC AND ENGINEERING ASSESSMENT

DOE ID NO.: GJ-08841-RS  
ADDRESS: 2519 SOUTH BROADWAY

APRIL 1985  
REVISED AUGUST 1985

URANIUM MILL TAILINGS REMEDIAL ACTION PROJECT OFFICE

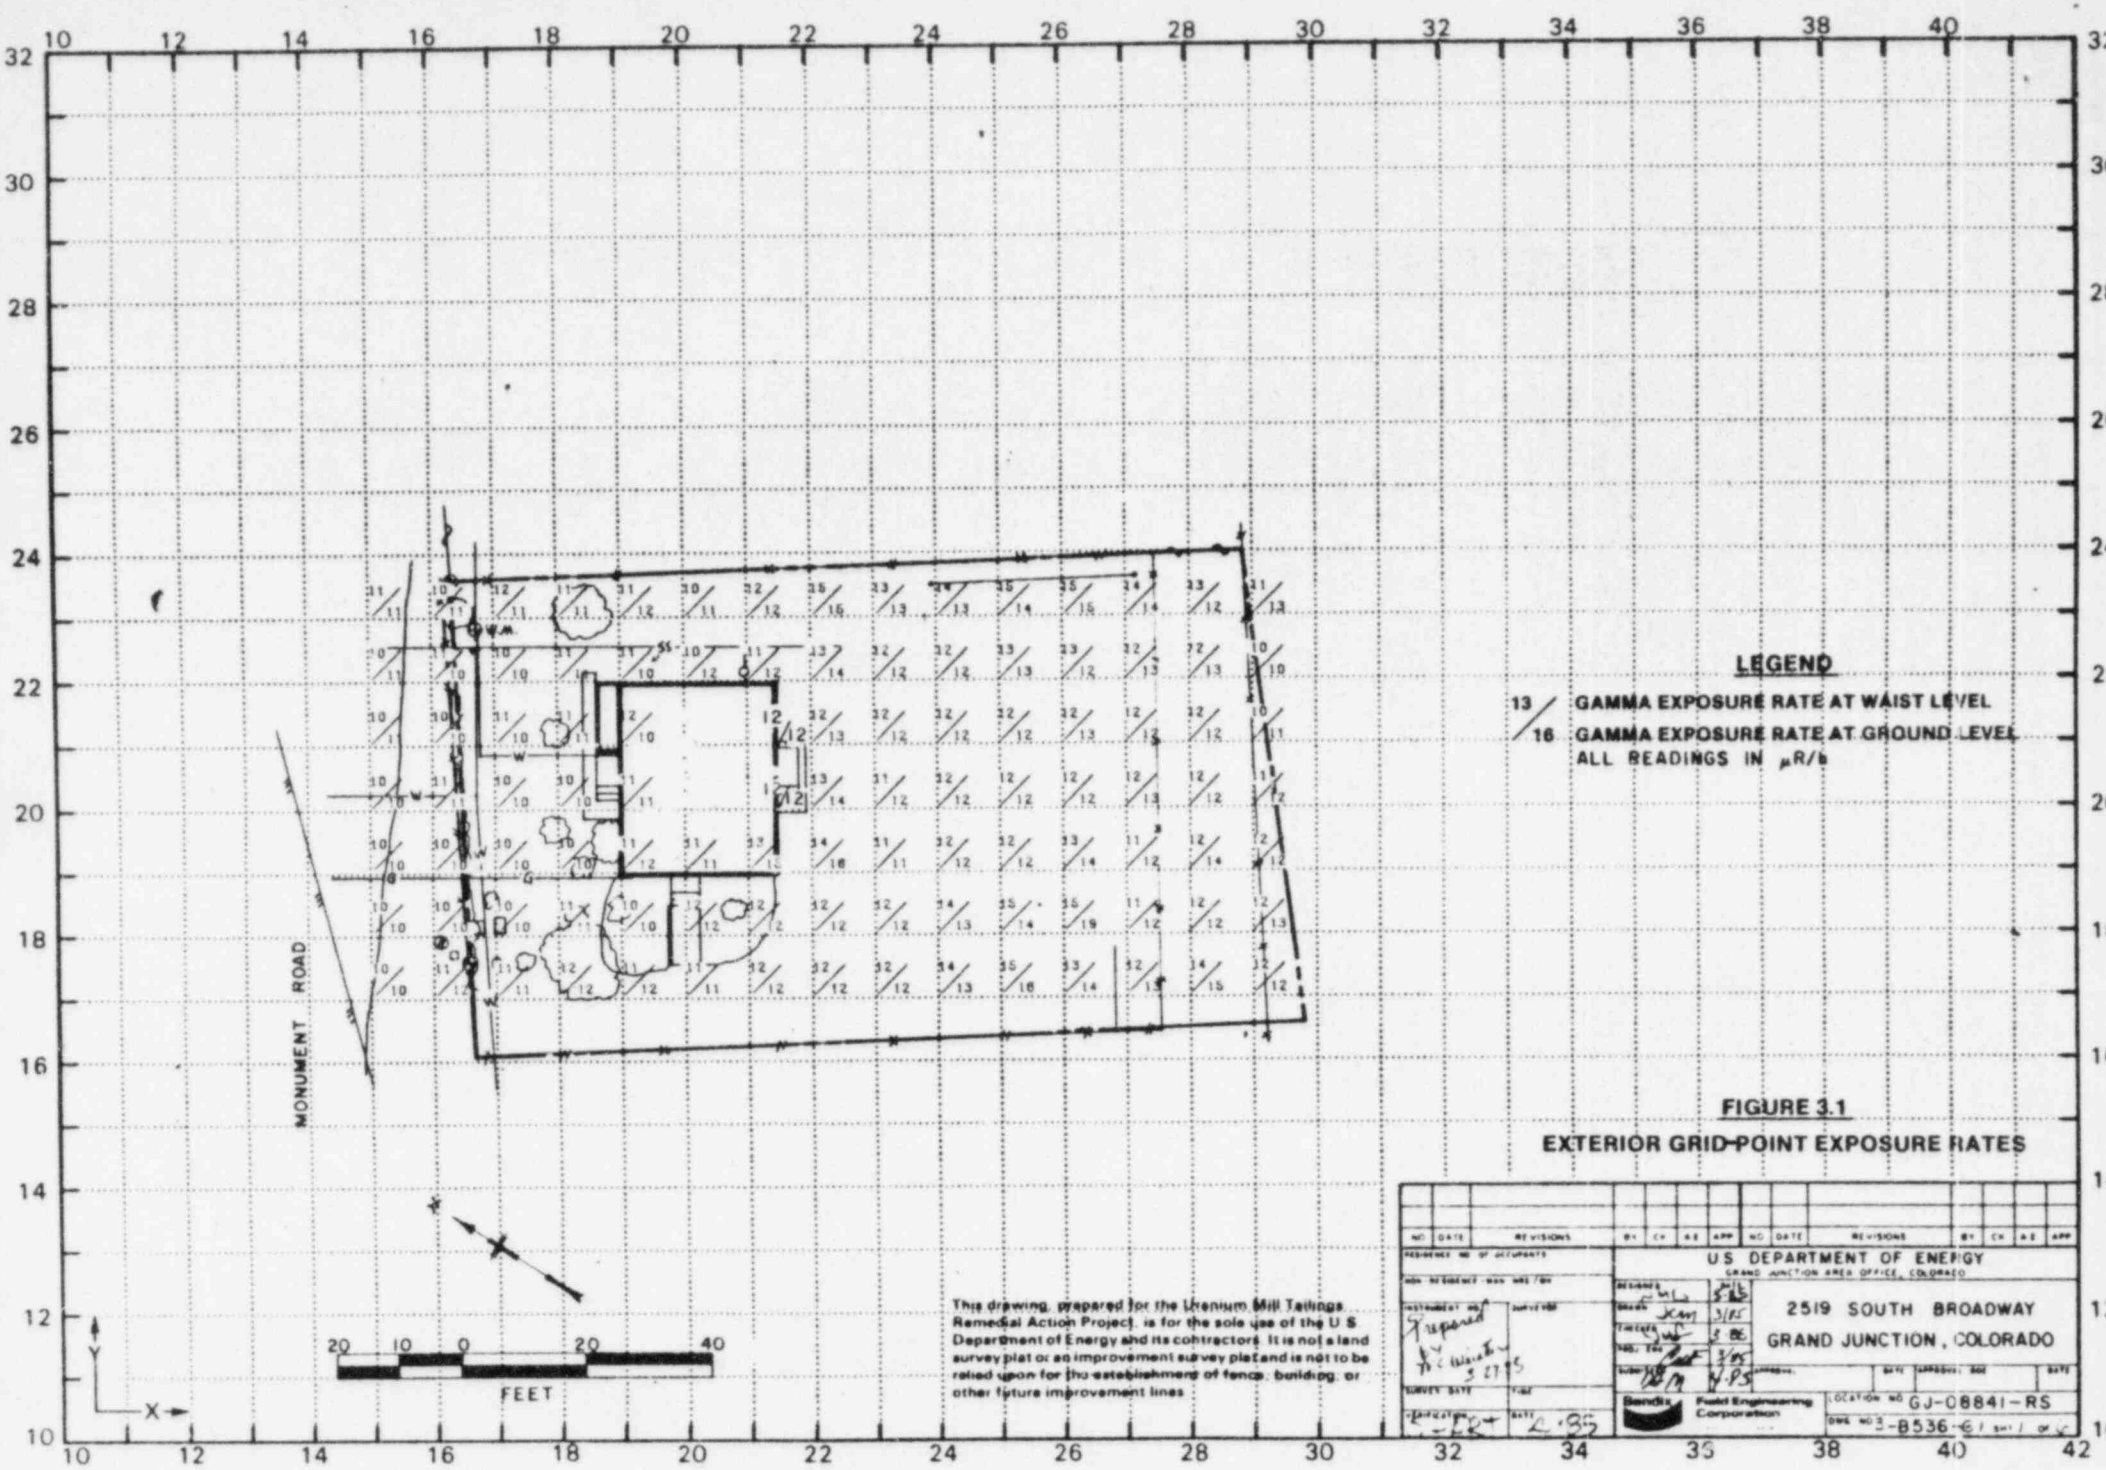
**FIGURE 3.1**

**EXTERIOR GRID-POINT EXPOSURE RATES**

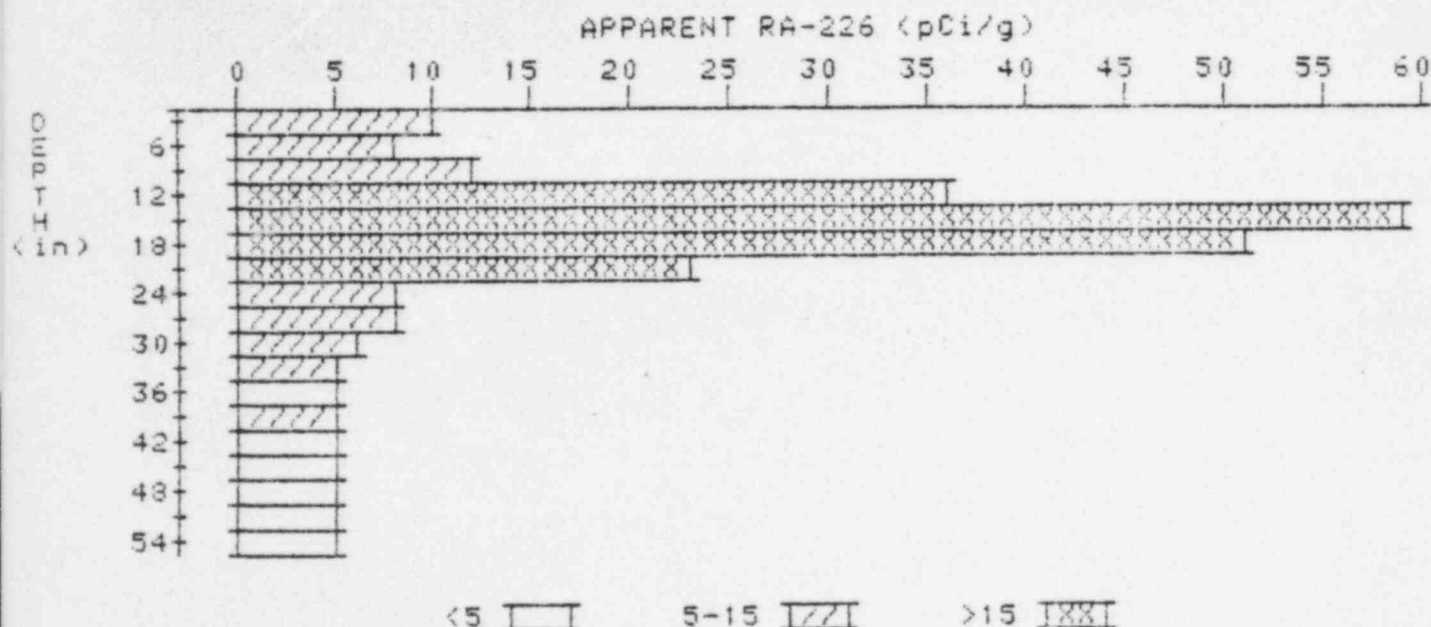
HOLE NUMBER: 9

Depth (in)	Apparent Radium-226 (pCi/g) Undeconvolved	Apparent Radium-226 (pCi/g) Deconvolved
3	10.4	10.4
6	13.6	7.7
9	20.1	12.3
12	31.0	35.8
15	39.2	58.8
18	36.4	50.8
21	25.5	22.8
24	16.1	7.9
27	11.3	8.1
30	8.3	5.8
33	6.7	5.5
36	5.8	4.9
39	5.4	5.4
42	5.0	4.6
45	4.8	4.6
48	4.7	4.5
51	4.7	4.9
54	4.6	4.6

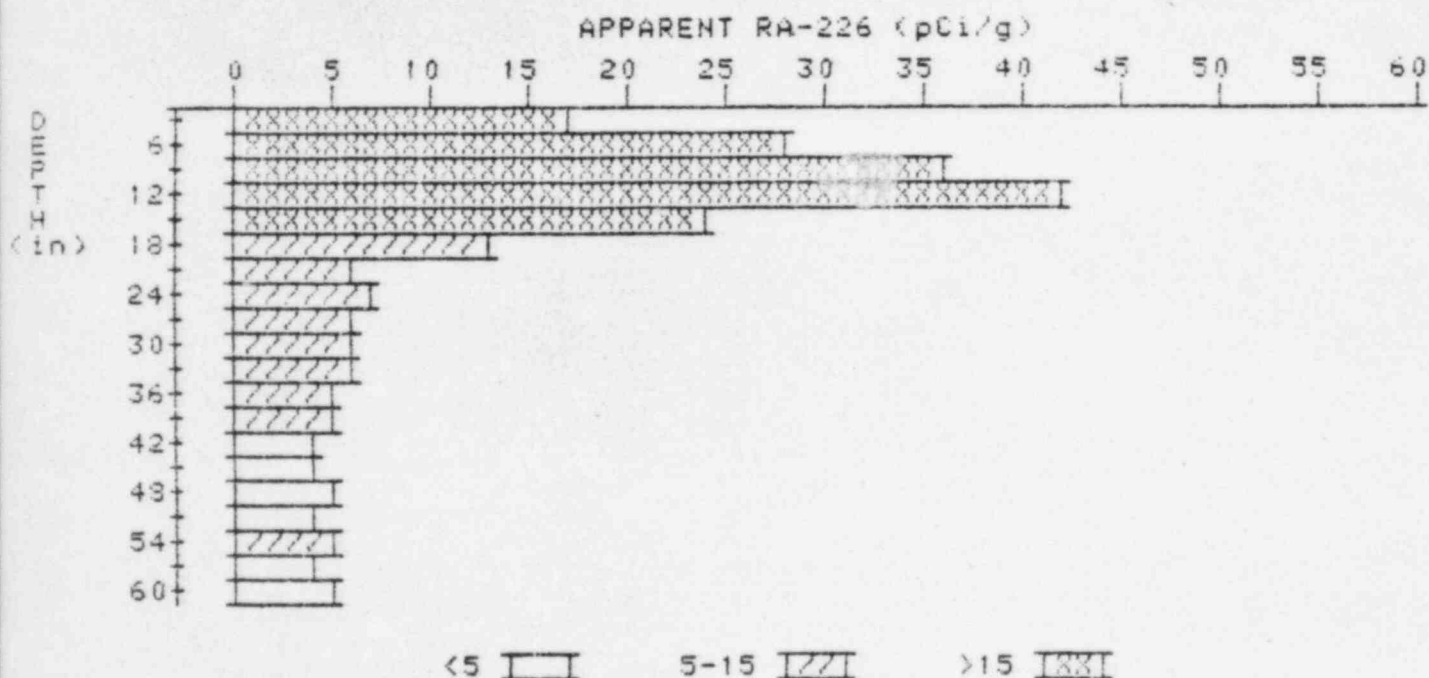
PROPERTY NUMBER: GJ-08941-RS  
HOLE NUMBER: 25  
LOCATION: 255175

Depth (in)	Apparent Radium-226 (pCi/g) Undeconvolved	Apparent Radium-226 (pCi/g) Deconvolved
3	16.8	16.8
6	23.8	27.5
9	28.7	36.2
12	29.4	41.7
15	23.2	24.4
18	16.3	13.3
21	11.1	6.3
24	8.6	7.0
27	7.0	5.6
30	6.2	5.7
33	5.7	5.5
36	5.3	5.1
39	5.0	5.0
42	4.7	4.3
45	4.6	4.4
48	4.6	4.6
51	4.6	4.4
54	4.7	5.1
