SUBJECT: CRACKING IN SEGMENT OF CORE SPRAY PIPING, PEACH BOTTOM ATOMIC POWER STATION (PBAPS), UNIT 3 (TAC NO. M88098)

PEACH BOTTOM ATOMIC POWER STATION, UNIT 3  
CORE SPRAY DOWNCOMER

CORE SPRAY LINE DOWNCOMER BRACKET  
STRESS ASSESSMENT REPORT  
for  
PEACH BOTTOM ATOMIC POWER STATION, UNIT 3  
Modification P00335

SUBJECT: REPAIR OF FLAWS FOUND IN CORE SPRAY DOWNCOMER JOINTS, PEACH BOTTOM  
ATOMIC POWER STATION, UNIT NO. 3 (TAC NO. M92639)

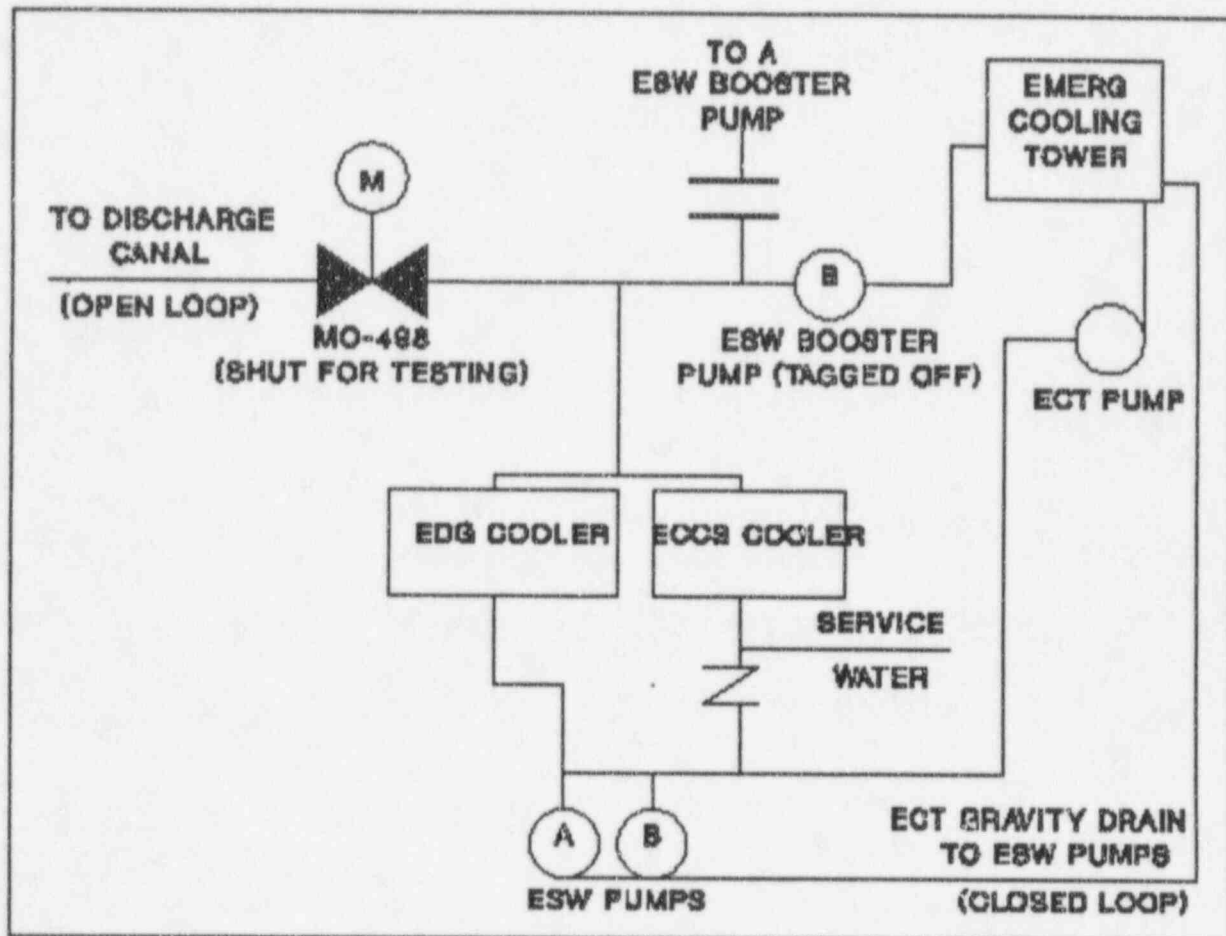
ESW FLOW DIAGRAM

The inspectors concluded that the overall safety consequence of this event was small since no conditions occurred that required the use of the EDGs and ECCS equipment, during the time that valve MO-498 was shut; however, the failure of the plant staff to ensure an adequate review of this situation, initially and afterward, represented a significant degradation in plant safety. The lower than design ESW flows could have unknowingly affected the operability of the EDGs and ECCS equipment. The effect could have been to place both units in an unanalyzed condition for assumed EDG and ECCS availability with respect to the worst case DBA analysis discussed in section 2.2.1.

- PECO Energy conducted the maintenance activity on valve MO-498 without completing a safety review to determine that it did not represent an unreviewed safety question. 10 CFR 50.59 required that PECO Energy perform a written safety evaluation prior to making a facility change to ensure it did not involve an unreviewed safety question. Contrary to the above, PECO Energy did not perform an analysis prior to making this change. This is an apparent violation of 10 CFR 50.59.

- Procedures were not in place to ensure that the ESW system would be able to perform its design function in the event of an accident. Procedures specifying that MO-498 needed to be opened in the event of an accident were not in place prior to the maintenance activity. This was significant given the importance of the MO-498 valve and the nature of the maintenance activity (VOTES testing) where the component had the potential to be left closed for an extended time. This was in apparent violation of 10 CFR 50, Appendix B, Criterion III, Design Controls.

- PECO energy did not identify that closing MO-498 altered the emergency service water system flow path and thus affected the flow rates to safety-related components, during their initial PEP review. The PECO Energy staff focused on the emergency cooling tower overflowing, not on any potential safety effects of the closure of MO-498. This represented an apparent violation of 10 CFR 50, Appendix B, Criterion XVI, Corrective Actions.
