RADIOLOGIC AND ENGINEERING ASSESSMENT

DOE ID NO.: GJ-12935-MR
ADDRESS: 532 WEST COLORADO AVENUE

JULY 1985

BENDIX FIELD ENGINEERING CORPORATION
P.O. Box 1569
Grand Junction, Colorado 81502

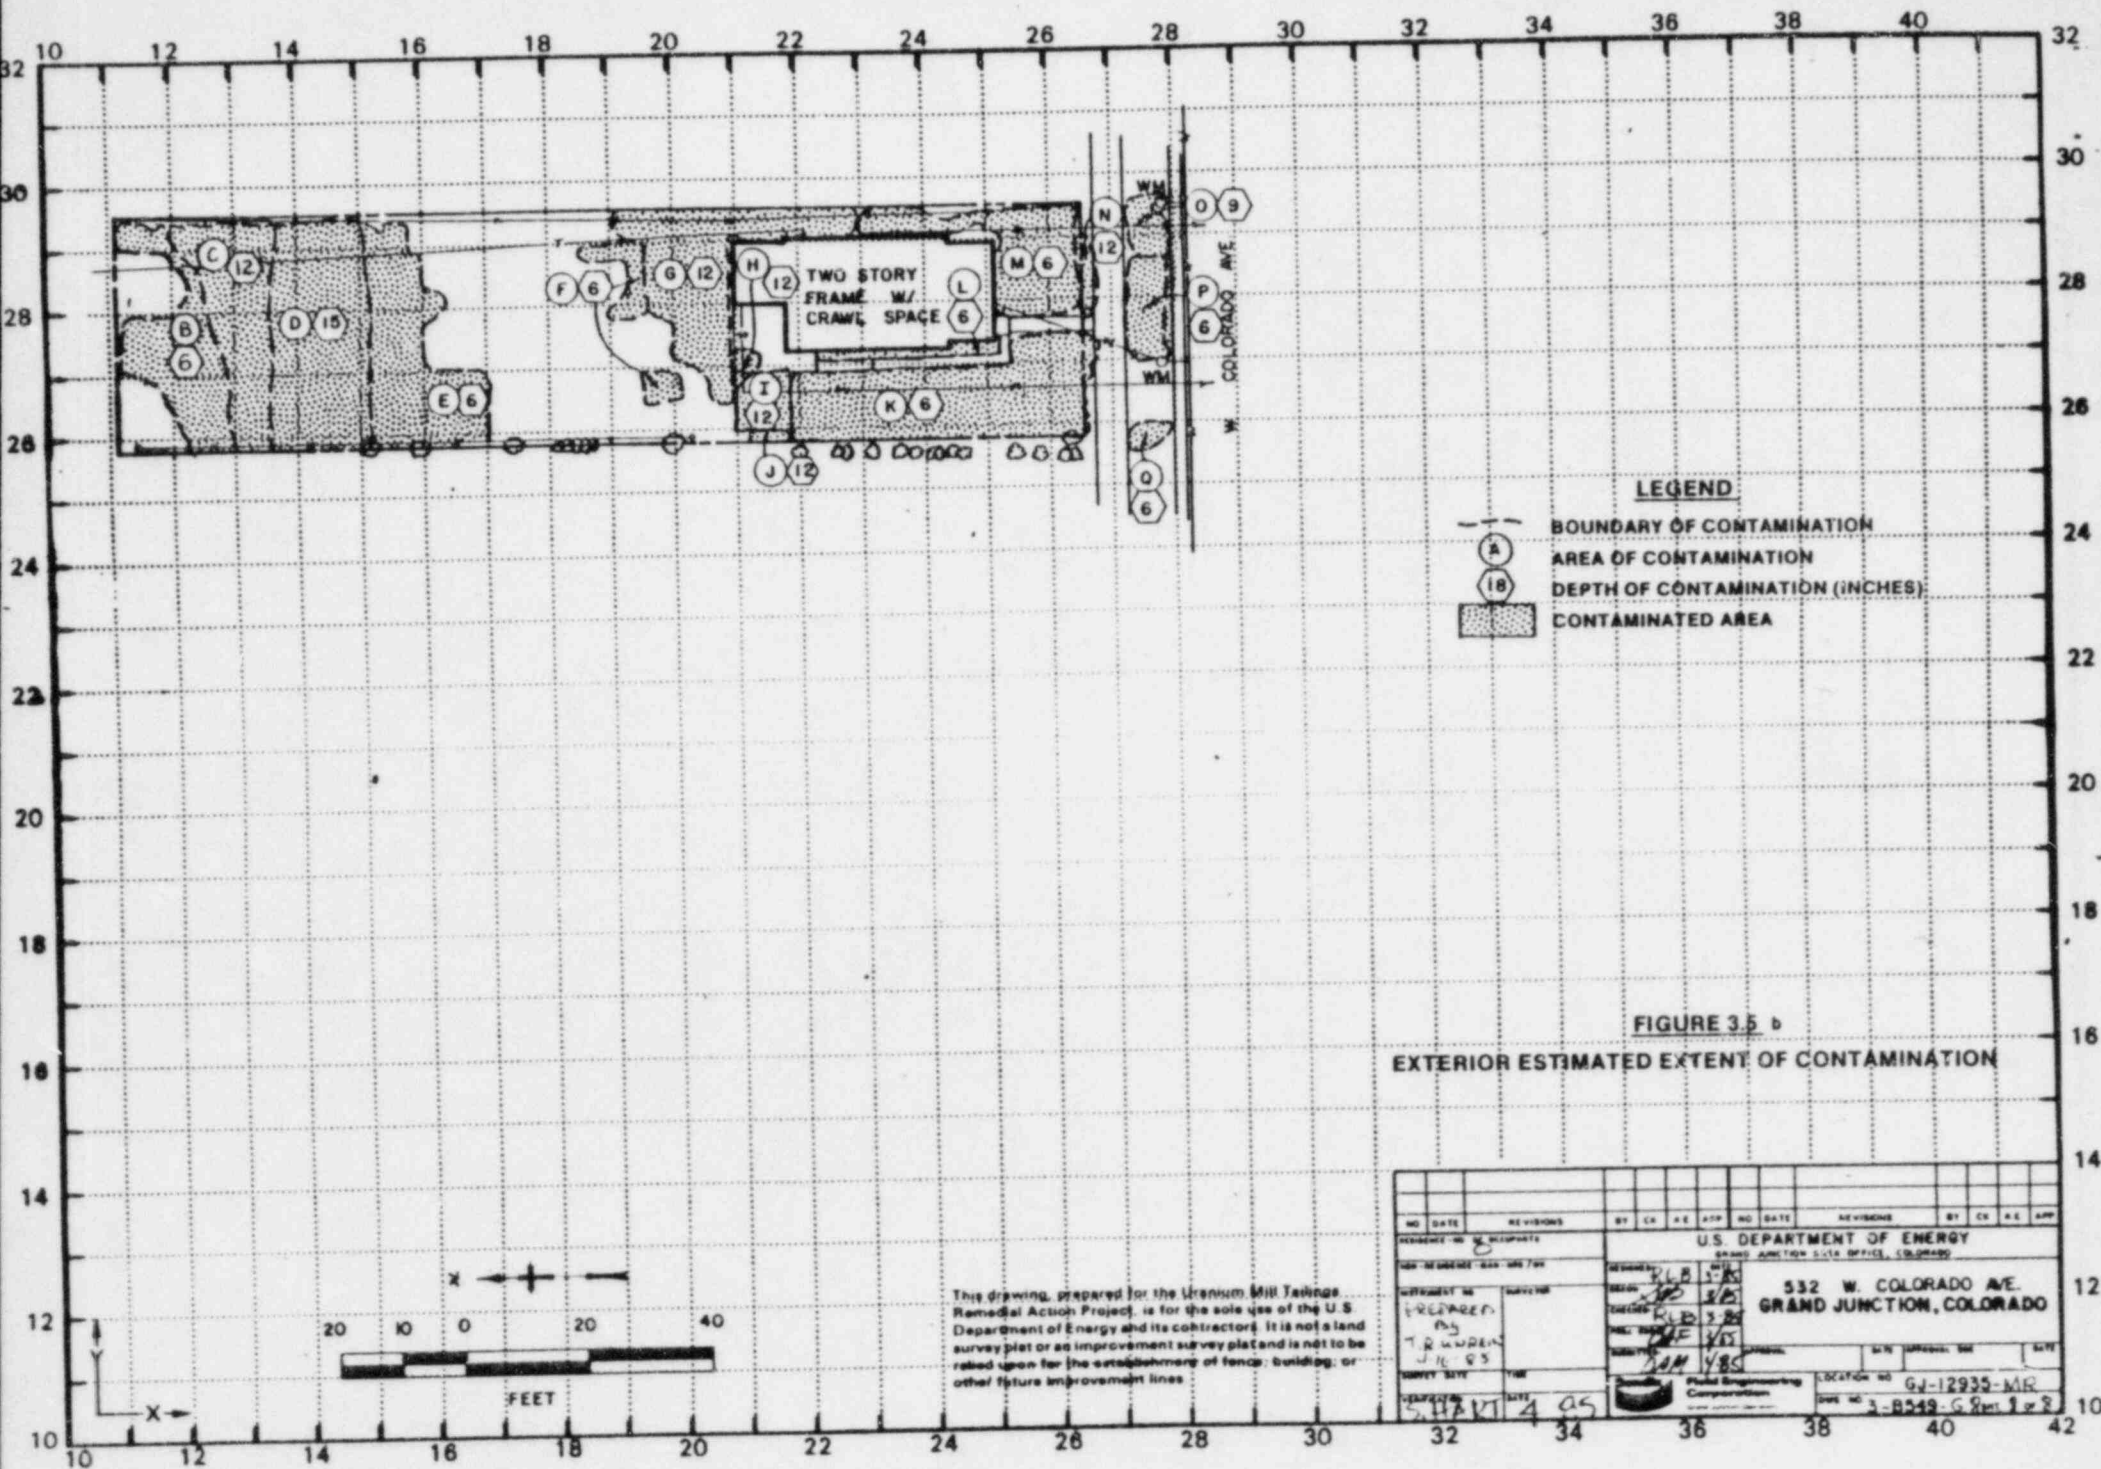
Appendix Figures 3.5a and 3.5b show identified areas and estimated depths of contamination on this property, based on assessments of all measurements taken. As noted in these figures, areas recommended for remedial action that contain identified residual radioactive materials are:

Under the north addition (Area A), elevated gamma readings were observed. Minimal exploration could be done to accurately identify the extent of this contamination. The deposit may extend beyond the boundaries indicated on Appendix Figure 3.5b.

The recommended remedial action for this property, DOE ID No. GJ-12935-MR, includes removal of all areas identified as containing radioactive material (as discussed in Section 3.5 and shown in Appendix Figures 3.5a and 3.5b) and transport of removed material to the disposal site.
