**RADIOLOGIC AND ENGINEERING ASSESSMENT**

DOE ID NO.: GJ-00110-RS  
ADDRESS: 2524 MESA AVENUE

JULY 1985

URANIUM MILL TAILINGS REMEDIAL ACTION PROJECT OFFICE

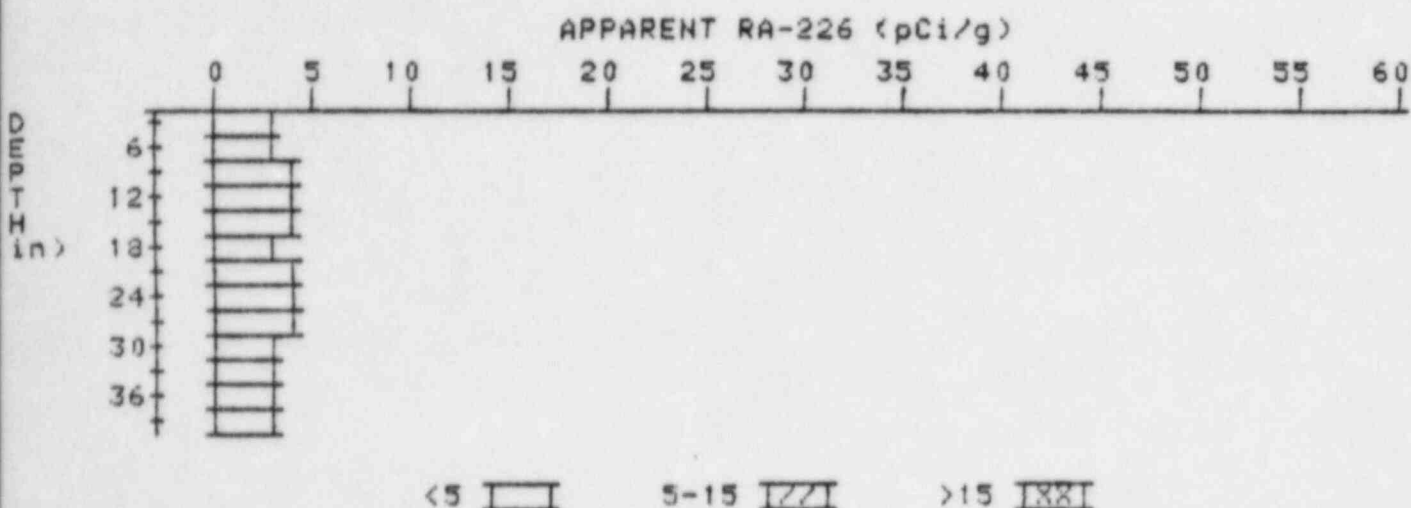
PROPERTY NUMBER: GJ-00110-RS  
HOLE NUMBER: 1  
LOCATION: 160240

Depth (in)	Apparent Radium-226 (pCi/g) Undeconvolved	Apparent Radium-226 (pCi/g) Deconvolved
3	2.7	2.7
6	3.1	3.3
9	3.4	3.8
12	3.5	3.5
15	3.6	4.0
18	3.5	3.3
21	3.5	3.5
24	3.5	3.7
27	3.4	3.8
30	3.1	2.6
33	3.1	3.1
36	3.1	3.3
39	3.0	3.0

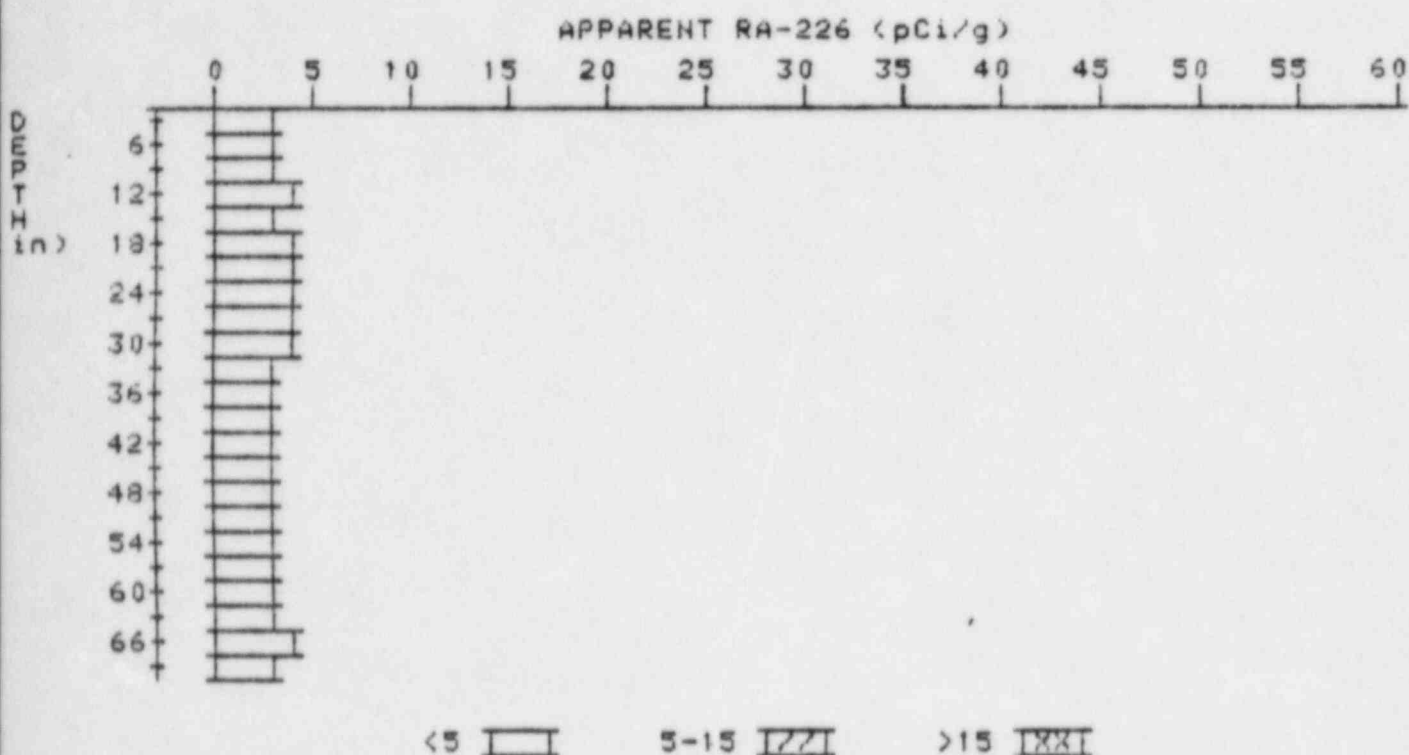
PROPERTY NUMBER: GJ-00110-RS  
HOLE NUMBER: 3  
LOCATION: 182240

Depth (in)	Apparent Radium-226 (pCi/g) Undeconvolved	Apparent Radium-226 (pCi/g) Deconvolved
3	2.8	2.8
6	3.0	3.0
9	3.2	3.2
12	3.4	3.3
15	3.4	3.2
18	3.5	3.5
21	3.6	3.6
24	3.7	3.7
27	3.8	4.3
30	3.6	3.8
33	3.3	3.1
36	3.1	2.9
39	3.0	2.8
42	3.0	3.0
45	3.0	2.8

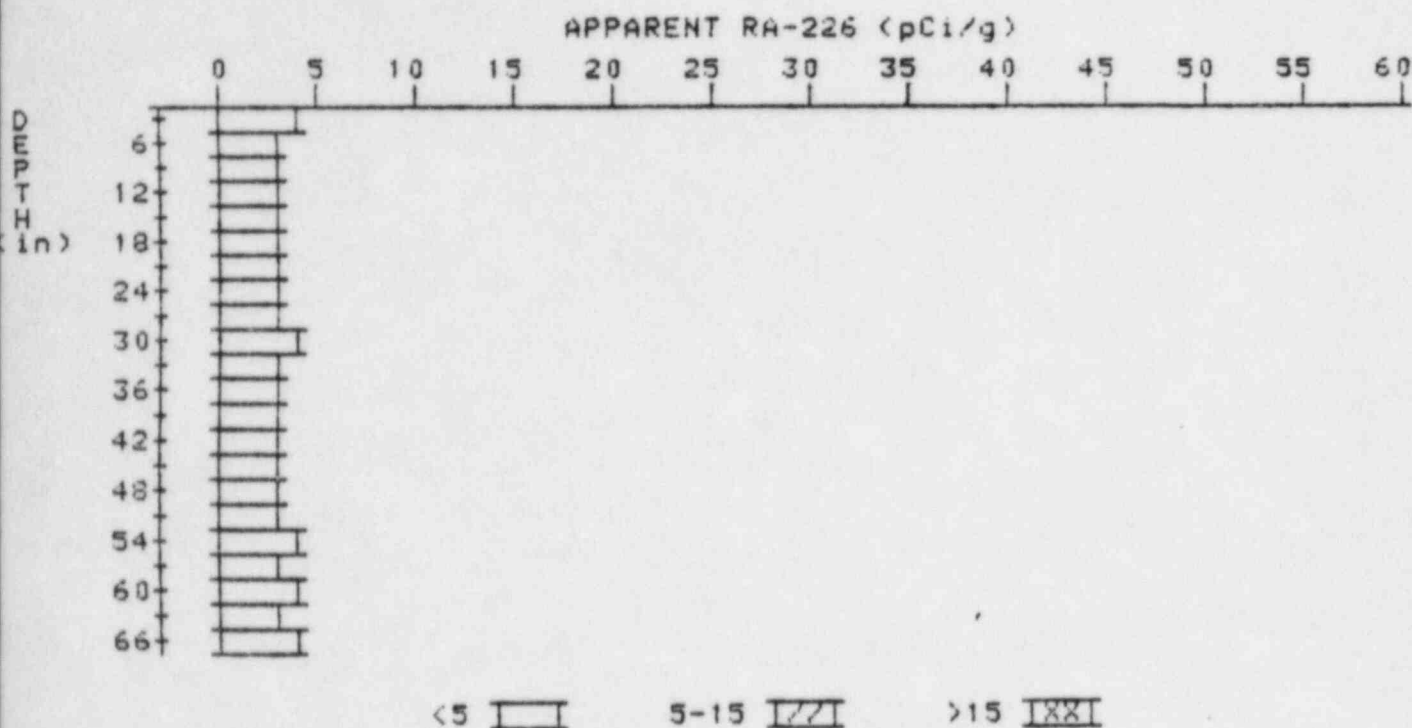
HOLE NUMBER: 7

Depth (in)	Apparent Radium-226 (pCi/g) Undeconvolved	Apparent Radium-226 (pCi/g) Deconvolved
3	3.5	3.5
6	3.4	3.2
9	3.4	3.4
12	3.4	3.4
15	3.4	3.4
18	3.4	3.4
21	3.4	3.4
24	3.4	3.4
27	3.4	3.4
30	3.4	3.6
33	3.3	3.1
36	3.3	3.5
39	3.2	3.0
42	3.2	3.0
45	3.3	3.5
48	3.3	3.3

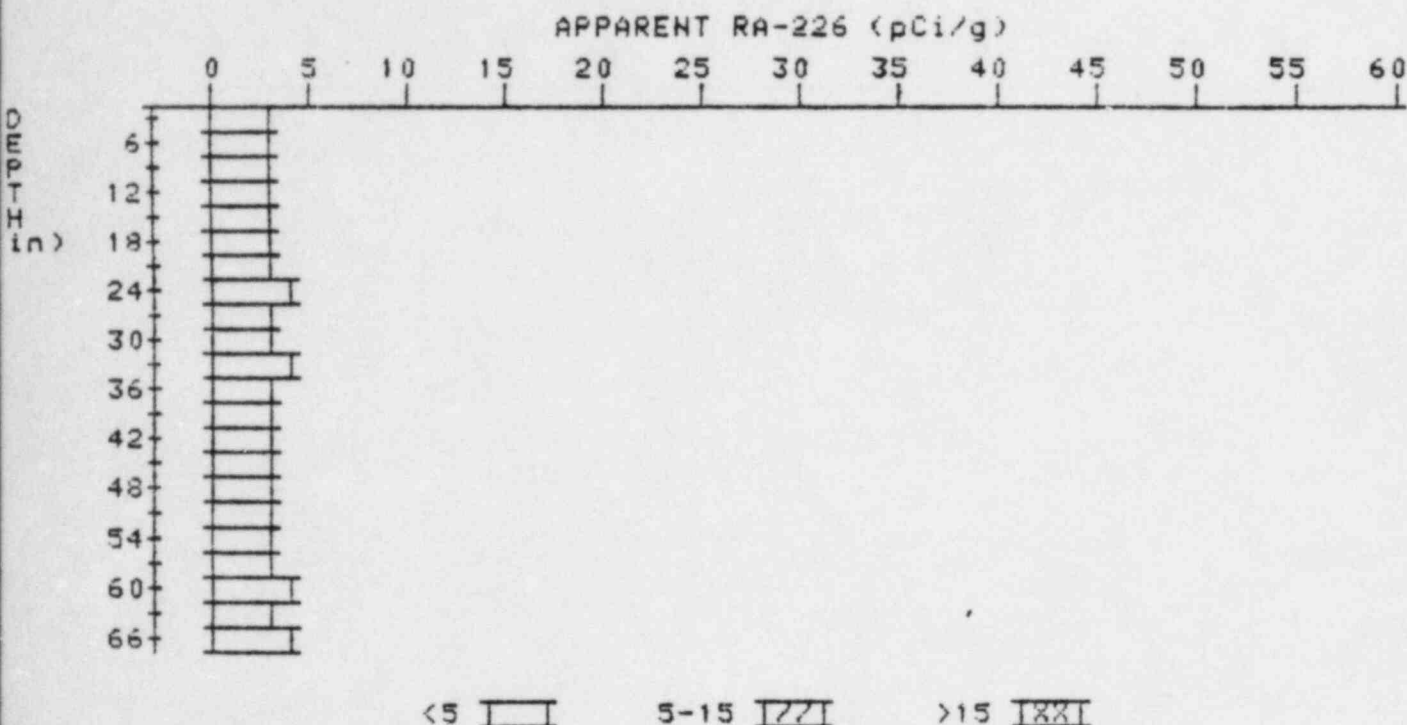
HOLE NUMBER: 9

Depth (in)	Apparent Radium-226 (pCi/g) Undeconvolved	Apparent Radium-226 (pCi/g) Deconvolved
3	2.8	2.8
6	2.9	2.9
9	3.0	3.2
12	3.0	2.8
15	3.1	3.3
18	3.1	2.9
21	3.2	3.2
24	3.3	3.7
27	3.2	3.0
30	3.2	3.0
33	3.3	3.7
36	3.2	3.0
39	3.2	3.2
42	3.2	3.2
45	3.2	3.0
48	3.3	3.5

51	3.3	3.3
54	3.3	3.3
57	3.3	3.1
60	3.4	3.8
63	3.3	2.8
66	3.5	3.5
