SUBJECT: MANAGEMENT MEETING TO DISCUSS SERVICE WATER SYSTEM
PERFORMANCE

Zebra Mussels

Condition Description and Corrective Actions

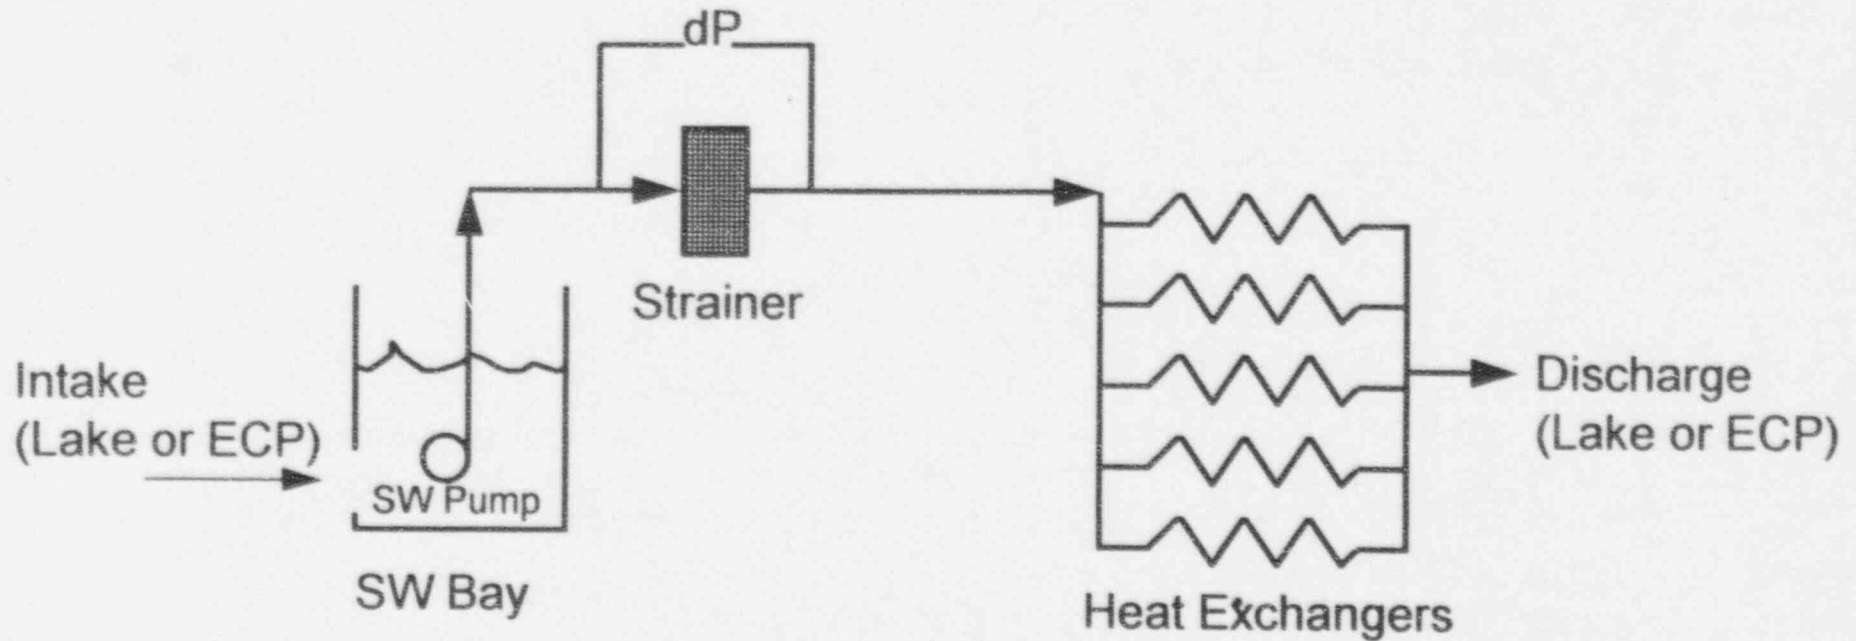
Service Water Strainer

- September 1992 - Zebra mussels detected in Lake Dardanelle
- September 1993 - Zebra mussels noted in Unit 1 CW bays
- No significant increase noted until March 1996
- July 1996 - High dP alarm on Unit 1 SW strainers
- September 1996 - Inspections confirmed that the numbers of zebra mussels had increased and excessive sluice gate leakage noted

- Sluice gate leakage
 - » Impact on ECP inventory control from sluice gate leakage was limited
- SW strainer dP
 - » SW system performance impact from pump discharge strainer delta P due to sediment deposits in the service water bays
 - Zebra mussel shell fragments are primary concern
 - Strainer dP setpoint conservatively set
 - Post event reviews show no operability concern

- Increased Unit 1 strainer area
 - » Holes in Basket Bottom
- Evaluate strainer basket redesign to increase area
- Evaluate strainer redesign
- Evaluate hydraulic modifications to SW bays to limit availability of strainer clogging material
 - » Experiment currently running at Alden Labs
- Evaluate modifying sluice gate operation to minimize turbulence on transfer from lake to pond
- Evaluate adding internal lake side sluice gates
- Evaluate revising sluice gate leakage test to demonstrate effectiveness of operator action
- Evaluate provision of ECP make-up possibilities
- Evaluate traveling screen and traveling screen wash system improvements

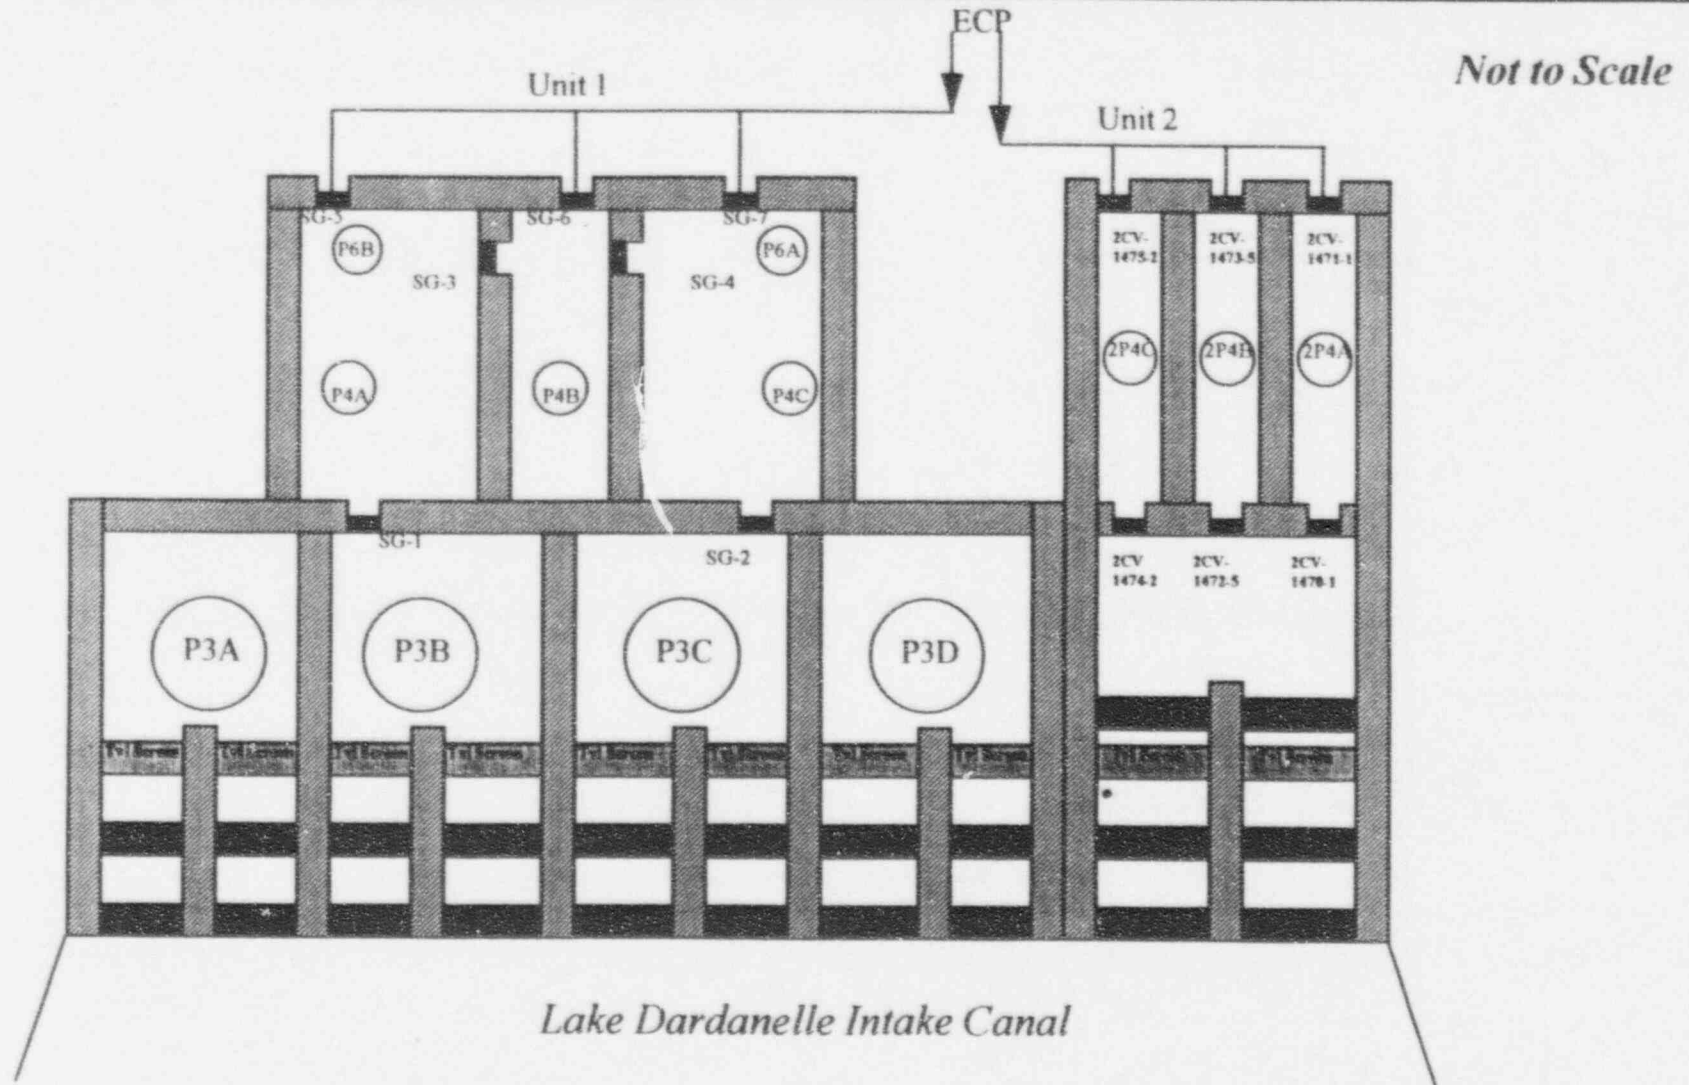
Unit 1 and Unit 2 Intake Structure

- A zebra mussel infestation of the circulating water (CW) system bays on Unit 1 and of the intake structure forebays on Unit 2
 - » The degree of infestation was graduated from very heavy on Unit 1 "B" CW to light in front of Unit 2
 - » No live marine growth observed in the SW system or established live marine growth in structures downstream of the service water (SW) bay inlets
 - Verified by component inspections and Unit 1 emergency cooling pond (ECP) suction line video inspection
 - Routine monitoring and treatment for zebra mussels in the ECP
 - SW bay inspections
- Silt deposits in the intake canal settling basin area immediately in front of the intake structure and in SW bays

- Drained and cleaned all Unit 1 SW bays during 1R13
- Inspected and cleaned all Unit 2 SW bays with divers
- Drained and cleaned Unit 1 "B" and "C" CW bays during 1R13
- Cleaned loose material from Unit 2 forebays with divers
- Cleaned sediment basin twelve feet in front of Unit 1 intake structure with sloping transition to remaining sediment deposits
- Scheduled dredging of entire sediment basin in first quarter 1997
