UNITED STATES OF AMERICA
NUCLEAR REGULATORY COMMISSION

COMMISSION MEETING

Briefing on Davis Besse

Date: Wednesday, July 24, 1985

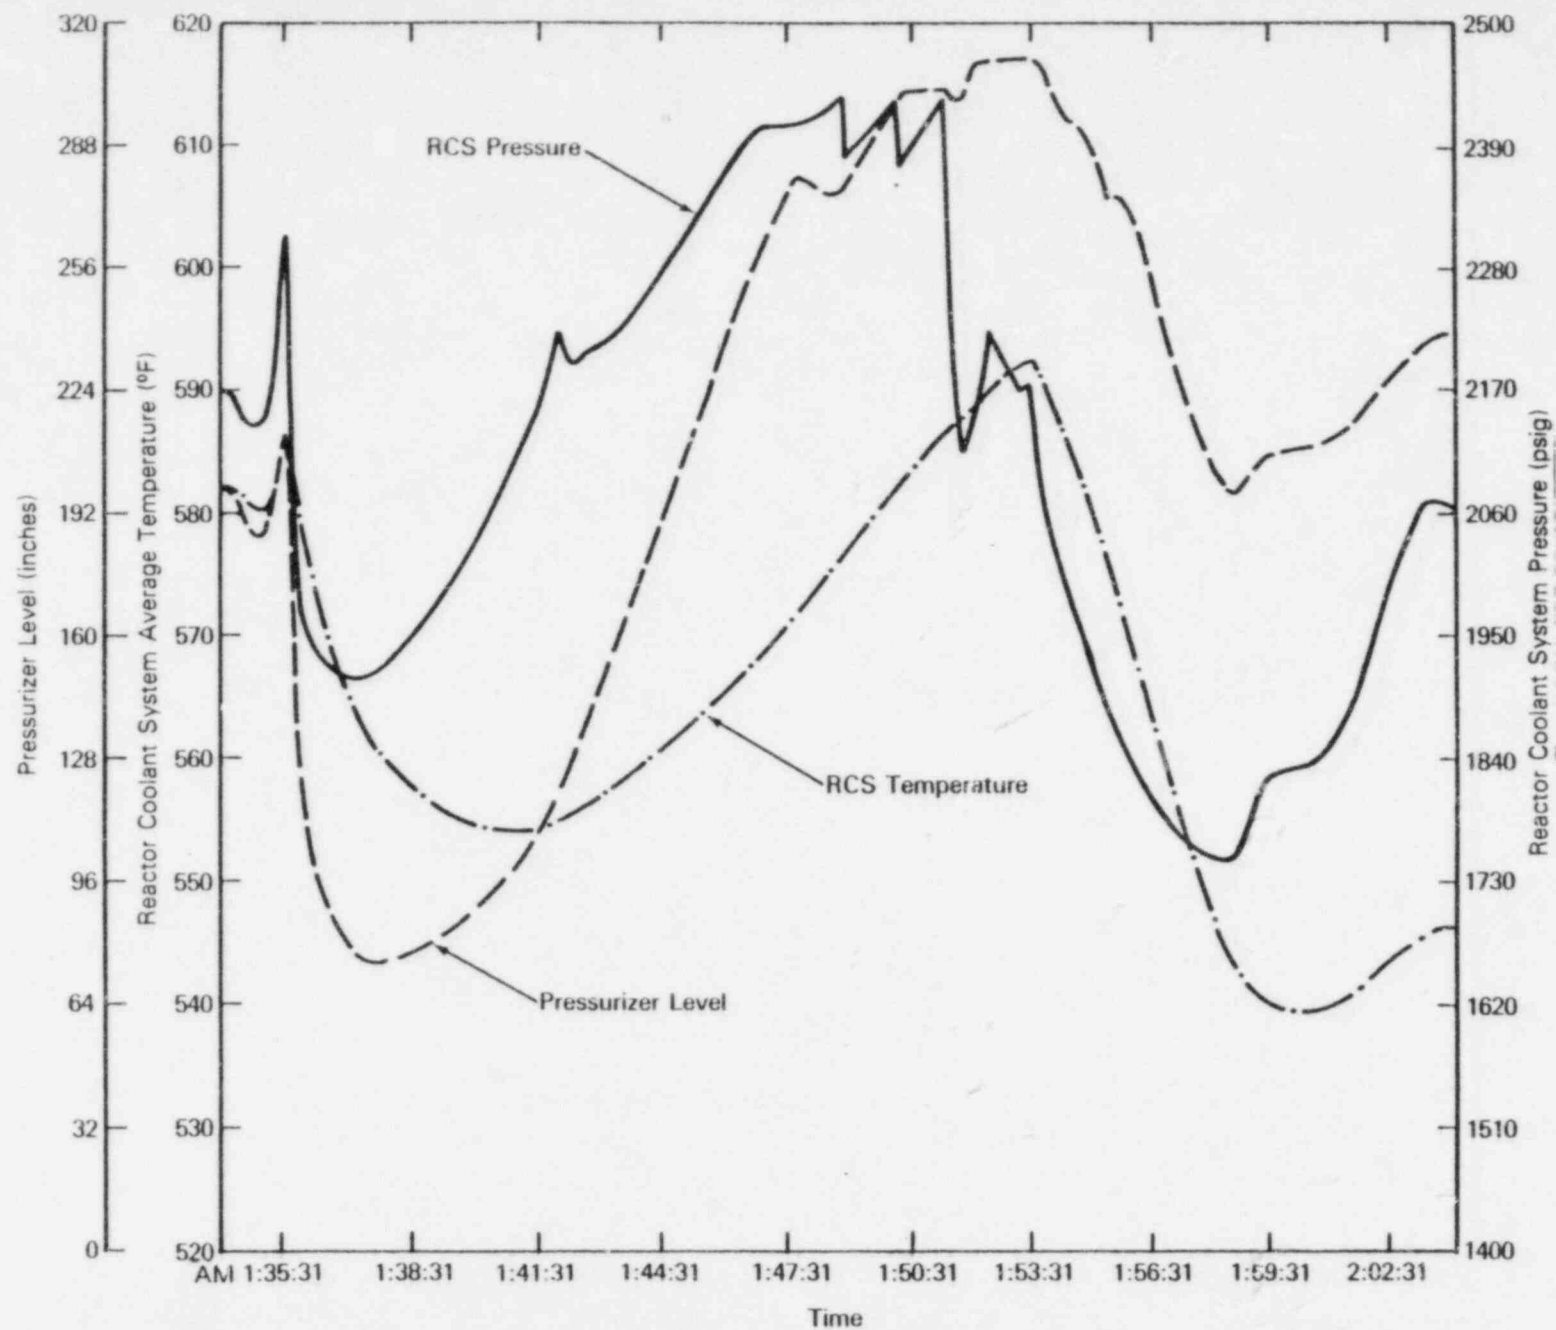
Figure 3.1 Reactor Coolant System and Pressurizer Response as a Function of Time, June 9, 1985

1. The above sequence of events is based upon combining information obtained from plant computer printouts and operator interviews.
 2. Adequate subcooled margin was available throughout the transient. The Reactor Coolant Pumps remained in operation. The Quench Tank contained the discharges from the PORV.
 3. There is a question regarding the operation of the atmospheric vent valves.
-

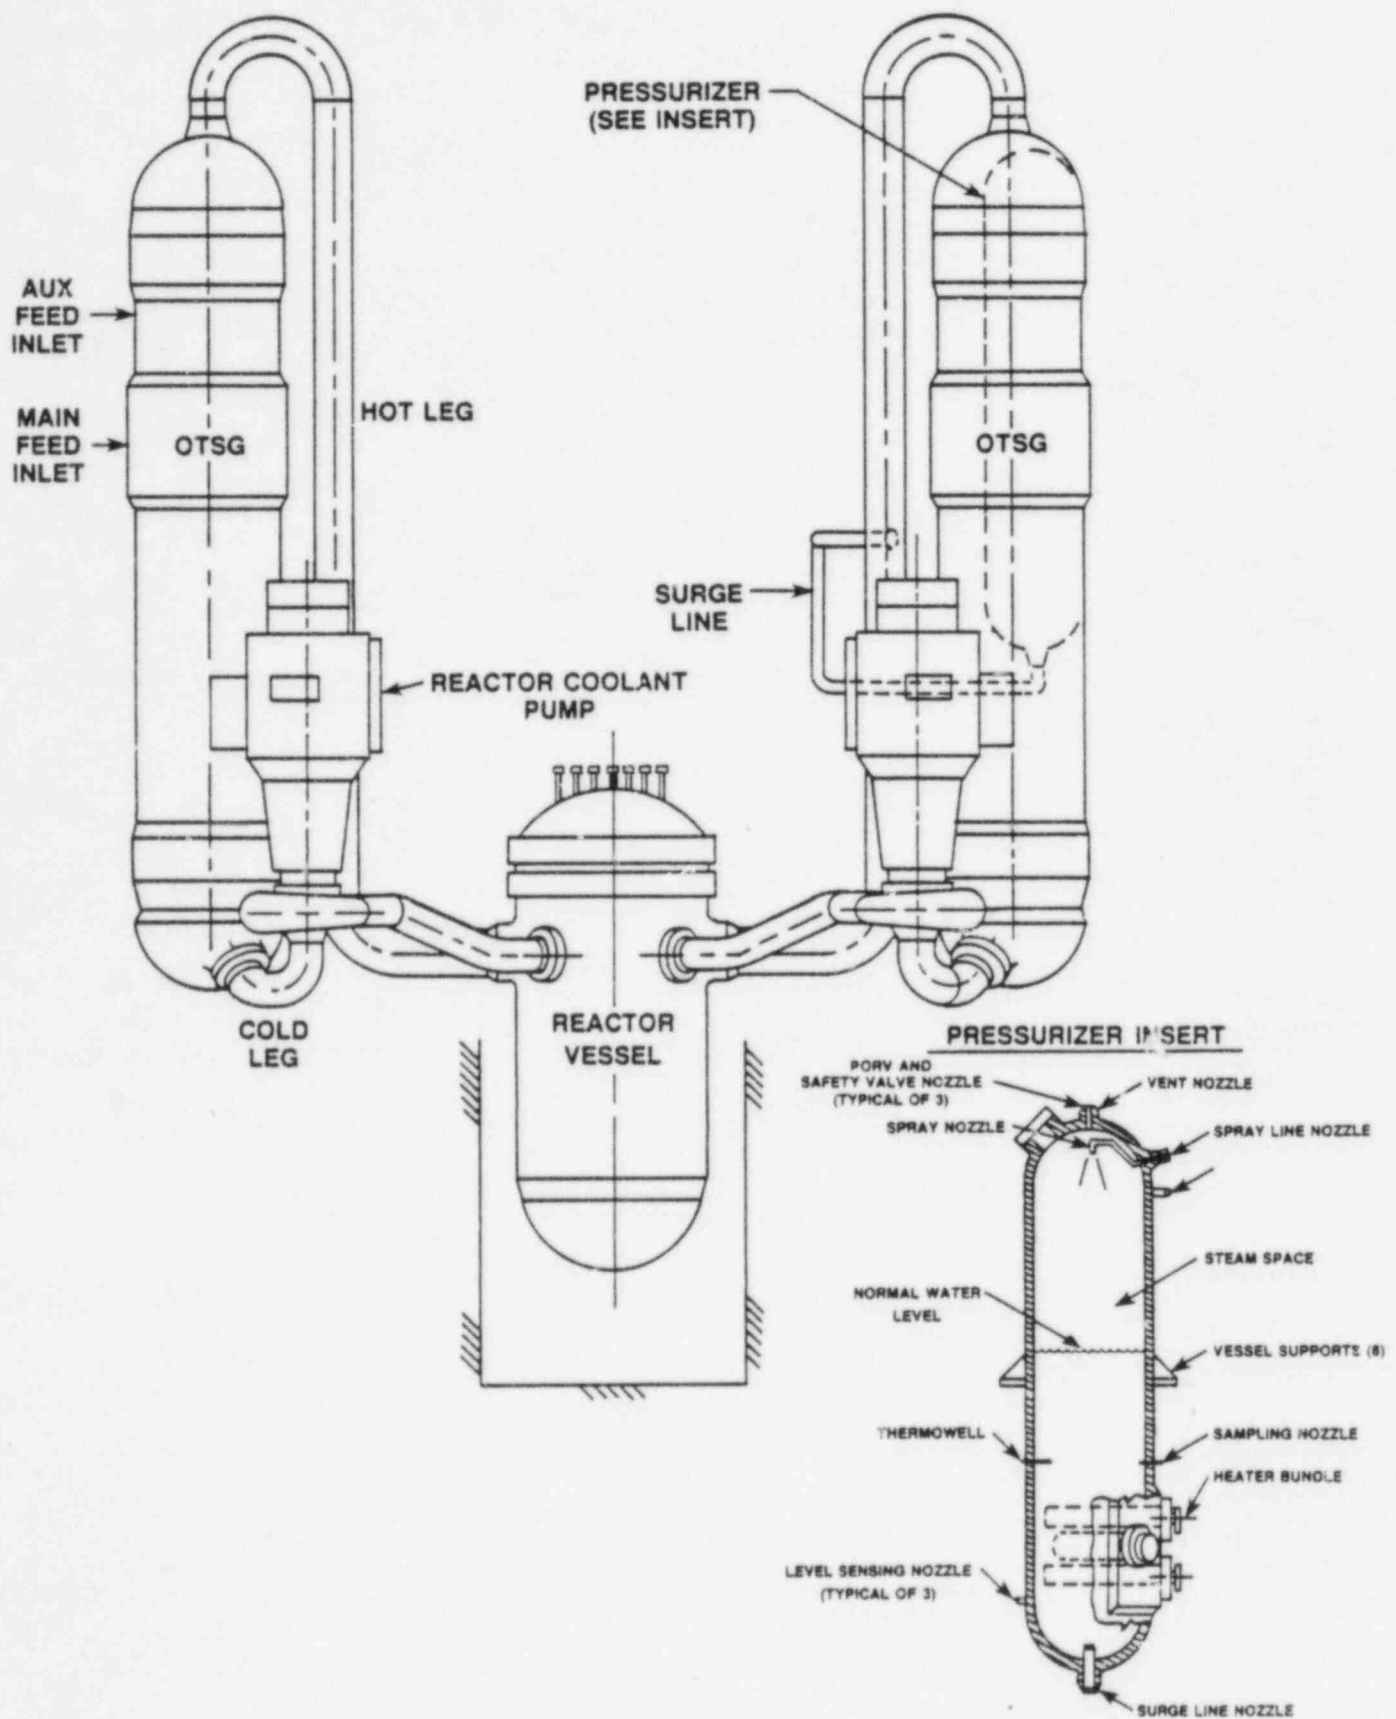
Figure 4.1 Davis-Besse Nuclear Steam Supply System

The Nuclear Steam Supply System (NSSS) for the Davis-Besse plant was supplied by the Babcock & Wilcox Company. The NSSS, shown in Figure 4.1, consists of two heat transport loops with each containing a hot leg, a once-through steam generator (OTSG), and two cold legs. Water from the OTSG is returned to the reactor vessel by the reactor coolant pumps, with one pump located in each cold leg. Reactor coolant system (RCS) pressure is maintained by an electrically heated pressurizer that is connected to one of the hot legs. During normal operations, the pressurizer contains a 700-cubic foot steam bubble that exerts a pressure of approximately 2150 psig on the RCS. Protection against overpressurization is provided by the pilot operated relief valve (PORV) and two code safety valves. The pilot operated relief valve discharges to a quench tank. The two code safety valves discharge directly to the containment building.

At the top of the pressurizer as shown in Figure 4.1, there are two code safety valves which vent directly to the containment atmosphere, a high-point vent line, and the pilot operated relief valve (PORV) with its associated upstream block valve.

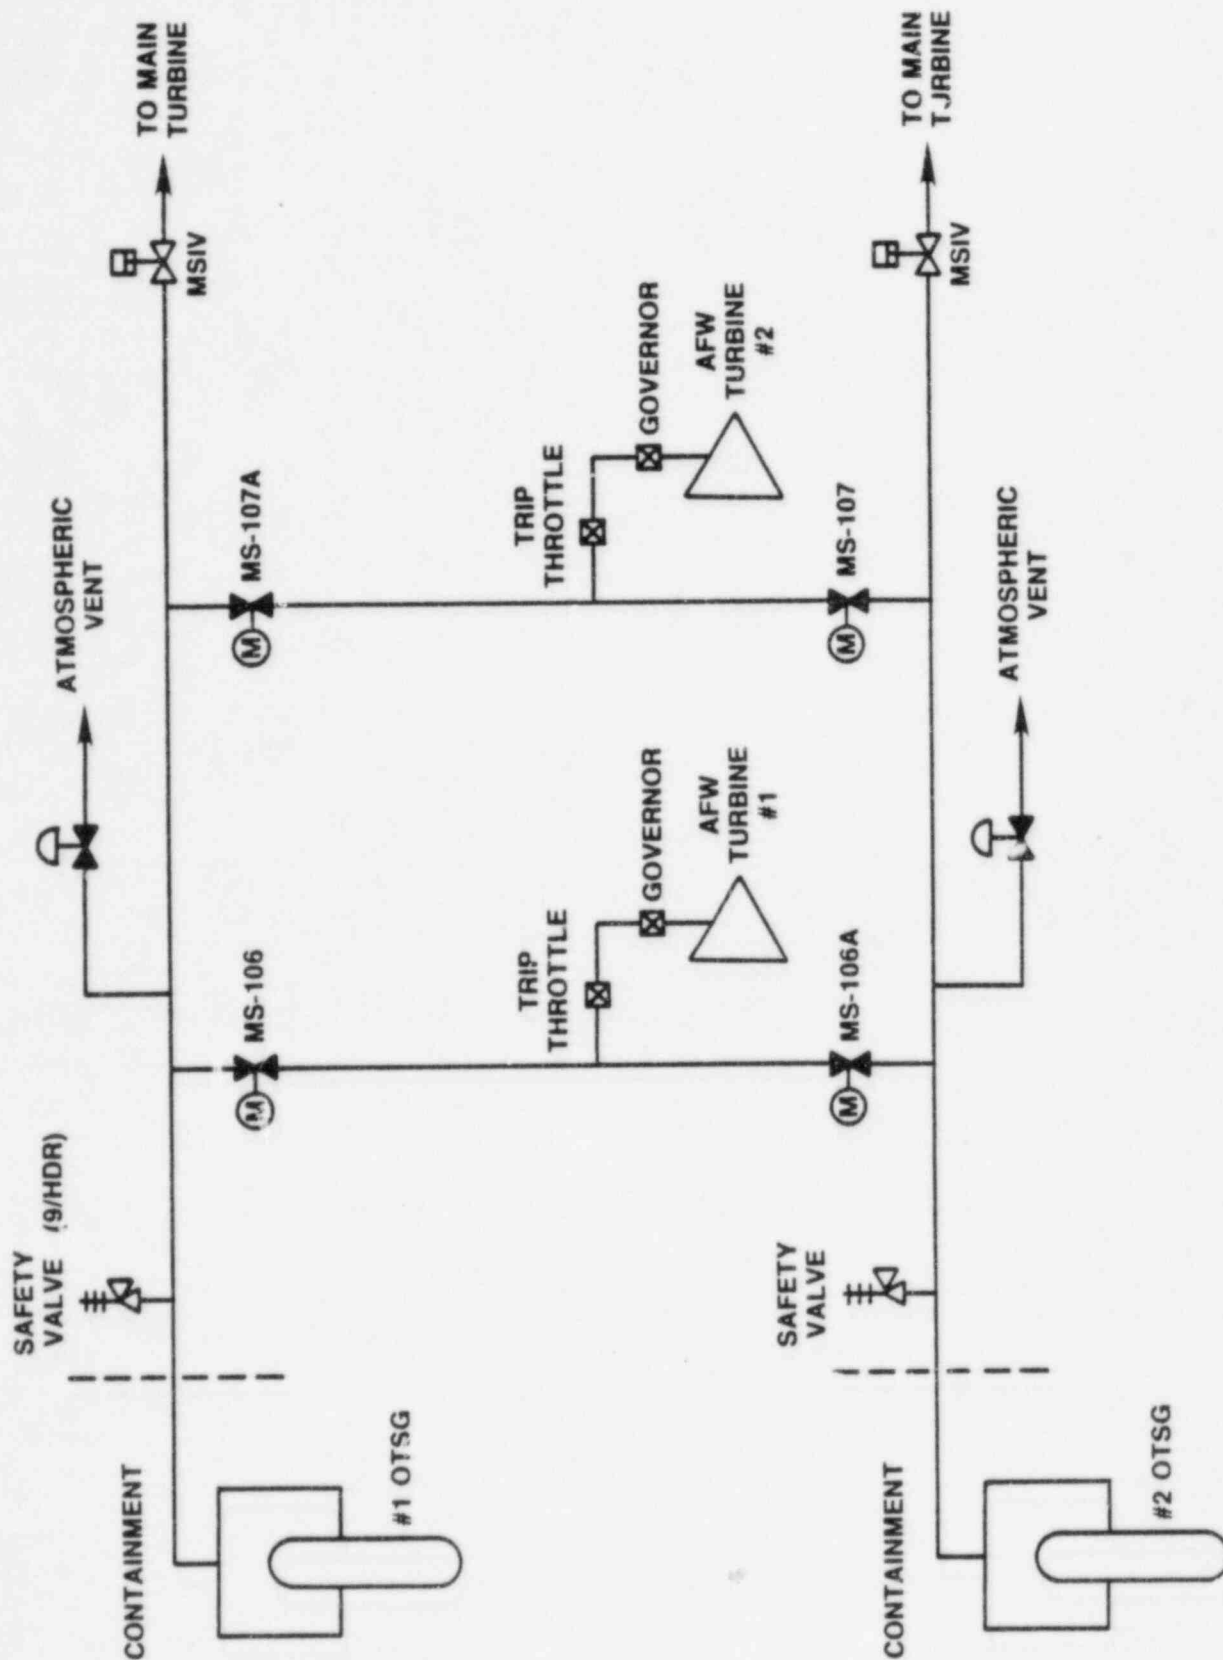
Figure 4.2 Main Steam System

The main steam system functions to deliver superheated steam from the steam generators (OTSGs) to the main turbine and required plant auxiliaries. As shown in Figure 4.2, the system begins with the outlet piping from the steam generators and passes through the containment building to the main steam isolation valves (MSIVs). Protection against overpressurization for the steam generators is provided by 18 code safety valves (9 per steam generator) located on the system piping upstream of the MSIVs, and two atmospheric vent valves (one per steam generator) which act as relief valves. The atmospheric vent valves are controlled by the integrated control system (ICS) and aid in controlling steam pressure if a large transient occurs when the unit is in service, if condenser vacuum is lost, or if the MSIVs are closed. Connections upstream of each main steam isolation valve supply steam to the redundant turbine-driven auxiliary feedwater pumps. Either system header is capable of supplying either turbine; however, the auxiliary feedwater pump turbine normally receives steam from its associated steam header.

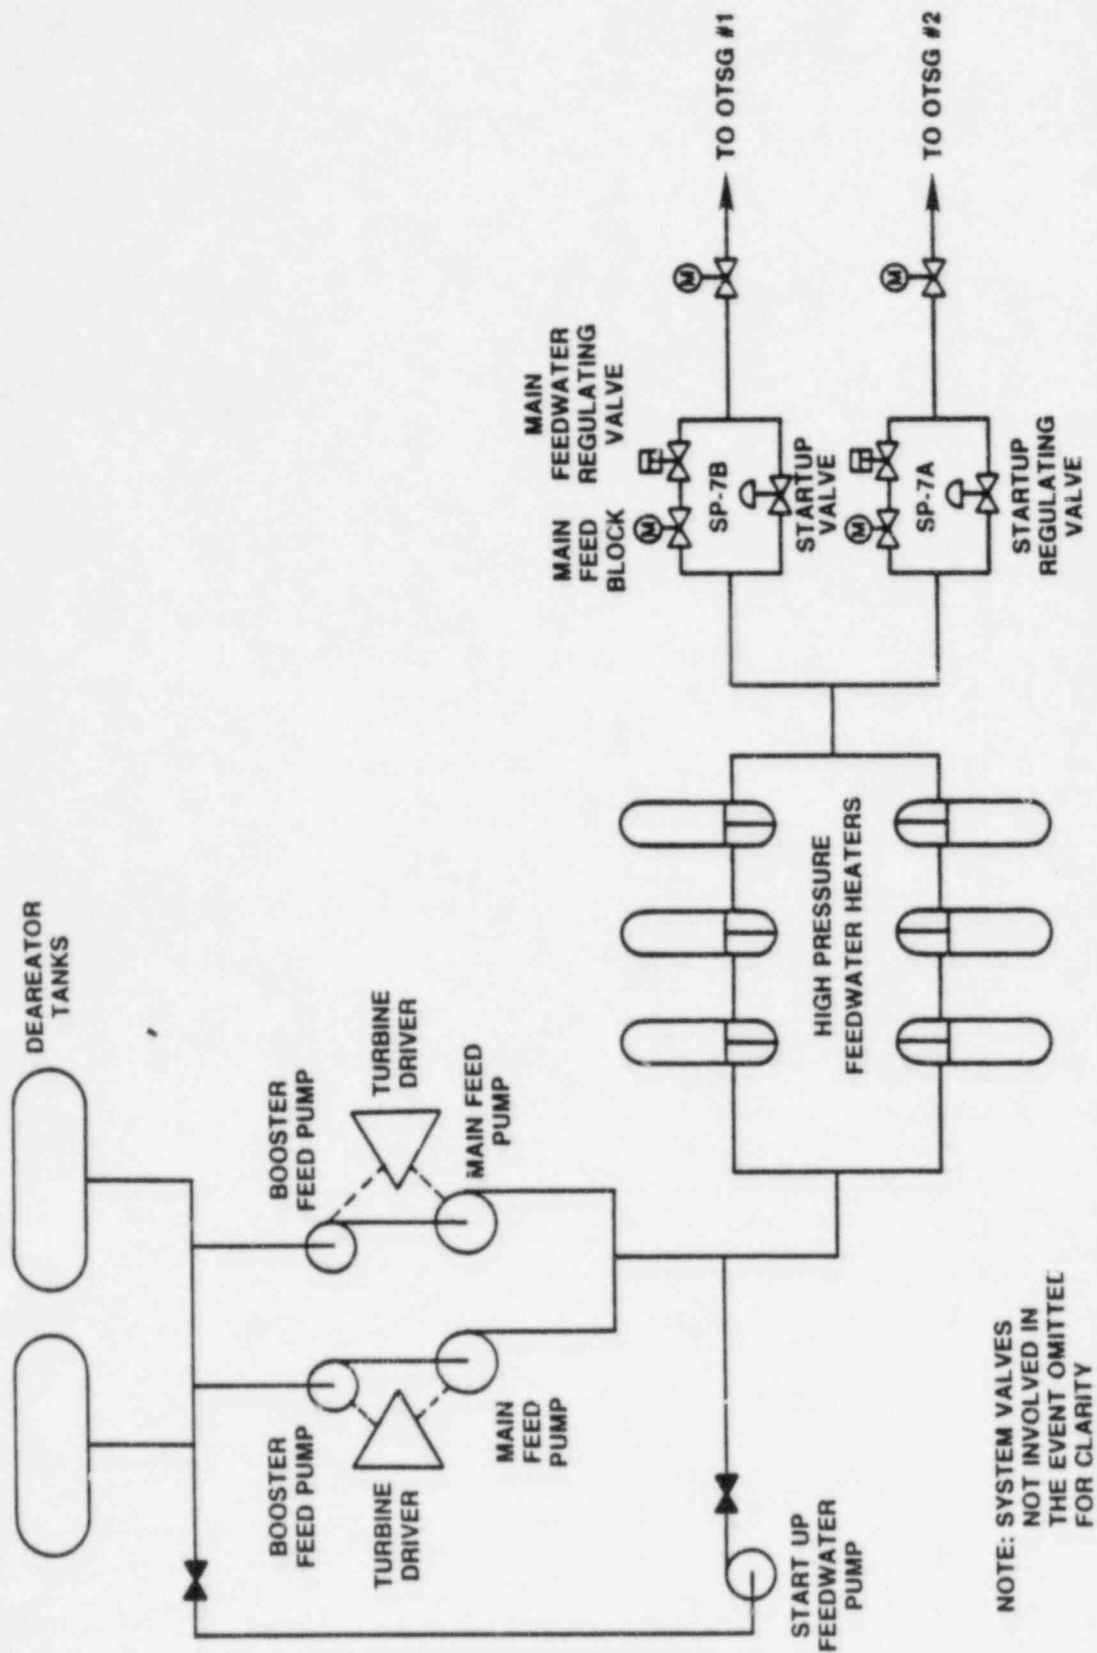
Figure 4.3 Main Feedwater System

The main feedwater system, Figure 4.3, begins with the cross-connected deareator storage tanks. Each of these tanks has a capacity of 64,000 gallons and provides the required net positive suction head (NPSH), i.e. pressure, for the booster feedwater pumps. The booster feedwater pumps are driven through a gear reducer by the main feedwater pump turbines and function to increase system pressure to satisfy the suction requirements for the main feedwater pumps. The direct-driven main feedwater pumps increase feedwater pressure to a value greater than steam generator pressure and discharge through the high pressure feedwater heaters to the feedwater regulating valves.

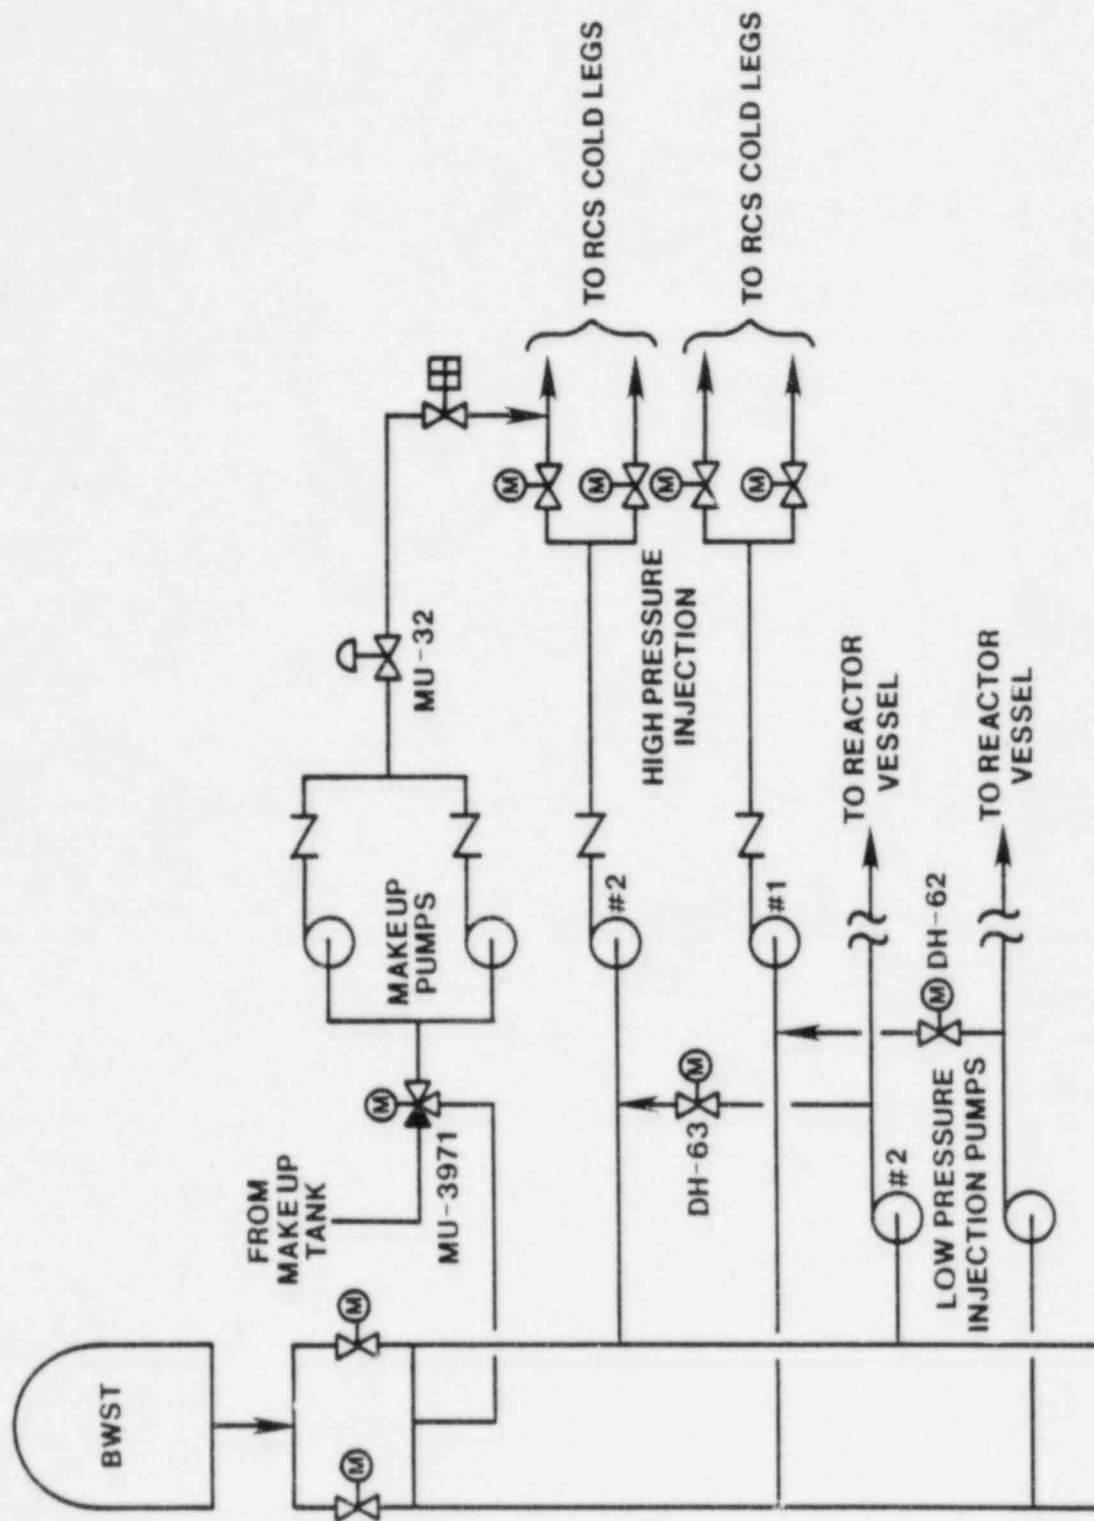
Figure 4.5 Makeup/HPI Cooling System

Makeup/High Pressure Injection (MU/HPI) core cooling (also called PORV cooling or feed and bleed core cooling) involves the use of the makeup and purification system, the high pressure injection system and, at the operator's discretion, the low pressure injection system. These three systems are shown in Figure 4.5. The system contains two multistage centrifugal makeup pumps rated at 150 gpm, with a discharge pressure of approximately 2500 psig. Two suction sources are available to the pumps; the makeup tank and the borated water storage tank (BWST). During normal operations, the makeup pumps supply seal injection and control pressurizer level by discharging into the RCS via the makeup flow control valve (MU-32). The discharge of the makeup pumps enters the RCS through one of the high pressure injection penetrations. When feed and bleed operations are required, plant procedures require the positioning of the three-way suction valve (MU-3971) to the BWST suction source, fully opening the makeup flow control valve, and the starting of both makeup pumps.

The low pressure injection (LPI) pumps are also a part of the emergency core cooling systems. The LPI pumps receive a suction from the BWST and discharge via the decay heat removal coolers (not shown in Figure 4.5) into the reactor

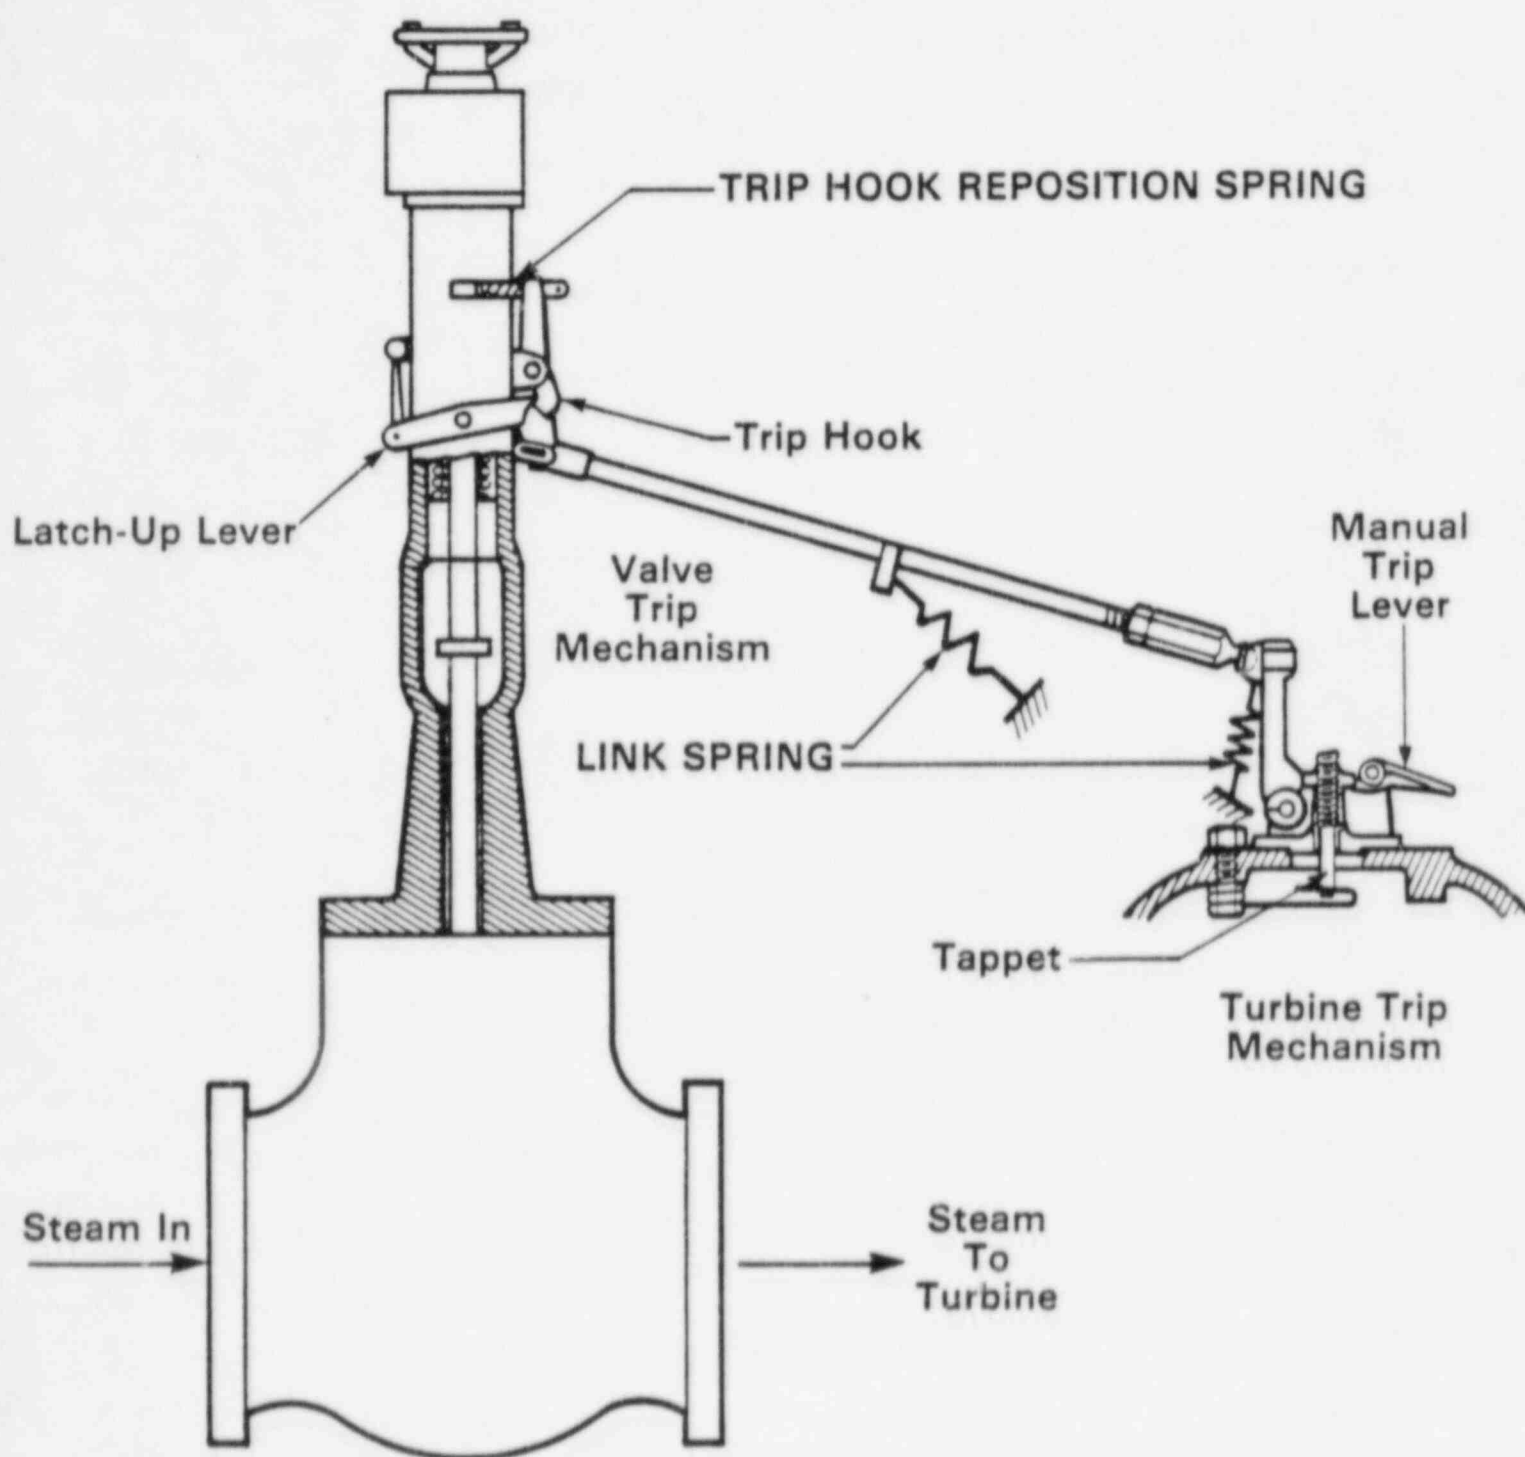
Figure 5.1 AFPT Trip-Throttle Valve

During a meeting with NRC on July 11, 1985, Toledo Edison discussed the status of the troubleshooting under plan No. 1D, which covers the re-latching of the turbine overspeed trip mechanism and difficulties in opening the turbine trip-throttle valve. Figure 5.1, from Toledo Edison's action plan, illustrates the pertinent aspects related to this problem. Except for some tests to be done under full steam pressure (plant mode 3), the actual troubleshooting has been completed. Toledo Edison believes the root cause for this item has been determined. All mechanisms have been checked and found to be properly adjusted, with all mechanism pivot points and components free to operate. The equipment operators who were involved during the June 9, 1985, event have been involved in every step of this troubleshooting activity. Toledo Edison stated that these equipment operators now believe that there was no mechanical problem with the mechanism, but rather that they did not know how to perform the necessary actions.

It is physically possible to pull the connecting arm sufficiently far (to the left in Figure 5.1) to be able to barely re-engage the trip hook at the trip-throttle valve but not reset the overspeed trip back at the other end, where the overspeed tappet and manual trip lever are located. This end of the connecting arm is behind the governor and is not easy to see.
