RADIOLOGIC AND ENGINEERING ASSESSMENT

DOE ID NO.: GJ-04232-RS  
ADDRESS: 1208 MAIN STREET

SEPTEMBER 1985

BENDIX FIELD ENGINEERING CORPORATION  
P.O. Box 1569  
Grand Junction, Colorado 81502

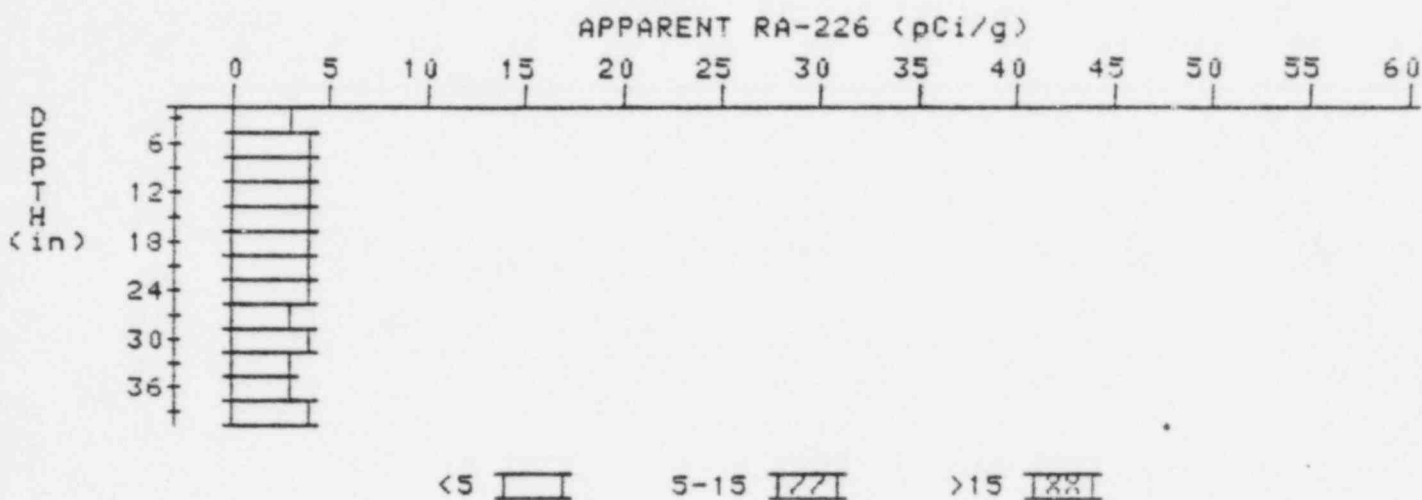
HOLE NUMBER: 7

Depth (in)	Apparent Radium-226 (pCi/g) Undeconvolved	Apparent Radium-226 (pCi/g) Deconvolved
3	3.2	3.2
6	3.5	3.9
9	3.6	3.6
12	3.7	3.9
15	3.7	3.5
18	3.8	4.2
21	3.7	3.5
24	3.7	3.9
27	3.6	3.4
30	3.6	3.8
33	3.5	3.3
36	3.5	3.1
39	3.7	3.7

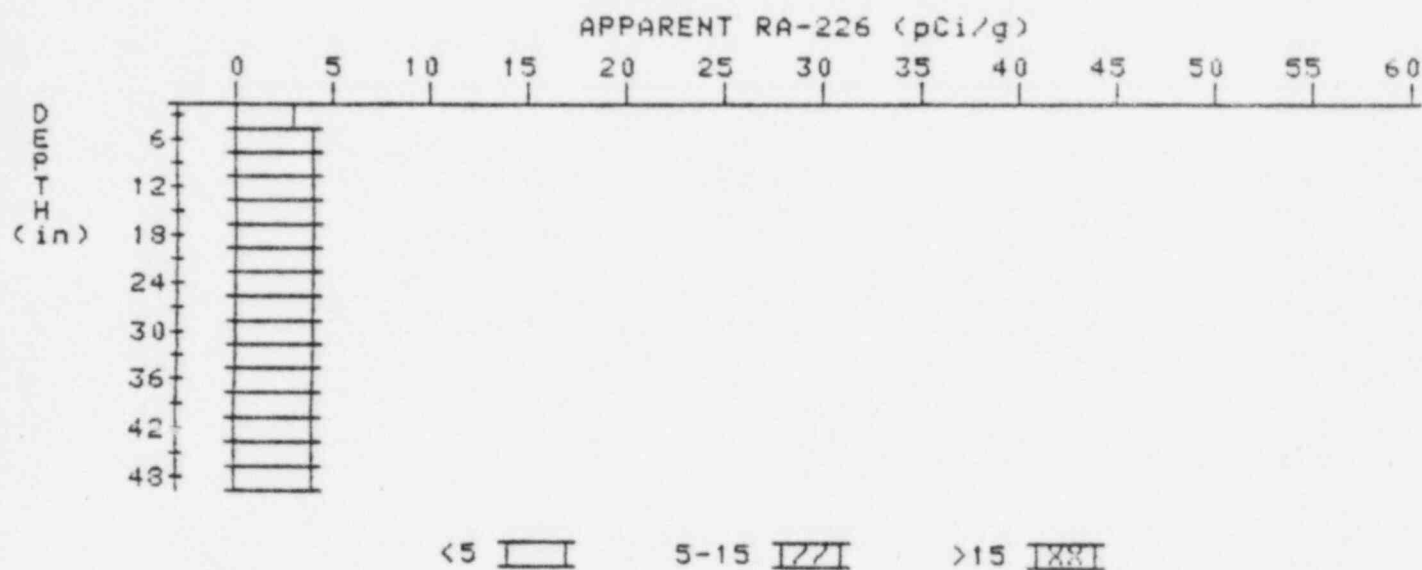
HOLE NUMBER: 9

Depth (in)	Apparent Radium-226 (pCi/g) Undeconvolved	Apparent Radium-226 (pCi/g) Deconvolved
3	3.3	3.3
6	3.6	3.8
9	3.8	4.2
12	3.8	3.6
15	3.9	4.1
18	3.9	3.9
21	3.9	3.7
24	4.0	4.0
27	4.1	4.3
30	4.1	4.1
33	4.1	4.1
36	4.1	3.9
39	4.2	4.4
42	4.2	4.0
45	4.3	4.5
48	4.3	4.3

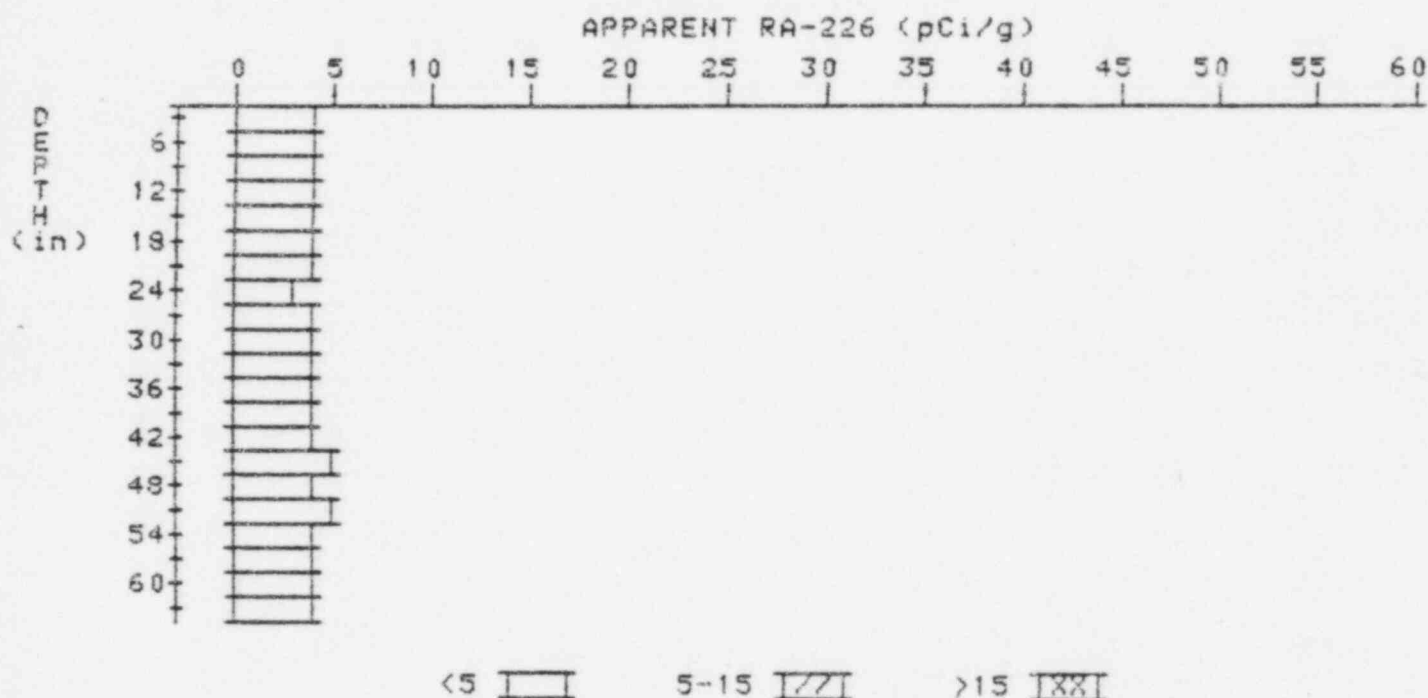
HOLE NUMBER: 10

Depth (in)	Apparent Radium-226 (pCi/g) Undeconvolved	Apparent Radium-226 (pCi/g) Deconvolved
3	3.6	3.6
6	3.9	4.3
9	4.0	4.2
12	4.0	4.0
15	4.0	4.2
18	3.9	4.1
21	3.7	3.5
24	3.6	3.2
27	3.7	3.5
30	3.9	4.3
33	3.9	3.7
36	4.0	4.2
39	4.0	3.8
42	4.1	4.1
45	4.2	4.6
48	4.1	3.7
51	4.2	4.6

54	4.1	3.9
57	4.1	4.1
60	4.1	4.1
63	4.1	4.1

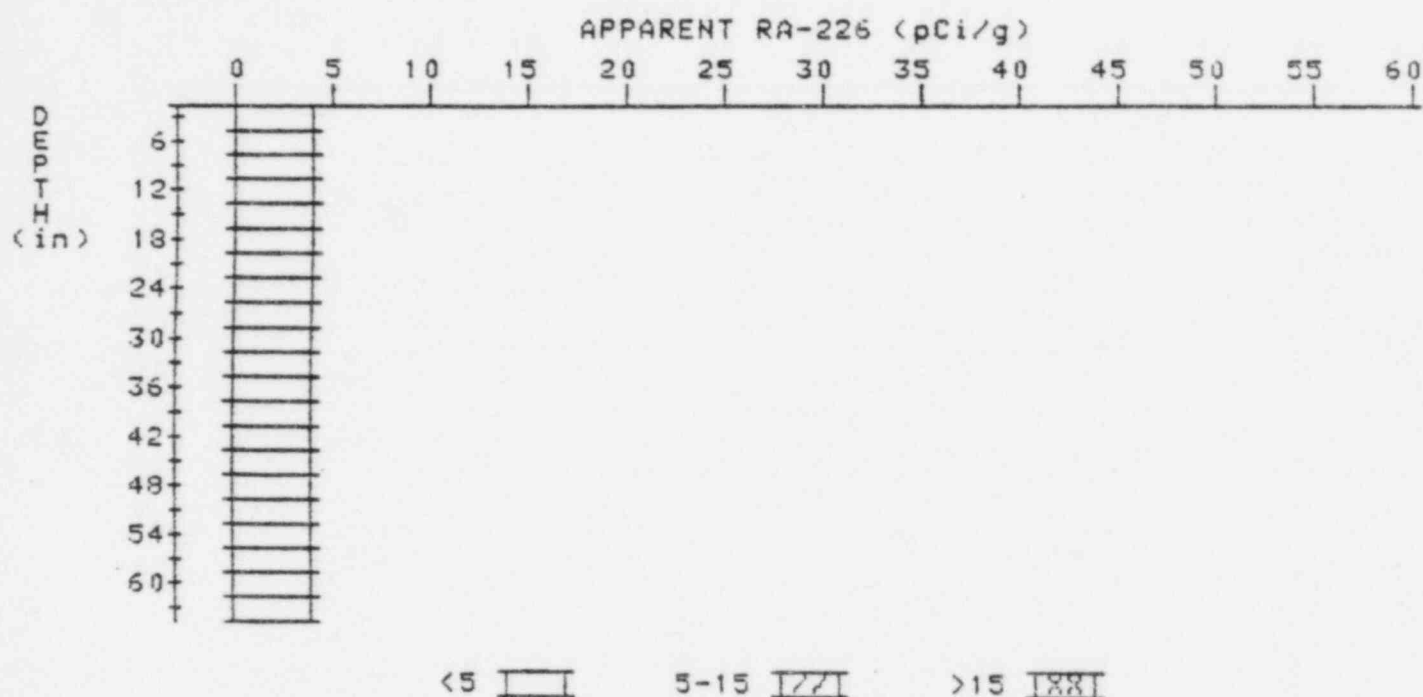
HOLE NUMBER: 12

Depth (in)	Apparent Radium-226 (pCi/g) Undeconvolved	Apparent Radium-226 (pCi/g) Deconvolved
3	3.5	3.5
6	3.7	3.9
9	3.9	3.8
12	3.9	4.3
15	3.8	3.6
18	3.8	3.6
21	3.9	4.1
24	3.9	3.7
27	4.0	4.4
30	3.9	3.7
33	3.9	3.7
36	4.0	4.4
39	3.9	3.9
42	3.8	3.6
45	3.8	3.6
48	3.9	4.3
51	3.8	3.6

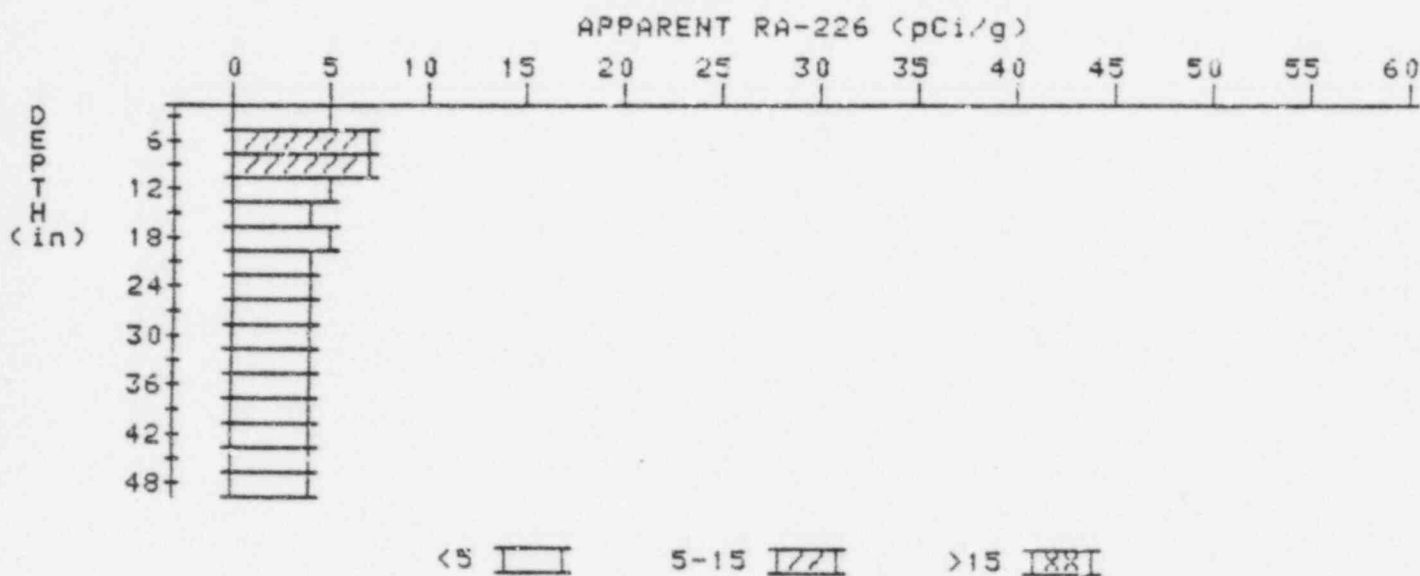
HOLE NUMBER: 15

Depth (in)	Apparent Radium-226 (pCi/g) Undeconvolved	Apparent Radium-226 (pCi/g) Deconvolved
3	4.8	4.8
6	5.5	6.6
9	5.6	6.7
12	5.1	4.9
15	4.7	4.3
18	4.5	4.5
21	4.3	4.3
24	4.1	3.6
27	4.2	4.4
30	4.2	4.4
33	4.1	3.9
36	4.1	4.3
39	4.0	3.3
42	4.0	4.0
45	4.0	4.2
48	3.9	3.9

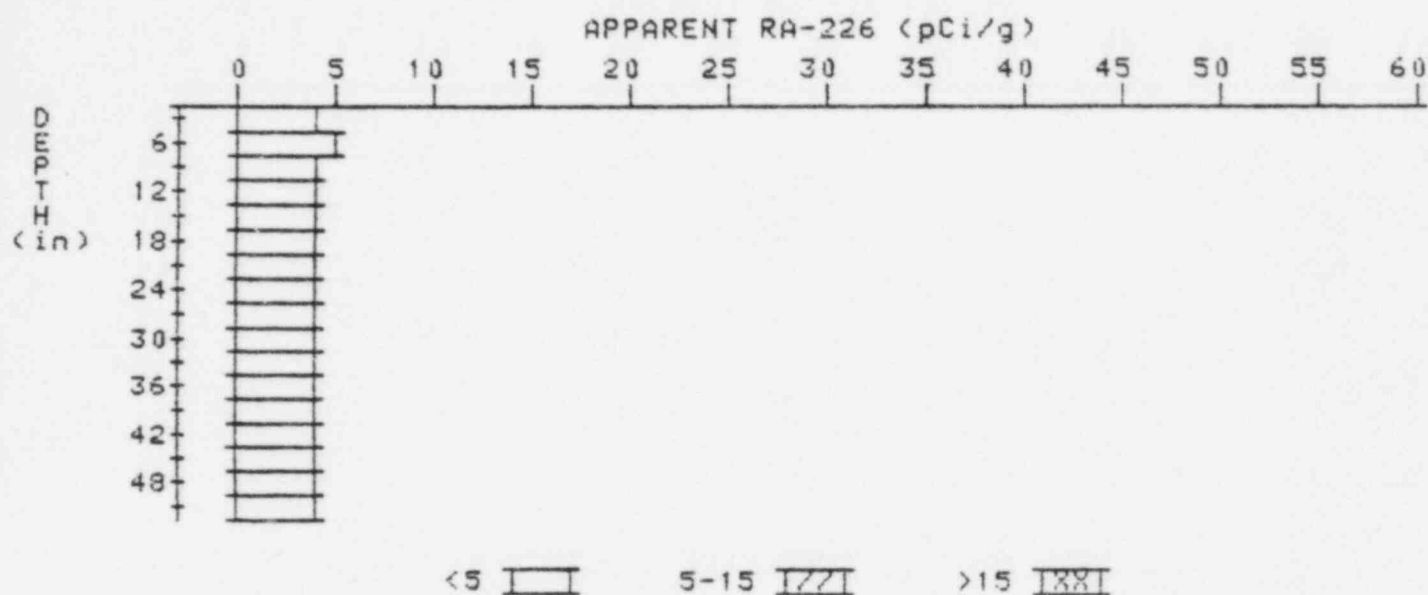
HOLE NUMBER: 17

Depth (in)	Apparent Radium-226 (pCi/g) Undeconvolved	Apparent Radium-226 (pCi/g) Deconvolved
3	3.5	3.5
6	3.9	4.6
9	3.9	3.7
12	4.0	4.2
15	4.0	4.2
18	3.9	3.7
21	3.9	3.9
24	3.9	3.7
27	4.0	4.2
30	4.0	3.8
33	4.1	4.5
36	4.0	3.6
39	4.1	4.5
42	4.0	3.8
45	4.0	4.0
48	4.0	4.0
51	4.0	4.0

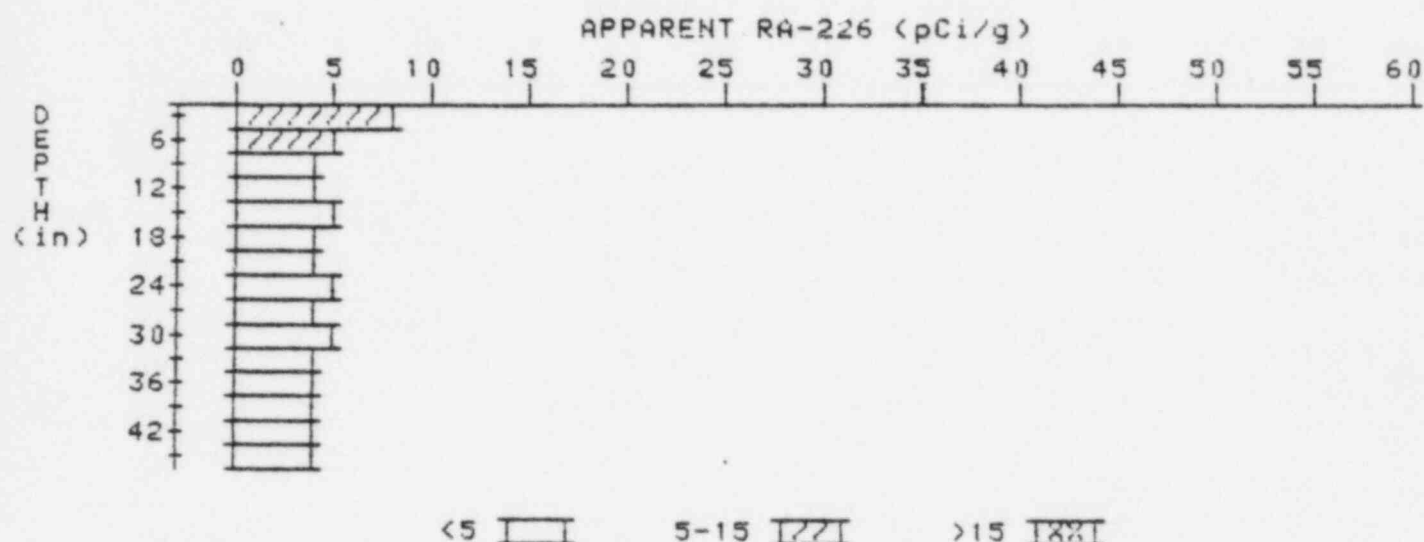
HOLE NUMBER: 19

Depth (in)	Apparent Radium-226 (pCi/g) Undeconvolved	Apparent Radium-226 (pCi/g) Deconvolved
3	7.5	7.5
6	6.1	5.2
9	5.2	4.5
12	4.7	4.2
15	4.5	4.7
18	4.2	3.8
21	4.1	3.7
24	4.2	4.6
27	4.1	3.7
30	4.2	4.6
33	4.1	4.1
36	4.0	4.0
39	3.9	3.5
42	4.0	4.2
45	4.0	4.0
