RADIOLOGIC AND ENGINEERING ASSESSMENT

DOE ID NO.: GJ-04676-RS
ADDRESS: 2126 TEXAS AVENUE

JULY 1985

BENDIX FIELD ENGINEERING CORPORATION
P.O. Box 1569
Grand Junction, Colorado 81502

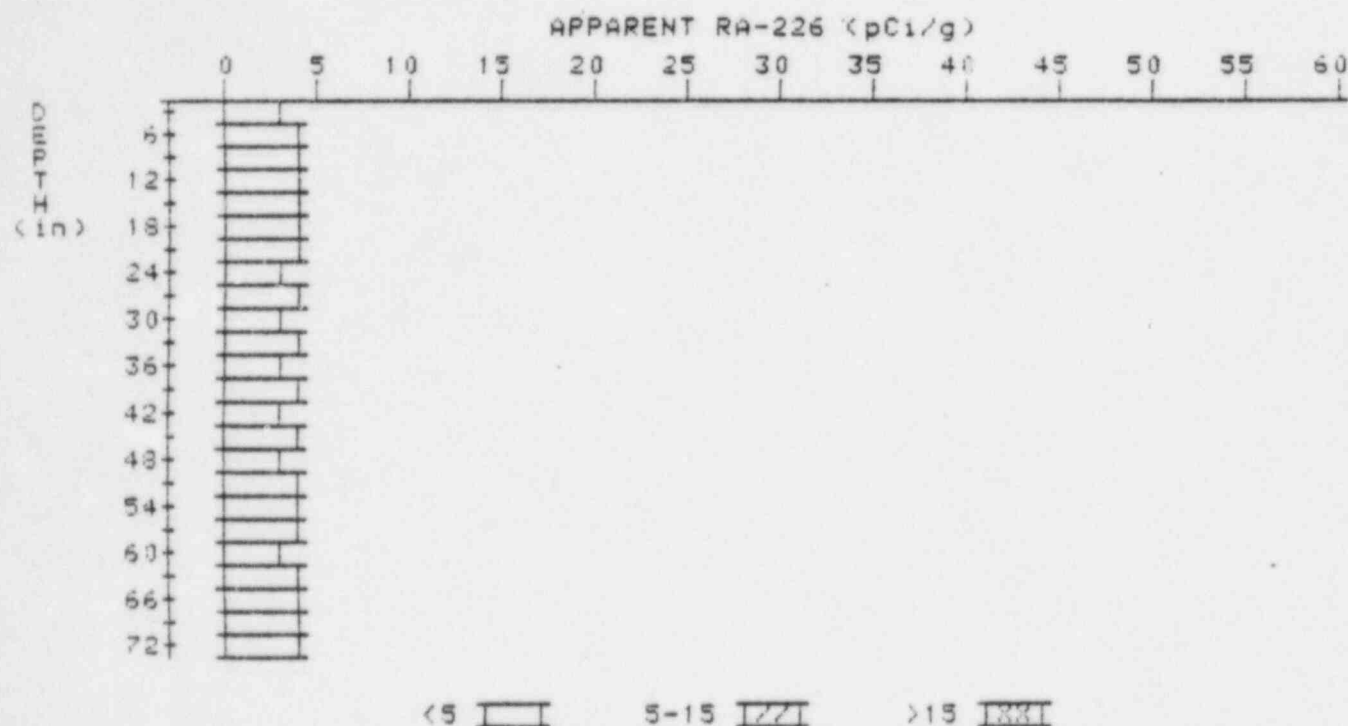
HOLE NUMBER: 5

Depth (in)	Apparent Radium-226 (pCi/g) Undeconvolved	Apparent Radium-226 (pCi/g) Deconvolved
3	3.3	3.3
6	3.5	3.7
9	3.6	3.6
12	3.7	3.9
15	3.7	3.7
18	3.7	3.7
21	3.7	3.9
24	3.6	3.2
27	3.7	4.1
30	3.5	3.2
33	3.7	4.1
36	3.6	3.4
39	3.5	3.3
42	3.5	3.1
45	3.6	4.0

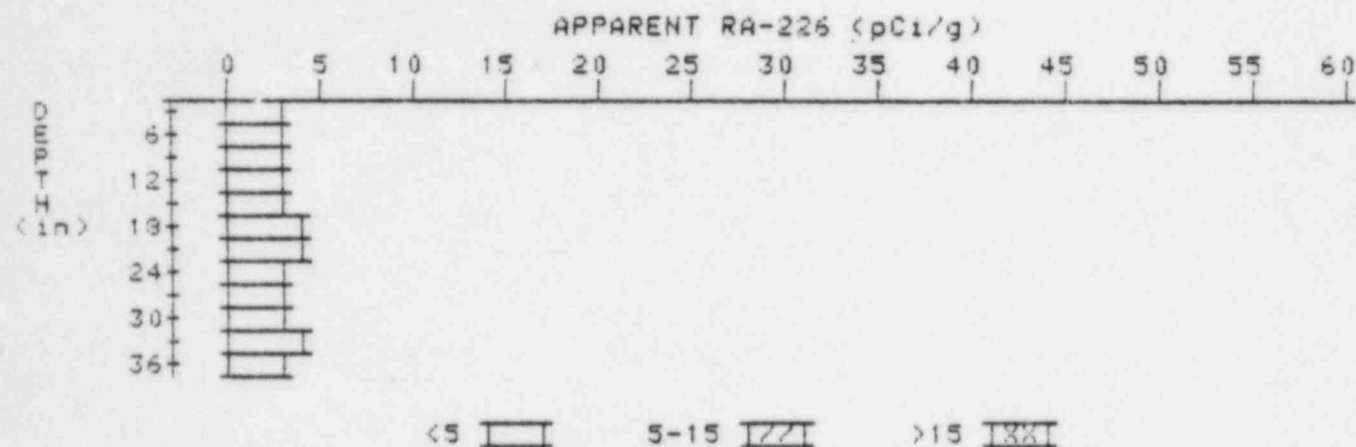
HOLE NUMBER: 6

Depth (in)	Apparent Radium-226 (pCi/g) Undeconvolved	Apparent Radium-226 (pCi/g) Deconvolved
3	3.0	3.0
6	3.2	3.4
9	3.3	3.5
12	3.3	3.3
15	3.3	3.1
18	3.4	3.6
21	3.4	3.6
24	3.3	3.1
27	3.3	3.3
30	3.3	3.1
33	3.4	3.9
36	3.2	3.2

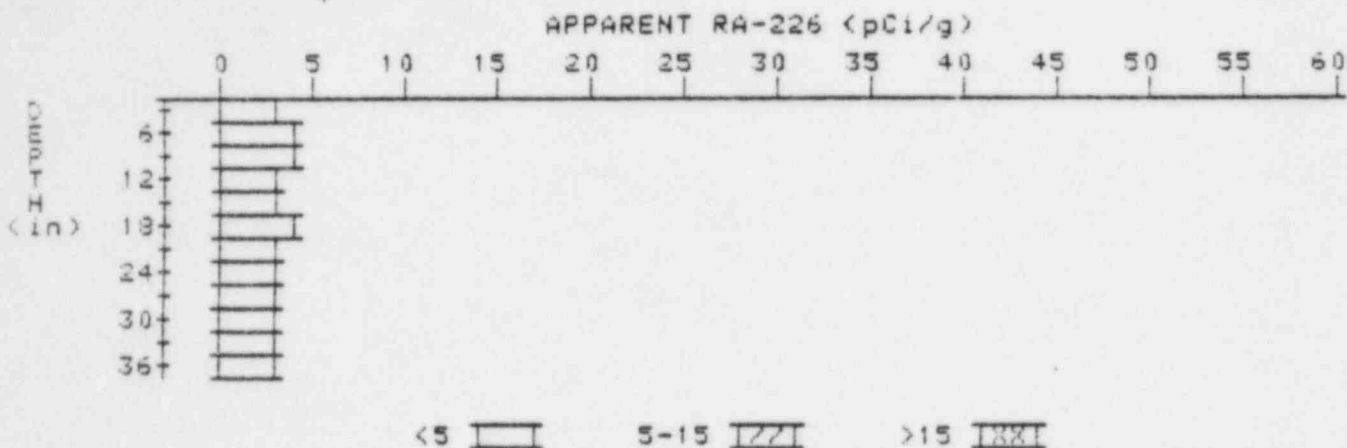
HOLE NUMBER: 8

Depth (in)	Apparent Radium-226 (pCi/g) Undeconvolved	Apparent Radium-226 (pCi/g) Deconvolved
3	3.4	3.4
6	3.6	4.1
9	3.5	3.5
12	3.4	3.2
15	3.4	3.4
18	3.4	3.6
21	3.3	3.1
24	3.3	3.5
27	3.2	3.2
30	3.1	3.1
33	3.0	2.8
36	3.0	3.0

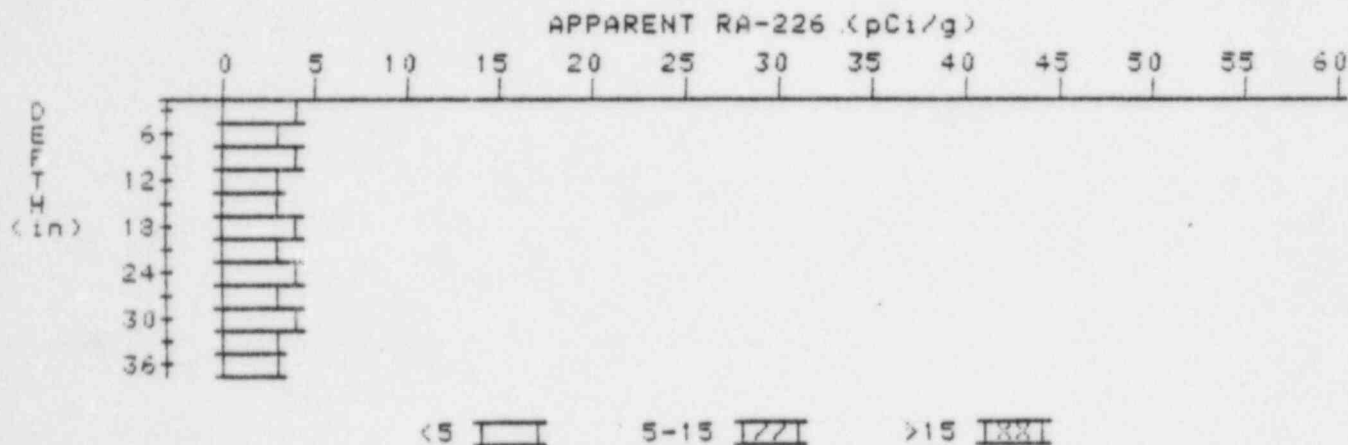
HOLE NUMBER: 9

Depth (in)	Apparent Radium-226 (pCi/g) Undeconvolved	Apparent Radium-226 (pCi/g) Deconvolved
3	3.6	3.6
6	3.6	3.4
9	3.7	4.1
12	3.6	3.4
15	3.6	3.4
18	3.7	4.1
21	3.6	3.4
24	3.6	3.3
27	3.8	3.3
30	3.8	3.9
33	3.3	2.9
36	3.3	3.3

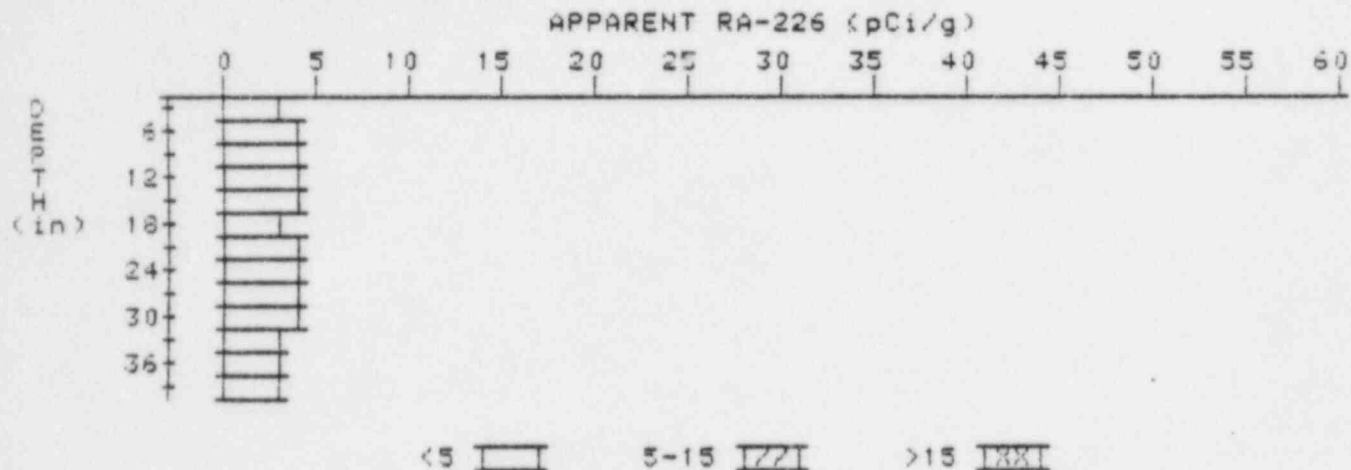
HOLE NUMBER: 10

Depth (in)	Apparent Radium-226 (pCi/g) Undeconvolved	Apparent Radium-226 (pCi/g) Deconvolved
3	3.2	3.2
6	3.5	3.7
9	3.7	3.7
12	3.9	4.4
15	3.8	4.0
18	3.6	3.2
21	3.6	3.6
24	3.6	3.6
27	3.6	3.3
30	3.8	3.5
33	3.4	3.4
36	3.3	3.1
39	3.3	3.3

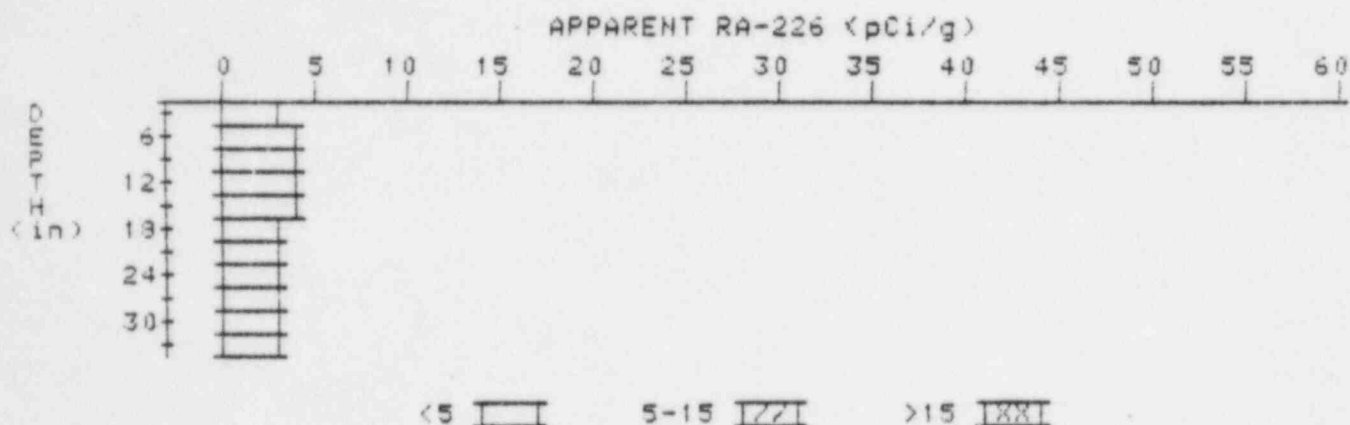
PROPERTY NUMBER: GJ-04676-RS
HOLE NUMBER: 19
LOCATION: 210291

Depth (in)	Apparent Radium-226 (pCi/g) Undeconvolved	Apparent Radium-226 (pCi/g) Deconvolved
3	3.4	3.4
6	3.5	3.5
9	3.6	3.8
12	3.6	3.8
15	3.5	3.5
18	3.4	3.4
21	3.3	3.3
24	3.2	3.0
27	3.2	3.4
30	3.1	2.9
33	3.1	3.1

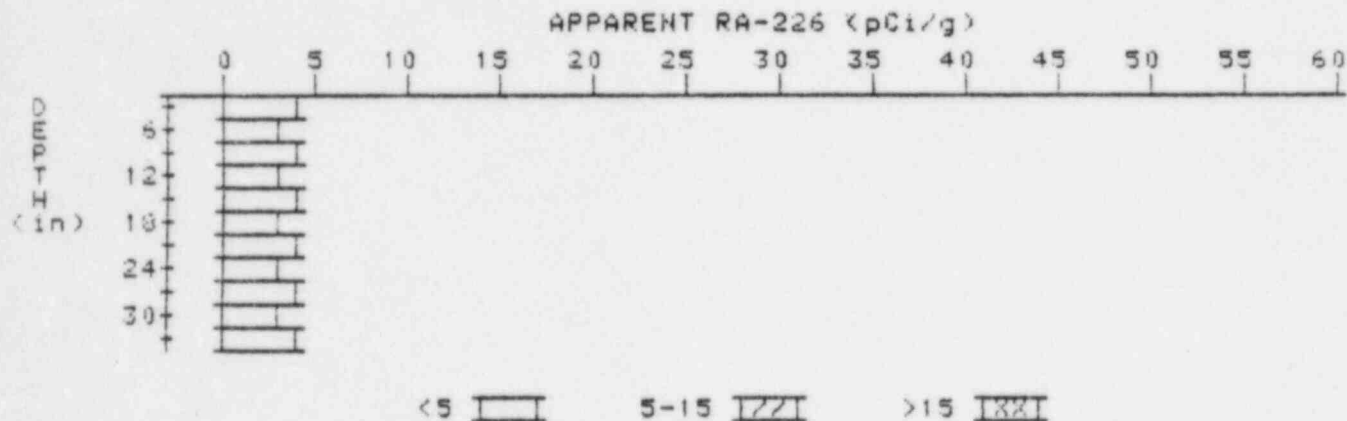
PROPERTY NUMBER: GJ-04676-RS
HOLE NUMBER: 23
LOCATION: 218286

Depth (in)	Apparent Radium-226 (pCi/g) Undeconvolved	Apparent Radium-226 (pCi/g) Deconvolved
3	3.5	3.5
6	3.6	3.4
9	3.8	4.3
12	3.7	3.3
15	3.8	4.3
18	3.6	3.1
21	3.7	4.1
24	3.6	3.4
27	3.6	3.8
30	3.5	3.3
33	3.5	3.5

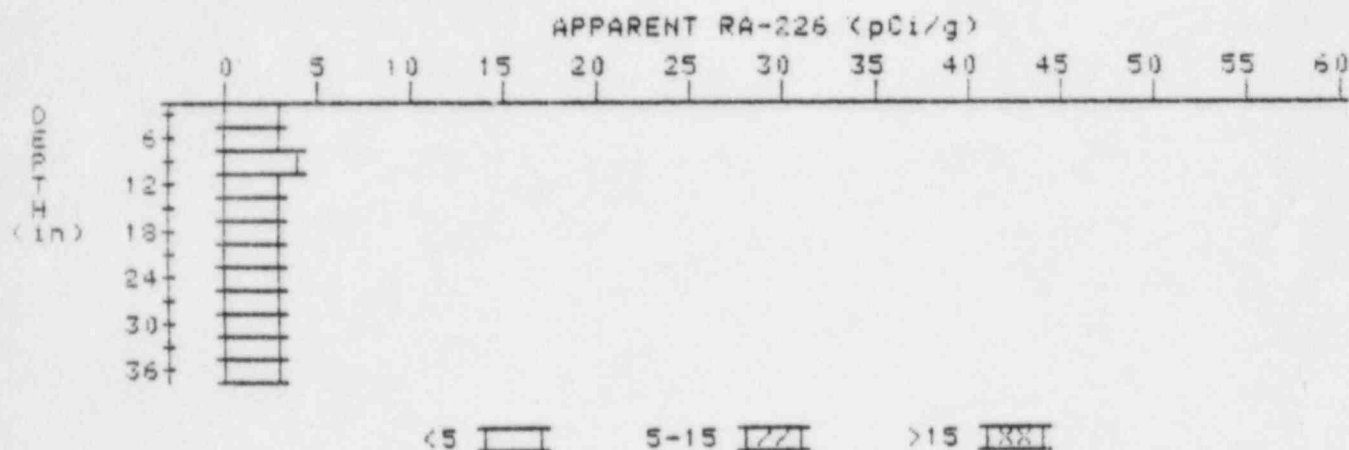
PROPERTY NUMBER: GJ-04676-RS
HOLE NUMBER: 24
LOCATION: 220269

Depth (in)	Apparent Radium-226 (pCi/g) Undeconvolved	Apparent Radium-226 (pCi/g) Deconvolved
3	2.7	2.7
6	3.0	3.2
9	3.2	3.6
12	3.2	3.0
15	3.3	3.5
18	3.3	3.3
21	3.3	3.5
24	3.2	3.0
27	3.2	3.2
30	3.2	3.4
33	3.1	3.1
36	3.0	3.0

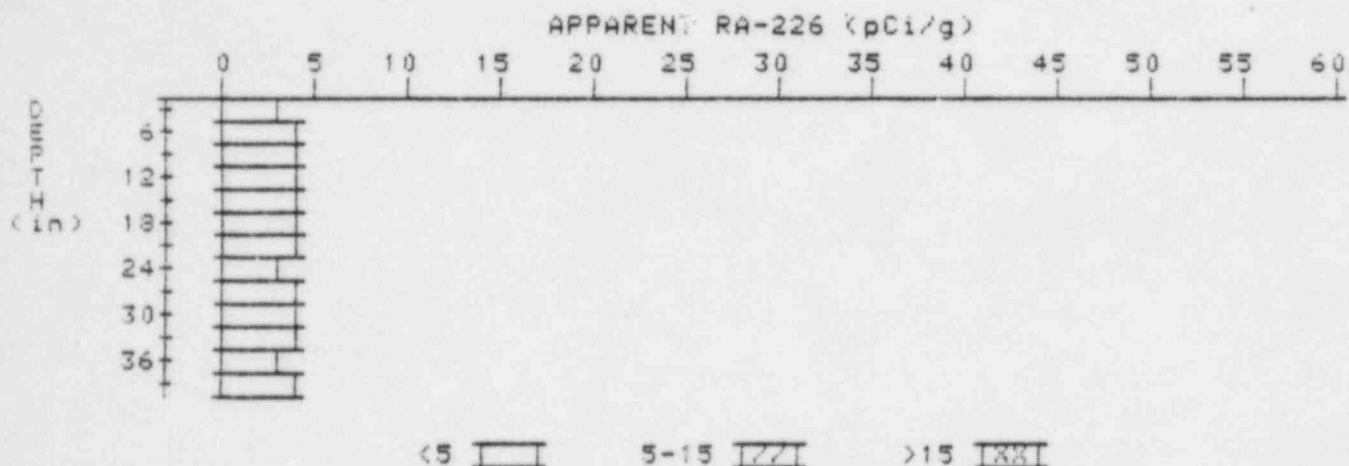
HOLE NUMBER: 27

Depth (in)	Apparent Radium-226 (pCi/g) Undeconvolved	Apparent Radium-226 (pCi/g) Deconvolved
3	3.0	3.0
6	3.4	3.8
9	3.6	3.8
12	3.7	3.7
15	3.8	3.8
18	3.9	4.4
21	3.7	3.5
24	3.6	3.2
27	3.7	3.9
30	3.7	3.9
33	3.6	3.6
36	3.5	3.3
39	3.5	3.5

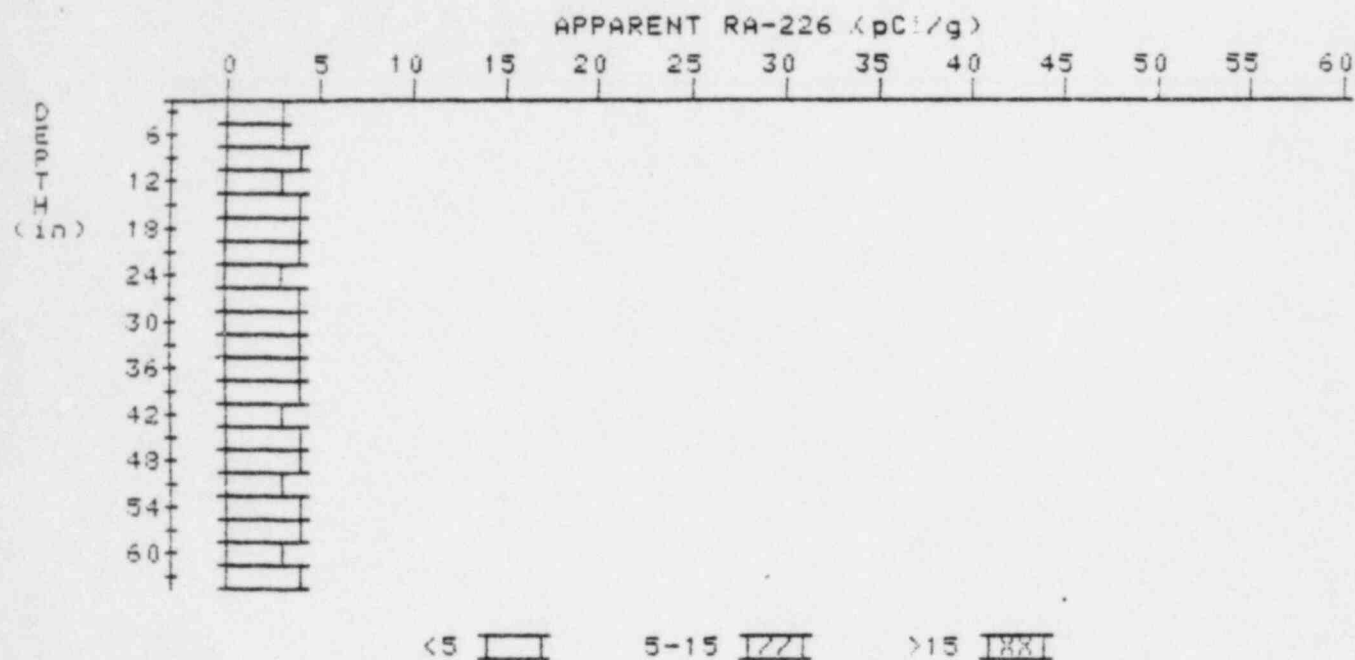
PROPERTY NUMBER: GJ-04676-RS
HOLE NUMBER: 30
LOCATION: 236263

Depth (in)	Apparent Radium-226 (pCi/g) Undeconvolved	Apparent Radium-226 (pCi/g) Deconvolved
3	2.8	2.8
6	3.1	3.1
9	3.4	3.8
12	3.5	3.3
15	3.7	4.1
18	3.7	3.5
21	3.8	4.3
24	3.6	3.1
27	3.7	3.7
30	3.8	4.0
33	3.8	3.8
36	3.8	3.6
39	3.9	4.4
42	3.7	3.3
45	3.7	3.9
48	3.6	3.6
51	3.5	3.3
