RADIOLOGIC AND ENGINEERING ASSESSMENT

DOE ID NO.: GJ-14639-MR
ADDRESS: 3142 F ROAD

JULY 1985

BENDIX FIELD ENGINEERING CORPORATION
P.O. Box 1569
Grand Junction, Colorado 81502

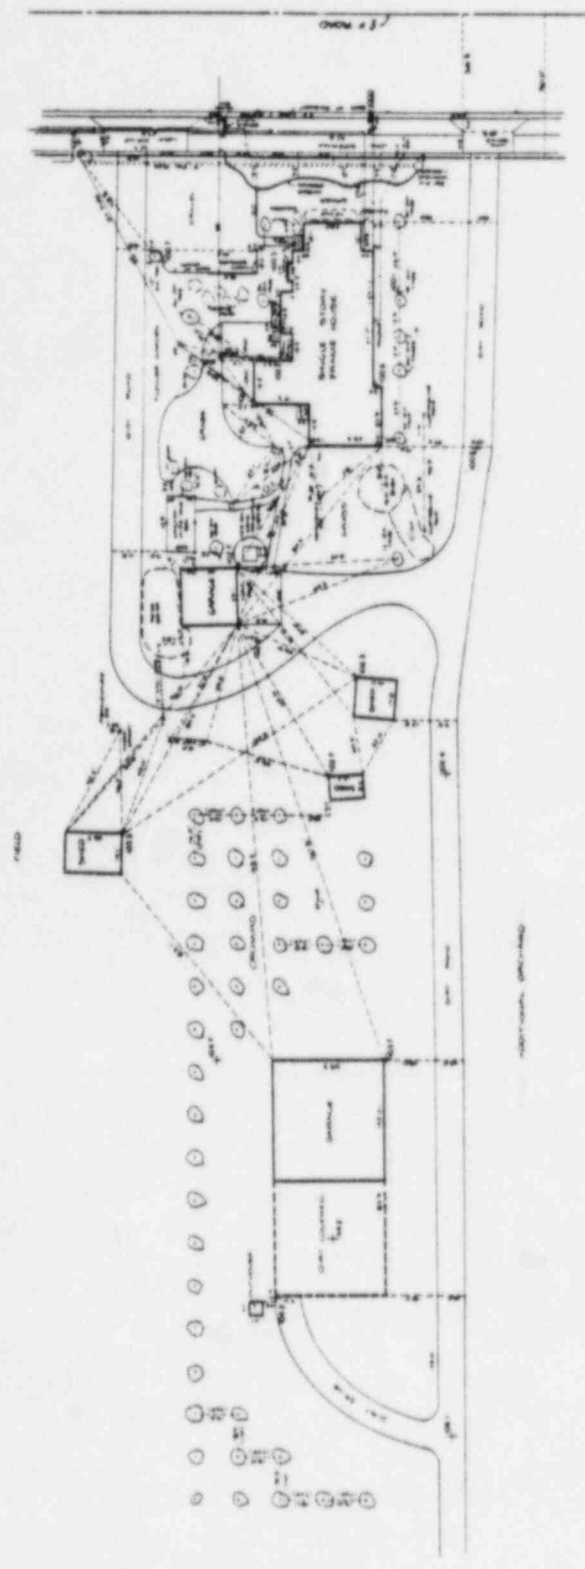
FIGURE 2.2a SITE PLAN

Structures, utilities, landscaping, and other special features of this property are included in Appendix Figure 2.2.

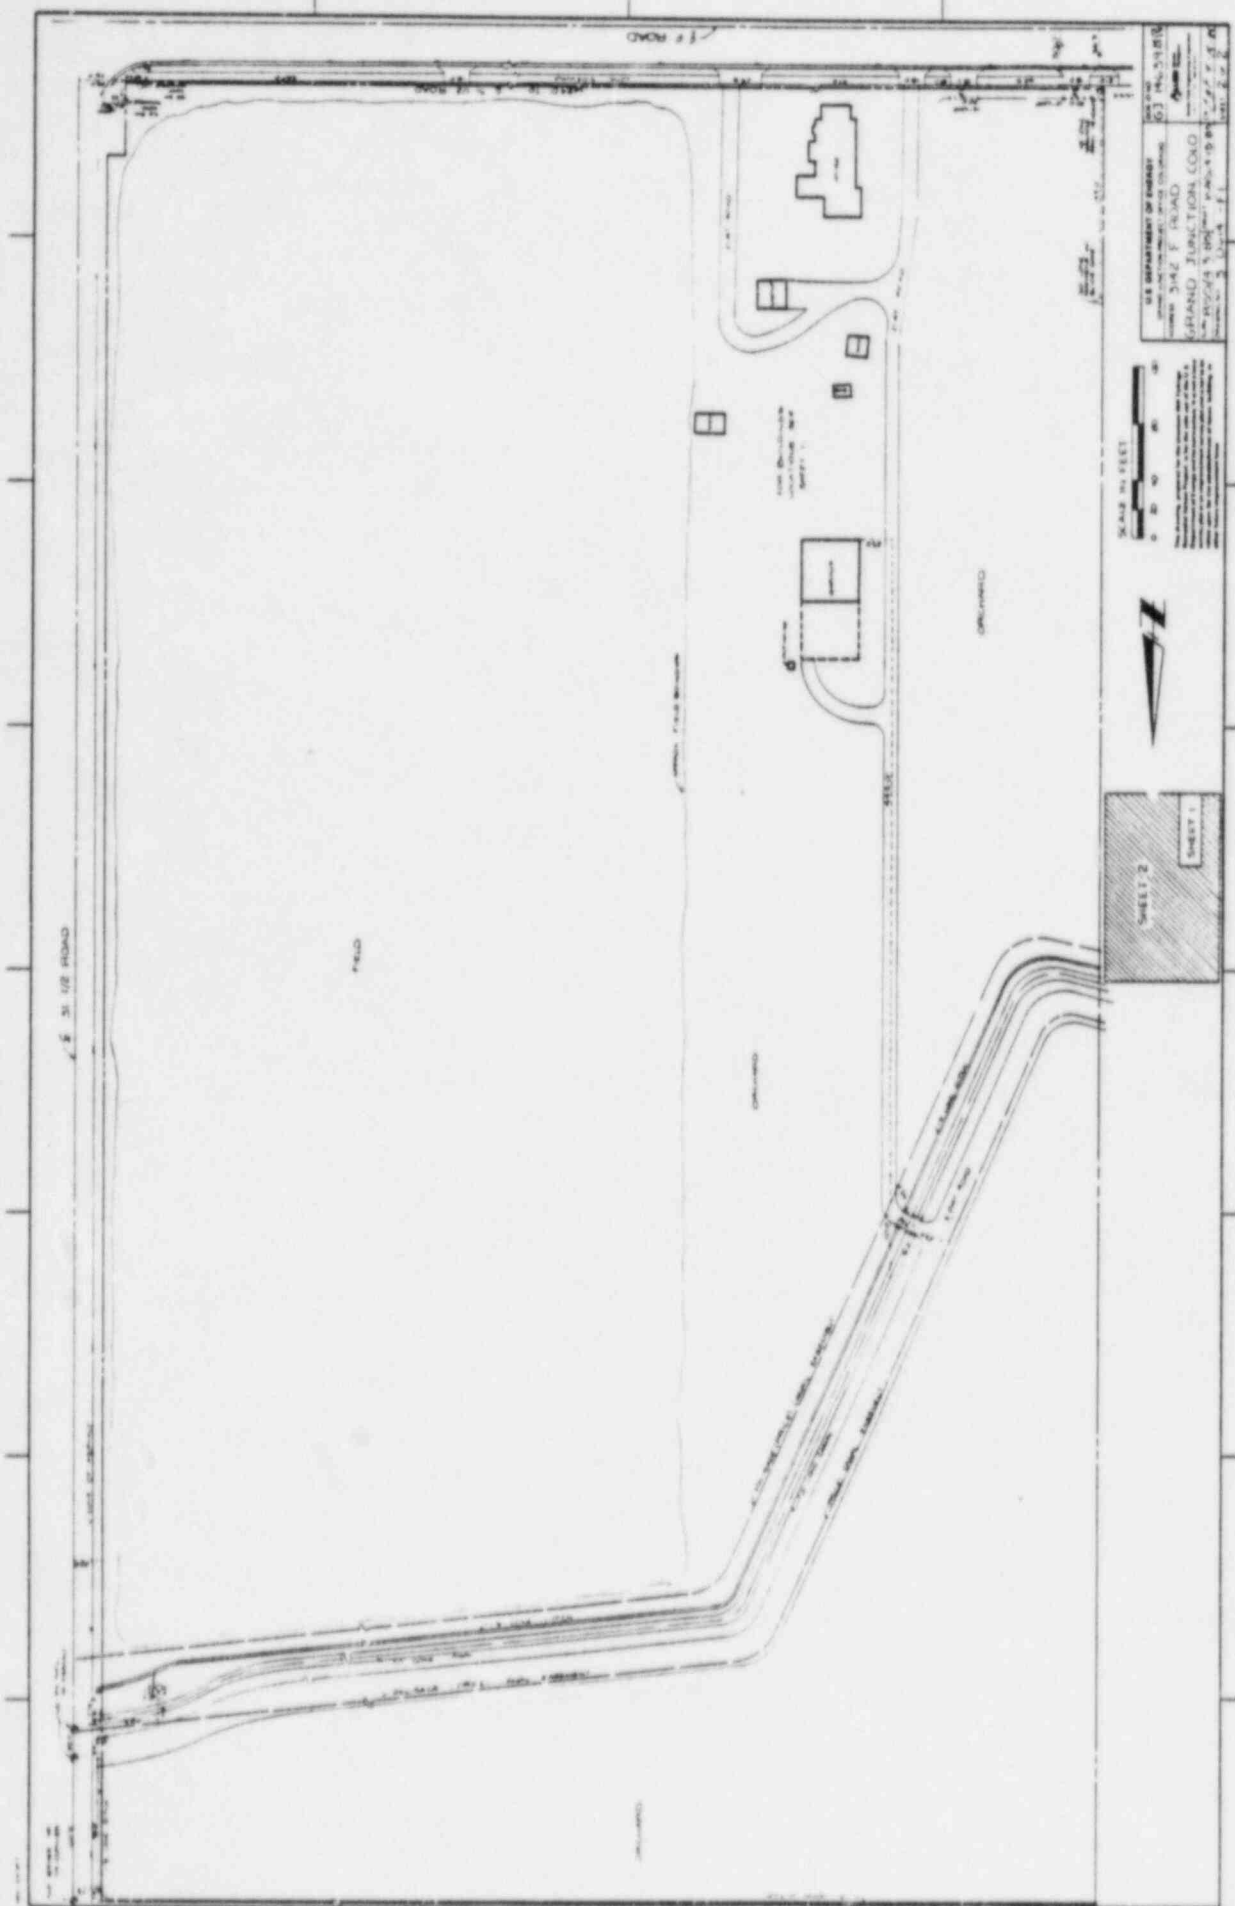
FIGURE 2.2b SITE PLAN

Utilities: Utility locations are shown in Appendix Figures 2.2a and 2.2b.

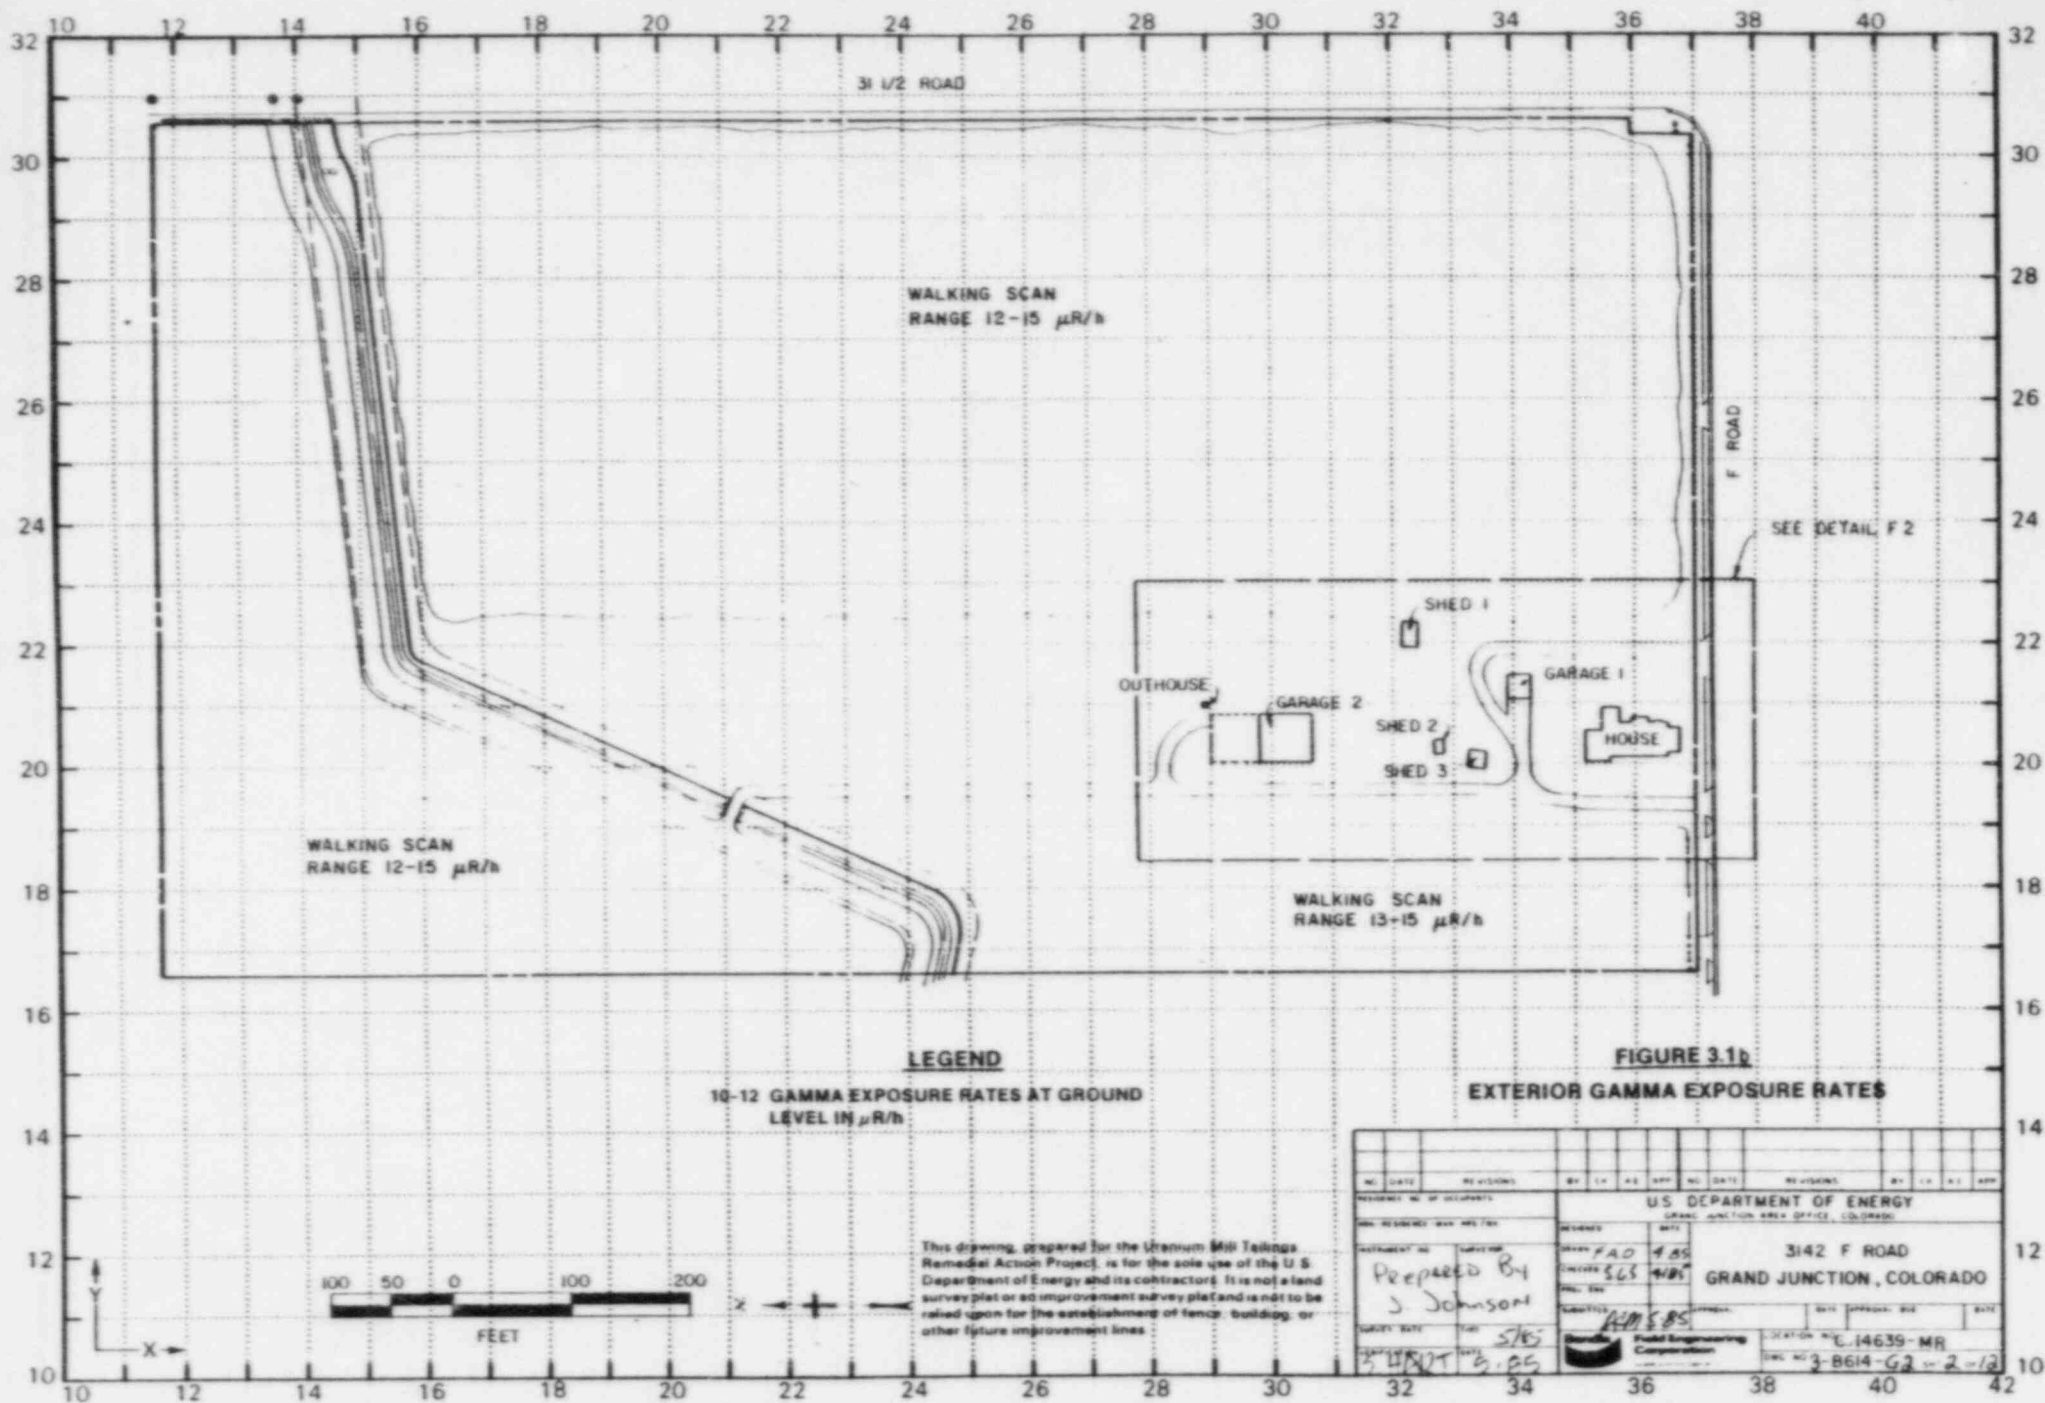
FIGURE 3.2b
EXTERIOR GAMMA SCAN

Exterior radium-concentration measurements are presented in Appendix Table 3.1. Grid-point survey results are shown in Appendix Figures 3.1a and 3.1b. Appendix Figures 3.2a and 3.2b present the ranges of elevated gamma readings and indicate areas of possible contamination.
