RADIOACTIVE MATERIALS SERVICES  
DATA REPORT

METALLURGICAL EVALUATION OF RANCHO SECO  
STEAM GENERATOR VENT LINE CRACKING

JULY 1985

RANCHO SECOSTA TRANSIENT ASSESSMENT REPORT NO. 5

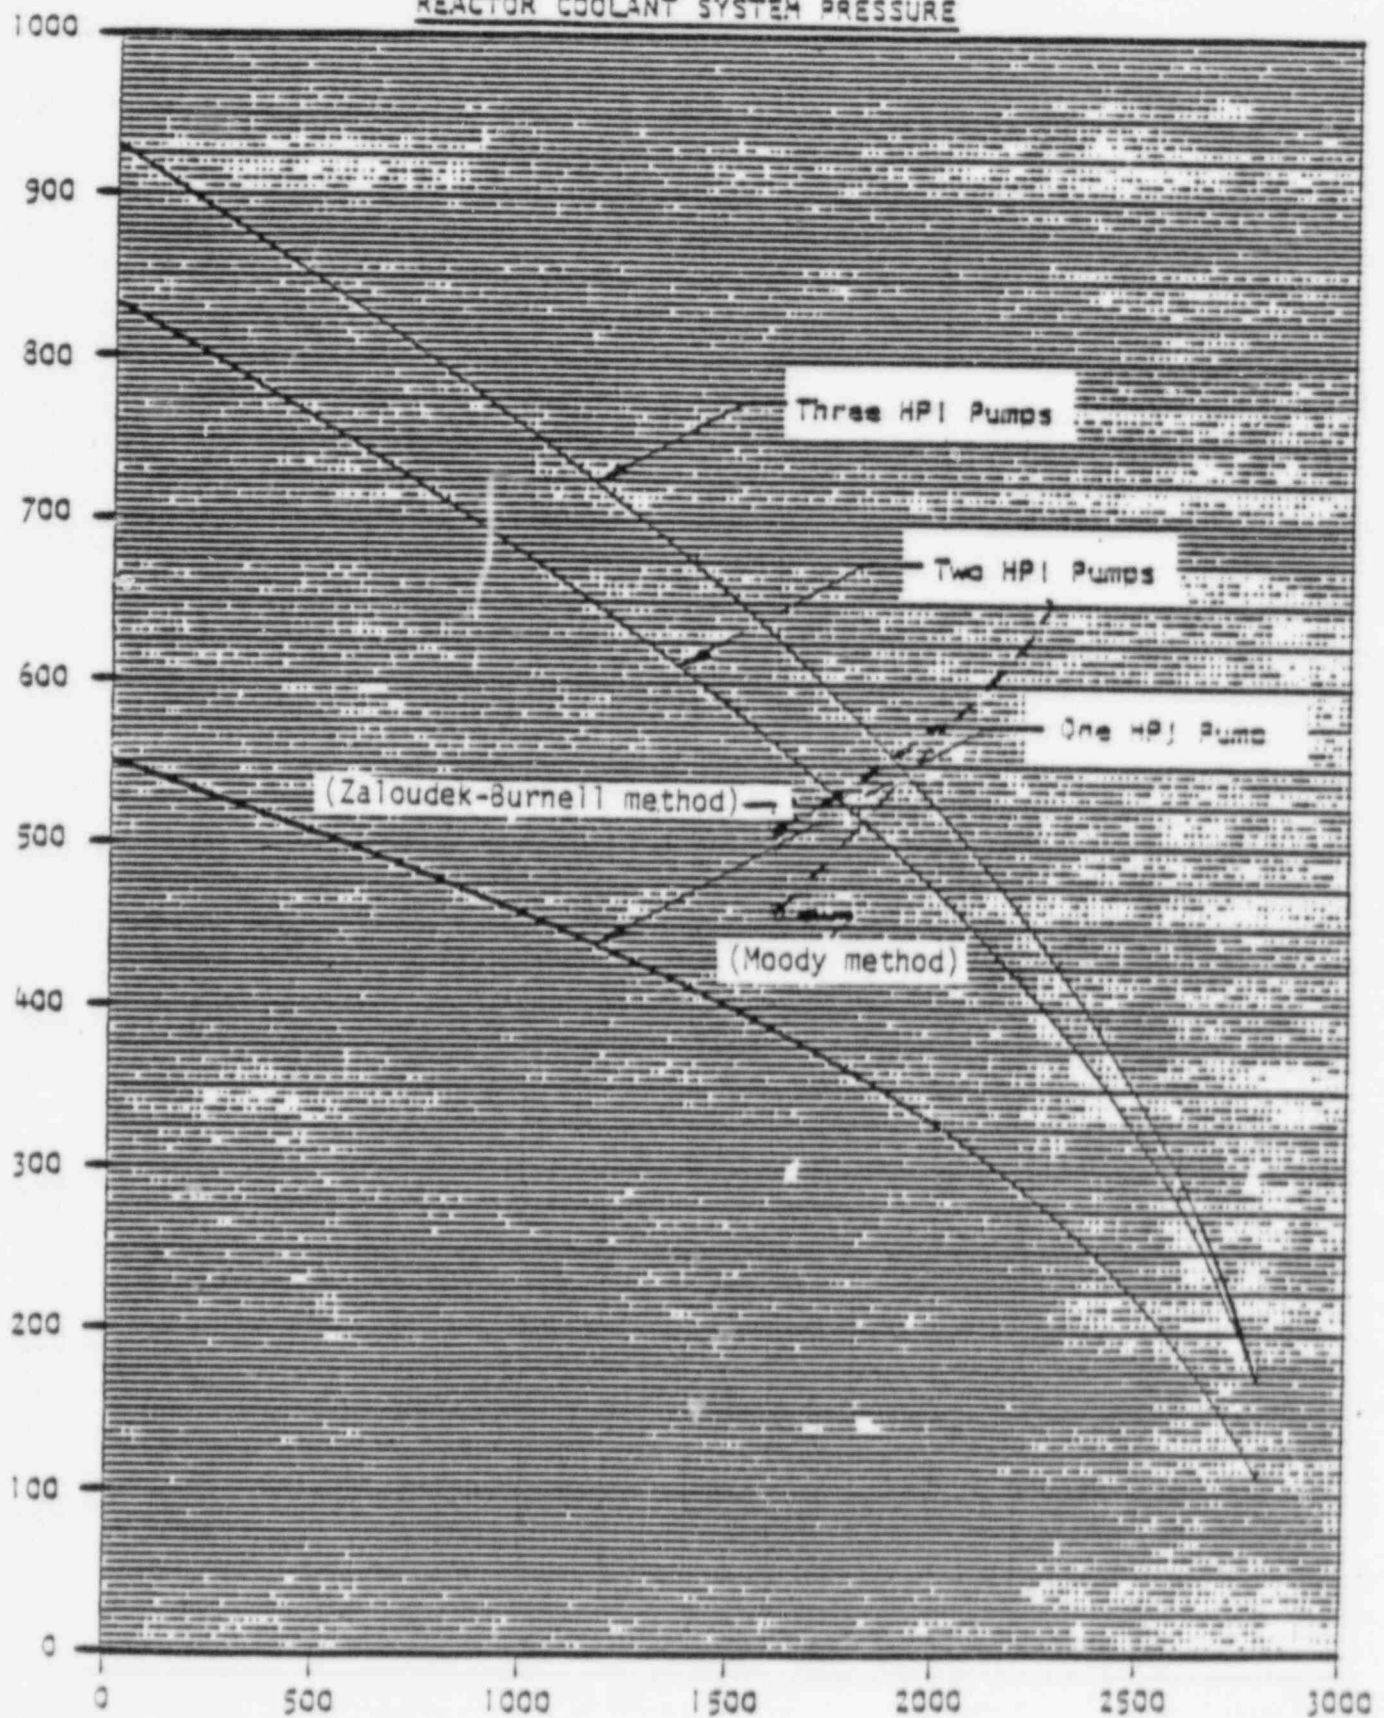
It must be noted that as the RCS pressure decreases, the leak will also decrease but the HPI flow will increase. Enclosure 6 shows HPI flow vs. system pressure. It should also be noted that this curve shows pre-throttled HPI flow and more HPI flow is actually available. The dashed curve represents leak rate vs. system pressure as calculated by B & W Engineering at several pressures and extrapolated. The intersection of the solid and dashed curves indicates at what pressure the RCS would be at when the leak would be in equilibrium with the HPI flowrate.

HIGH PRESSURE INJECTION FLOW

VS.

REACTOR COOLANT SYSTEM PRESSURE
