OMAHA PUBLIC POWER DISTRICT
FORT CALHOUN

Steam Generator Tube Rupture Incident Report

June 1984

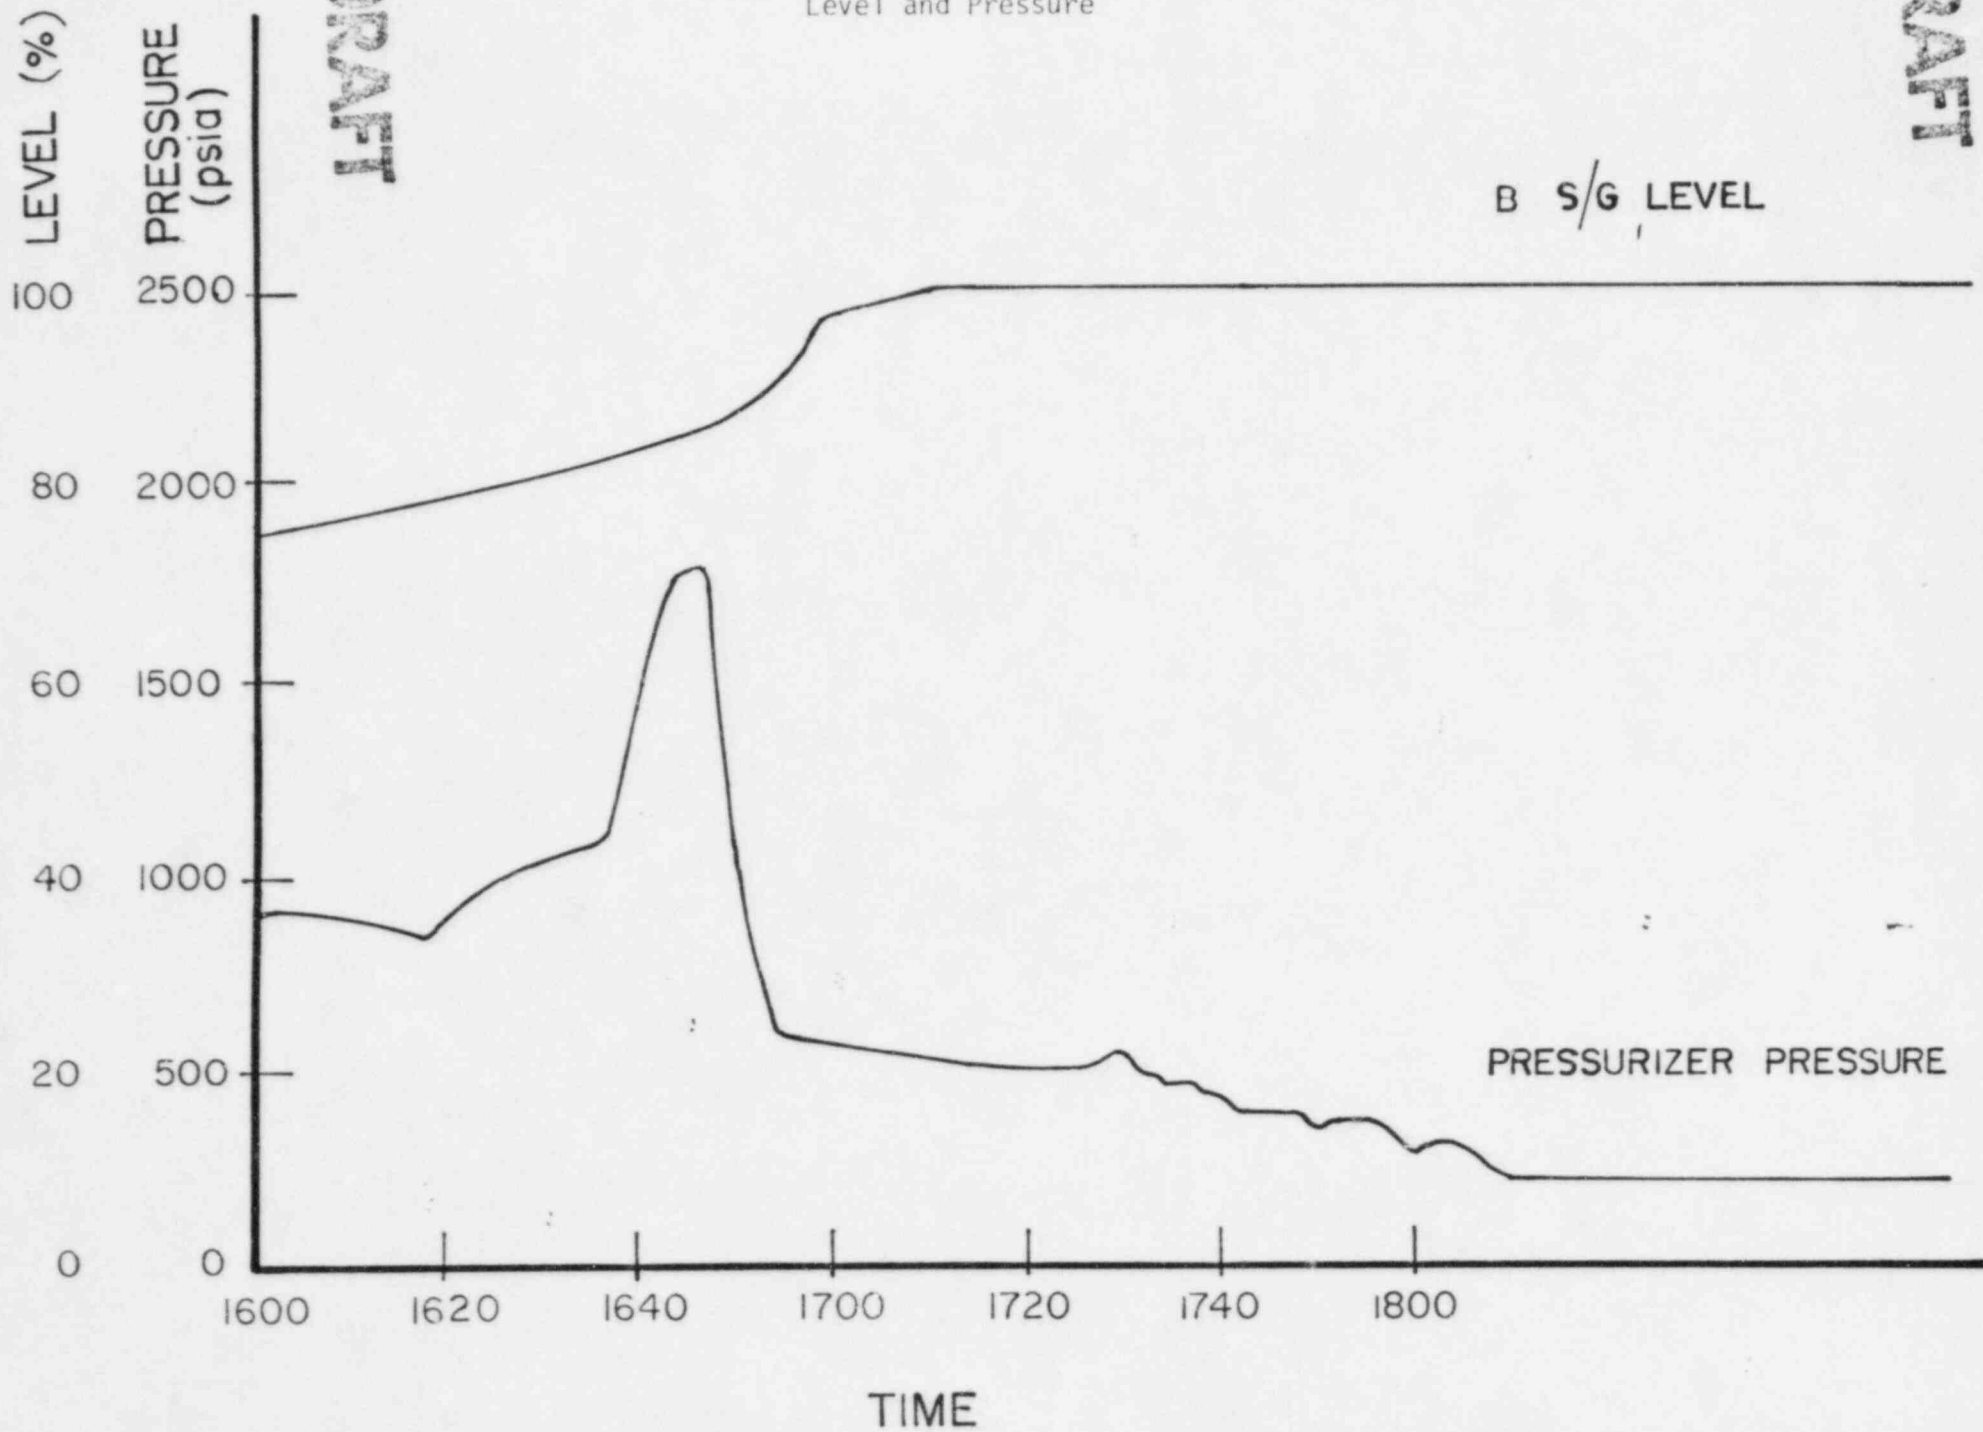
Figure 1: Time Sequence Relating to Steam Generator Level and Pressure

Figure 1 contains a time sequence relating to steam generator level and pressure.

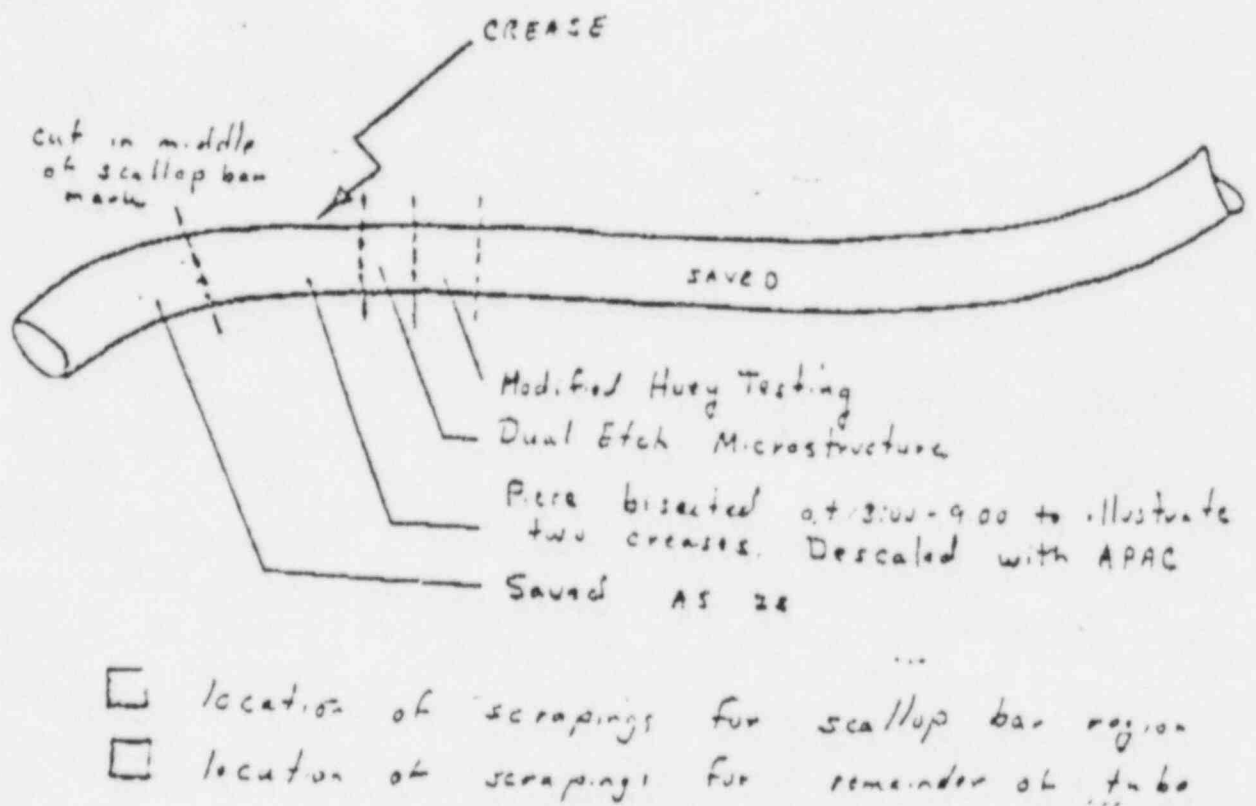
Figure 5 - Disposition of Pieces from Tube L29R86, Section 13A

Figure 5 illustrates the sectioning of tube section 13A to provide samples for subsequent examinations. These samples were removed for dual etch microstructure characterization, modified Huey testing, and surface examination. Prior to the sectioning, samples of the deposits were collected for chemical analysis. The locations of scrapings for chemical analysis are also illustrated in Figure 5.

One section from tube specimen 13A was chemically descaled using APAC, a standard two step descaling solution. The piece chosen was from the middle of one scallop bar to just past the kink in the tube, as shown in Figure 5. The purpose was to establish whether defects other than the kink/crease existed, and if so to correlate them to the previously observed eddy current indications. Once descaled, the specimen was examined at 5-40X under a microscope. Whereas only one crease was visible on the exterior surface of the tube, two creases were observed on the inside diameter. The shallower of the two creases corresponded to the location of the scallop bar. The distance between the two creases also matched the distance between the two eddy current signals. No other externally or internally visible defects were identified.
