RADIOLOGIC AND ENGINEERING ASSESSMENT

DOE ID NO.: GJ-13036-RS  
ADDRESS: 501 WEST MAIN STREET

AUGUST 1985

BENDIX FIELD ENGINEERING CORPORATION  
P.O. Box 1569  
Grand Junction, Colorado 81502

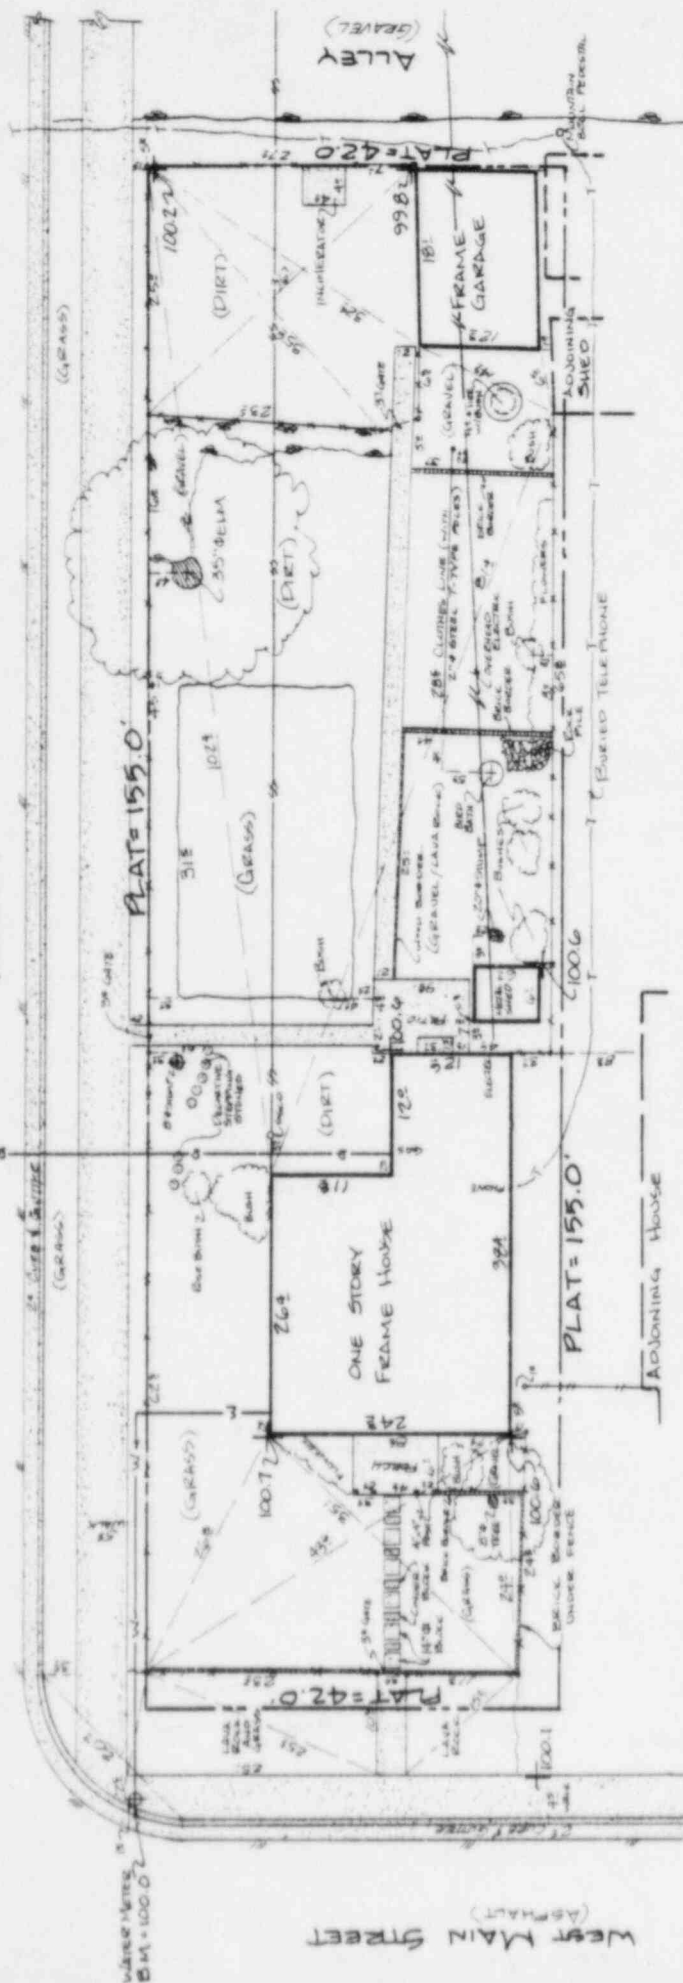
FIGURE 2.2 SITE PLAN

Utilities: Utility locations are shown in Appendix Figure 2.2.

Structures, utilities, landscaping, and other special features of this property are included in Appendix Figure 2.2.

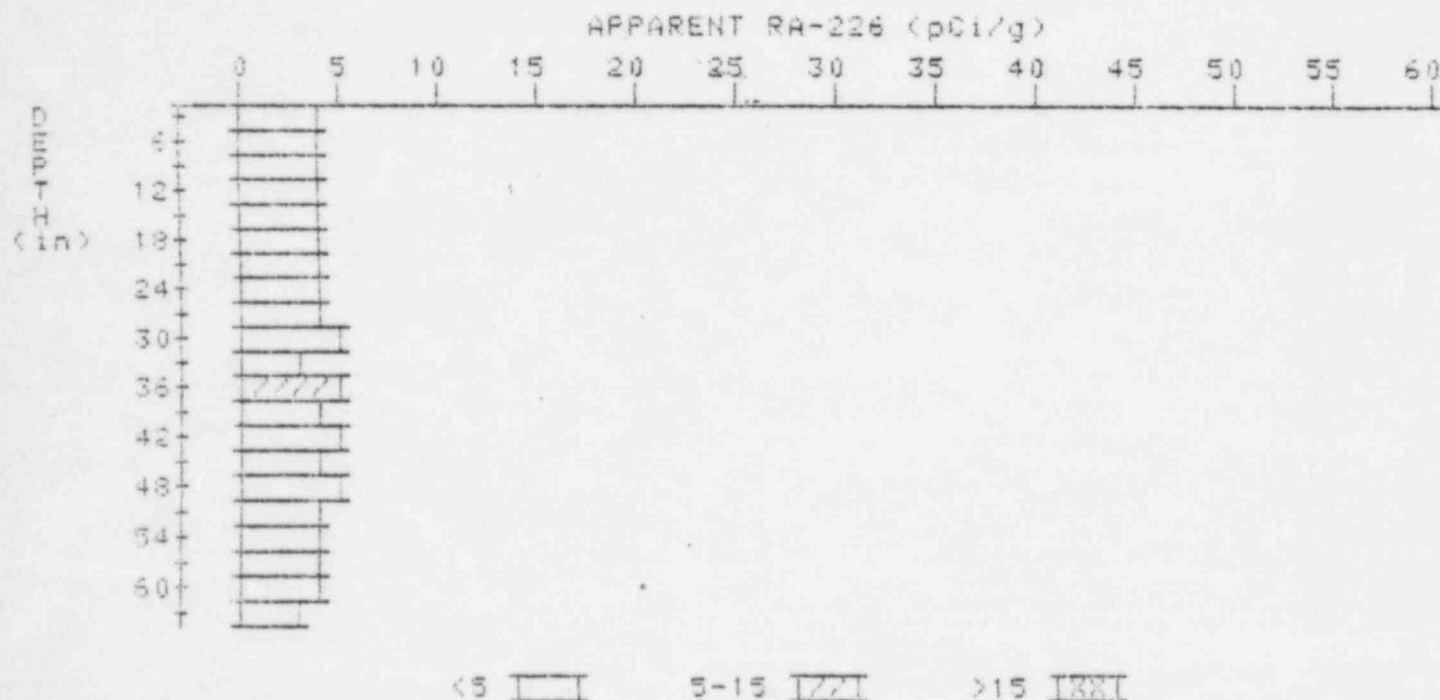
# APPARENT RADIUM-226 CONCENTRATION 12 DECONVOLUTION GRAPH

Depth (in)	Apparent Radium-226 (pCi/g) Undeconvolved	Apparent Radium-226 (pCi/g) Deconvolved
3	3.9	3.9
6	4.0	4.2
9	4.0	3.3
12	4.1	4.3
15	4.0	3.6
18	4.1	4.1
21	4.2	4.4
24	4.2	4.0
27	4.3	4.5
30	4.3	4.9
33	4.0	2.0
36	4.4	3.1
39	4.4	4.4
42	4.4	4.6
45	4.3	4.1
48	4.3	4.7
51	4.1	3.7

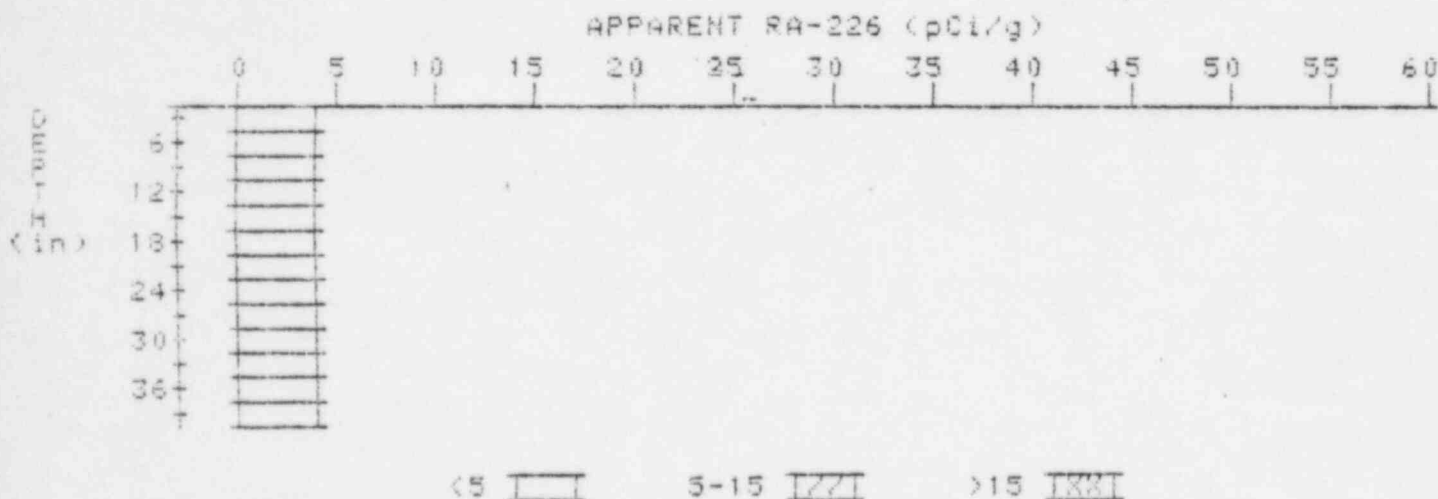
# APPARENT RADIUM-226 CONCENTRATION 15 DECONVOLUTION GRAPH

Depth (in)	Apparent Radium-226 (pCi/g) Undeconvolved	Apparent Radium-226 (pCi/g) Deconvolved
3	3.5	3.5
6	3.8	4.0
9	4.0	4.4
12	4.0	3.9
15	4.1	4.1
18	4.2	4.4
21	4.2	4.2
24	4.2	4.0
27	4.3	4.5
30	4.3	4.5
33	4.2	4.2
36	4.1	4.1
39	4.0	4.0

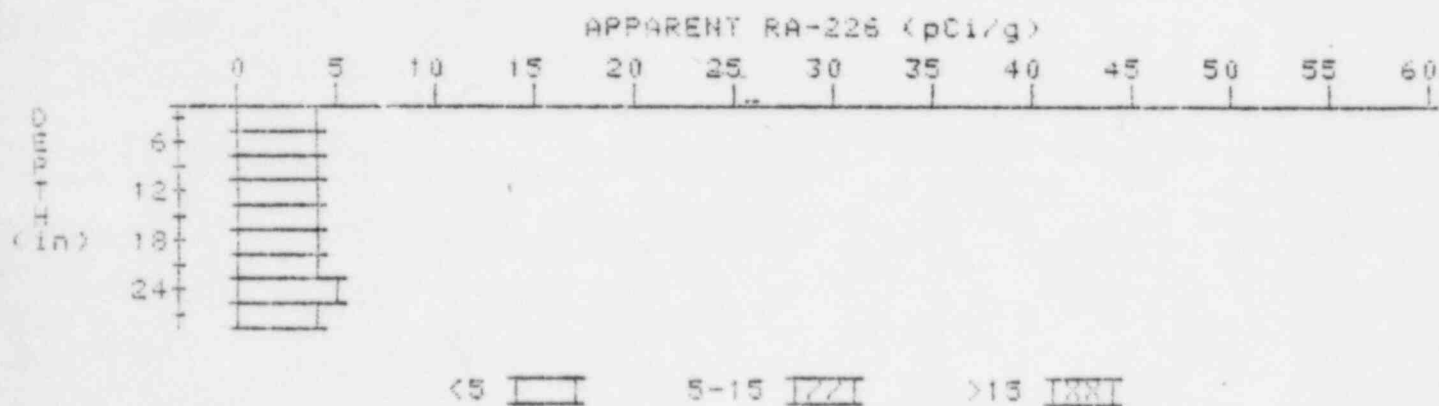
# APPARENT RADIUM-226 CONCENTRATION 17 DECONVOLUTION GRAPH

Depth (in)	Apparent Radium-226 (pCi/g) Underconvolved	Apparent Radium-226 (pCi/g) Deconvolved
3	4.0	4.0
6	4.1	4.3
9	4.1	3.9
12	4.2	4.2
15	4.3	4.5
18	4.3	4.1
21	4.4	4.4
24	4.5	4.9
27	4.4	4.4

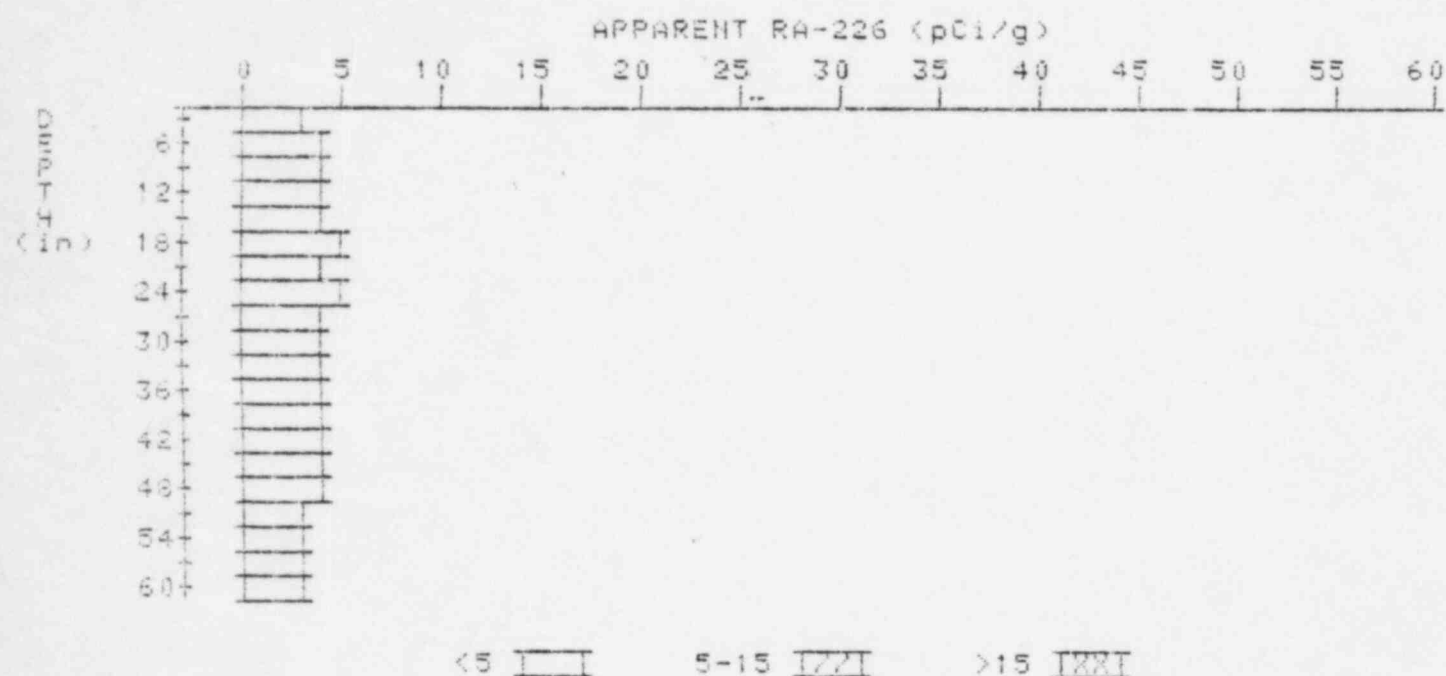
# APPARENT RADIUM-226 CONCENTRATION 18 DECONVOLUTION GRAPH

Depth (in)	Apparent Radium-226 (pCi/g) Undeconvolved	Apparent Radium-226 (pCi/g) Deconvolved
3	3.3	3.3
6	3.7	3.9
9	4.0	4.4
12	4.1	4.1
15	4.2	4.2
18	4.3	4.7
21	4.2	3.8
24	4.3	4.7
27	4.2	4.2
30	4.1	4.1
33	4.0	3.8
36	4.0	4.2
39	3.9	4.1
42	3.7	3.5
45	3.6	3.6
48	3.5	3.7
51	3.3	2.4
54	3.3	3.3
