RADIOLOGIC AND ENGINEERING ASSESSMENT

DOE ID NO.: GJ-10337-RS
ADDRESS: 635 CHIPETA AVENUE

AUGUST 1985

BENDIX FIELD ENGINEERING CORPORATION
P.O. Box 1569
Grand Junction, Colorado 81502

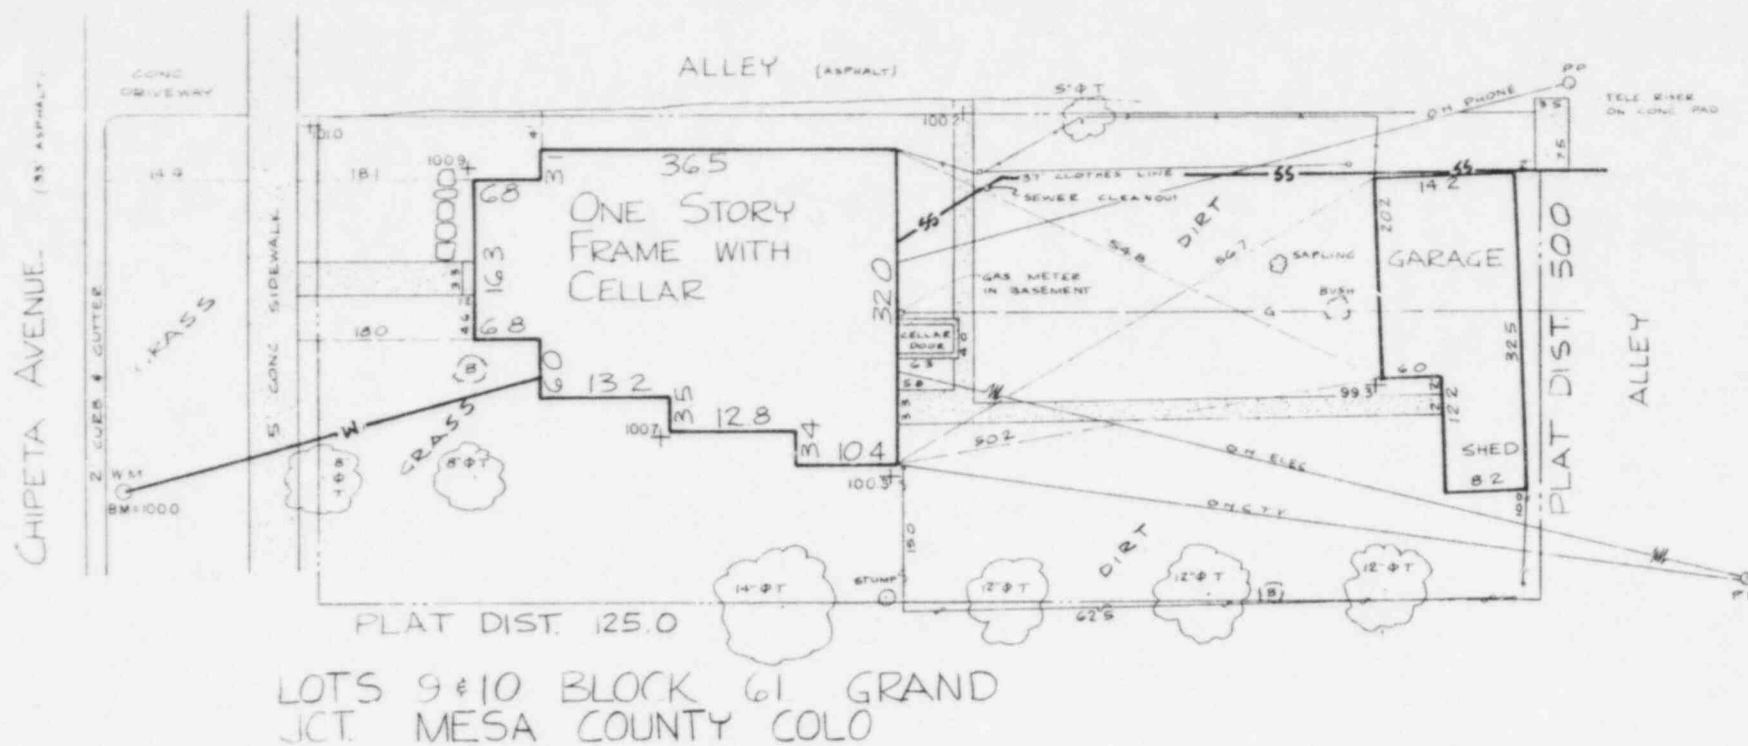
FIGURE 2.2 SITE PLAN

Utilities: Utility locations are shown in Appendix Figure 2.2.

Structures, utilities, landscaping, and other special features of this property are included in Appendix Figure 2.2.

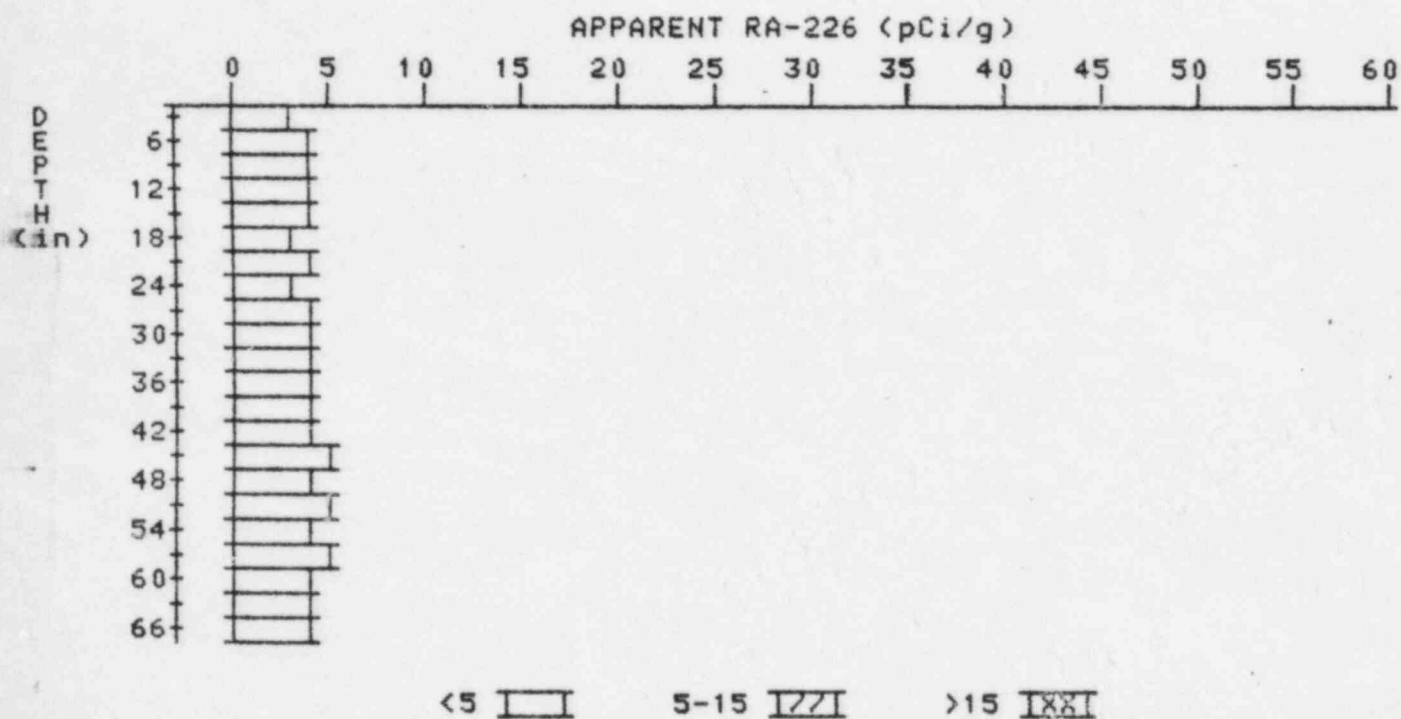
HOLE NUMBER: 5

Depth (in)	Apparent Radium-226 (pCi/g) Undeconvolved	Apparent Radium-226 (pCi/g) Deconvolved
3	3.2	3.2
6	3.4	3.6
9	3.5	3.7
12	3.5	3.5
15	3.5	3.5
18	3.5	3.3
21	3.6	3.8
24	3.6	3.4
27	3.7	3.7
30	3.8	3.8
33	3.9	3.9
36	4.0	4.0
39	4.1	4.3
42	4.1	3.7
45	4.3	4.7
48	4.3	4.1

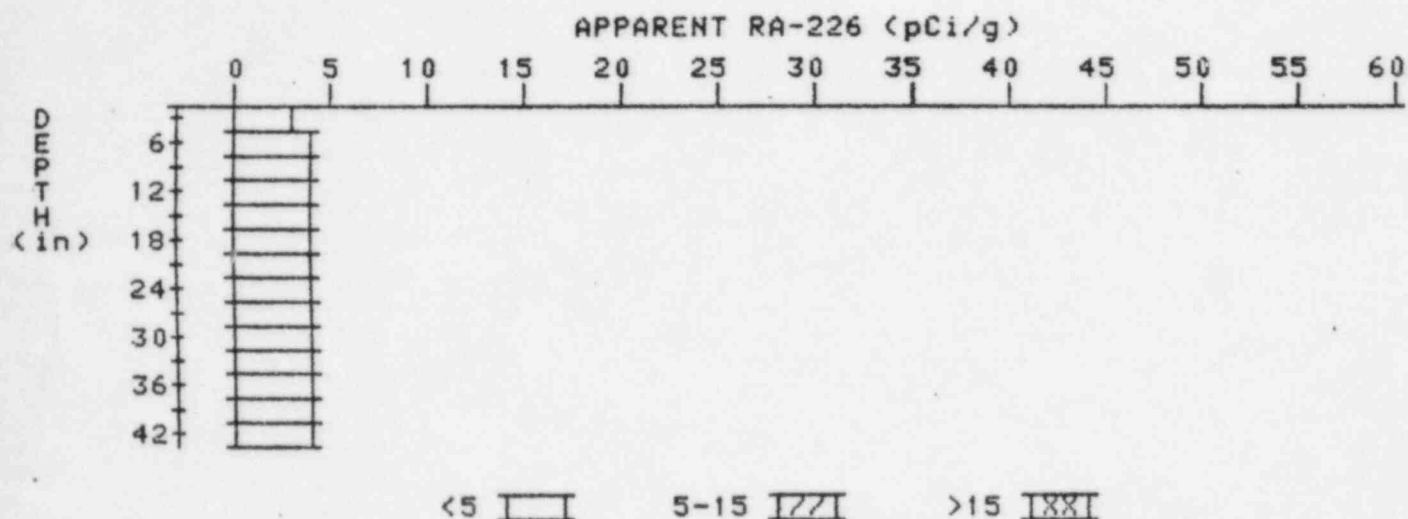
HOLE NUMBER: 7

Depth (in)	Apparent Radium-226 (pCi/g) Undeconvolved	Apparent Radium-226 (pCi/g) Deconvolved
3	3.1	3.1
6	3.4	3.6
9	3.6	3.6
12	3.8	4.0
15	3.9	4.1
18	3.9	3.9
21	3.9	3.7
24	4.0	4.4
27	3.9	3.5
30	4.0	4.0
33	4.1	4.3
36	4.1	4.1
39	4.1	3.9
42	4.2	4.2

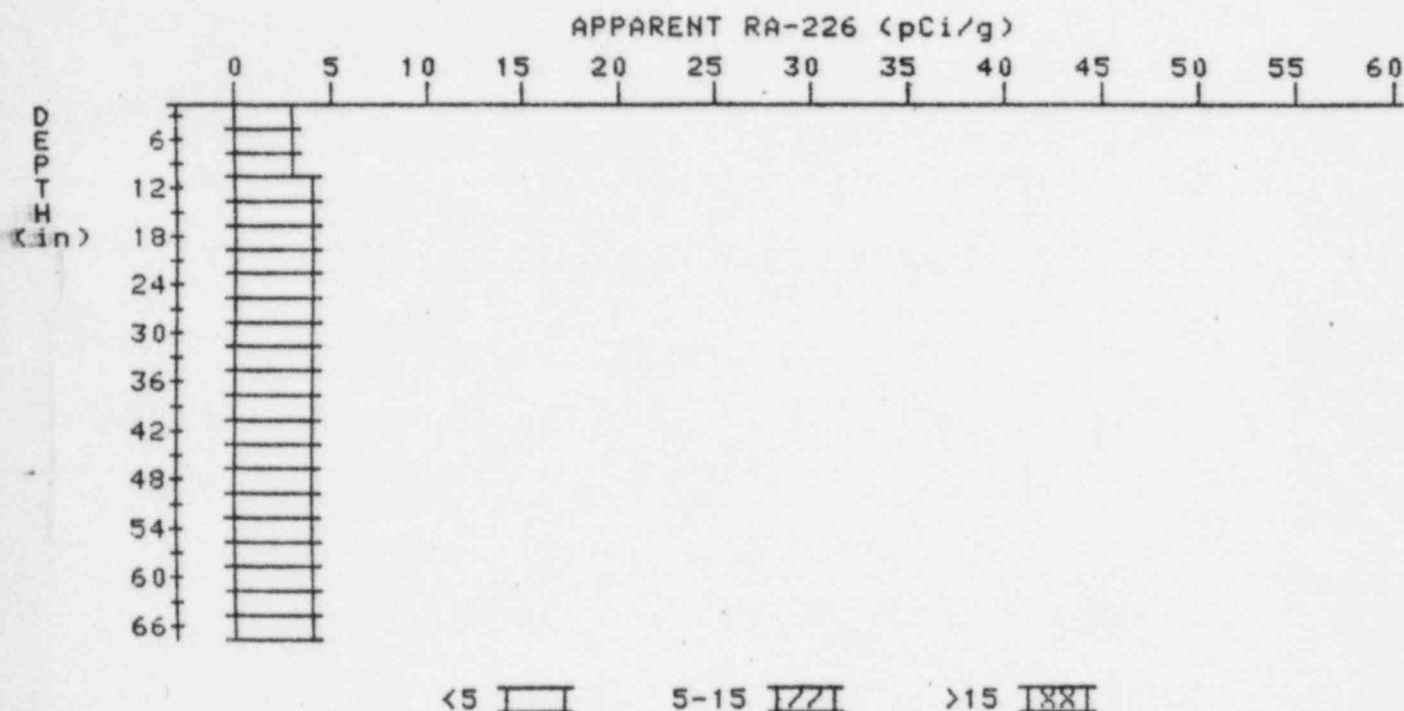
HOLE NUMBER: 8

Depth (in)	Apparent Radium-226 (pCi/g) Undeconvolved	Apparent Radium-226 (pCi/g) Deconvolved
3	2.6	2.6
6	2.9	2.9
9	3.2	3.4
12	3.4	3.6
15	3.5	3.5
18	3.6	3.6
21	3.7	3.7
24	3.8	3.6
27	4.0	4.4
30	4.0	4.0
33	4.0	4.0
36	4.0	4.0
39	4.0	4.0
42	4.0	4.0
45	4.0	4.0
48	4.0	3.8
