RADIOLOGIC AND ENGINEERING ASSESSMENT

DOE ID NO.: GJ-03077-MR  
ADDRESS: 2313 ORCHARD AVENUE

JULY 1985

BENDIX FIELD ENGINEERING CORPORATION  
P.O. Box 1569  
Grand Junction, Colorado 81502

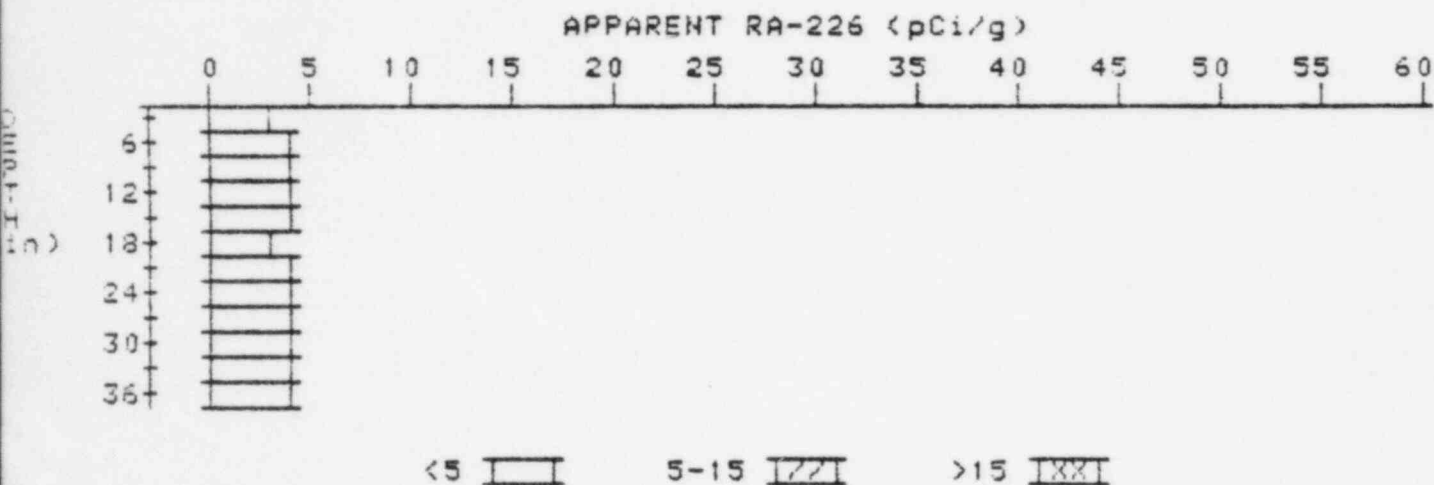
HOLE NUMBER: 6

Depth (in)	Apparent Radium-226 (pCi/g) Undeconvolved	Apparent Radium-226 (pCi/g) Deconvolved
3	3.0	3.0
6	3.4	3.9
9	3.5	3.7
12	3.5	3.5
15	3.5	3.5
18	3.5	3.3
21	3.6	3.8
24	3.6	3.6
27	3.6	3.6
30	3.6	3.6
33	3.6	3.6
36	3.6	3.6

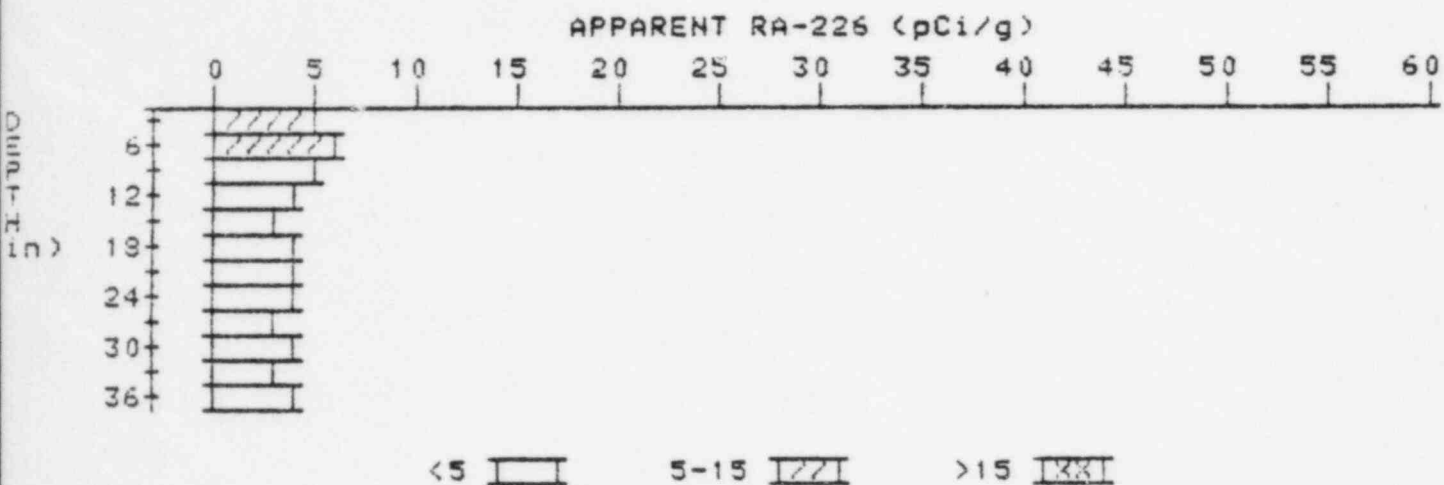
PROPERTY NUMBER: GJ-03077-R6MR *mp7.85*  
HOLE NUMBER: 9  
LOCATION: 189249

Depth (in)	Apparent Radium-226 (pCi/g) Undeconvolved	Apparent Radium-226 (pCi/g) Deconvolved
3	5.1	5.1
6	5.0	5.5
9	4.6	4.6
12	4.2	4.2
15	3.8	3.1
18	3.8	3.8
21	3.8	4.0
24	3.7	3.7
27	3.6	3.2
30	3.7	4.2
33	3.5	3.0
36	3.6	3.6

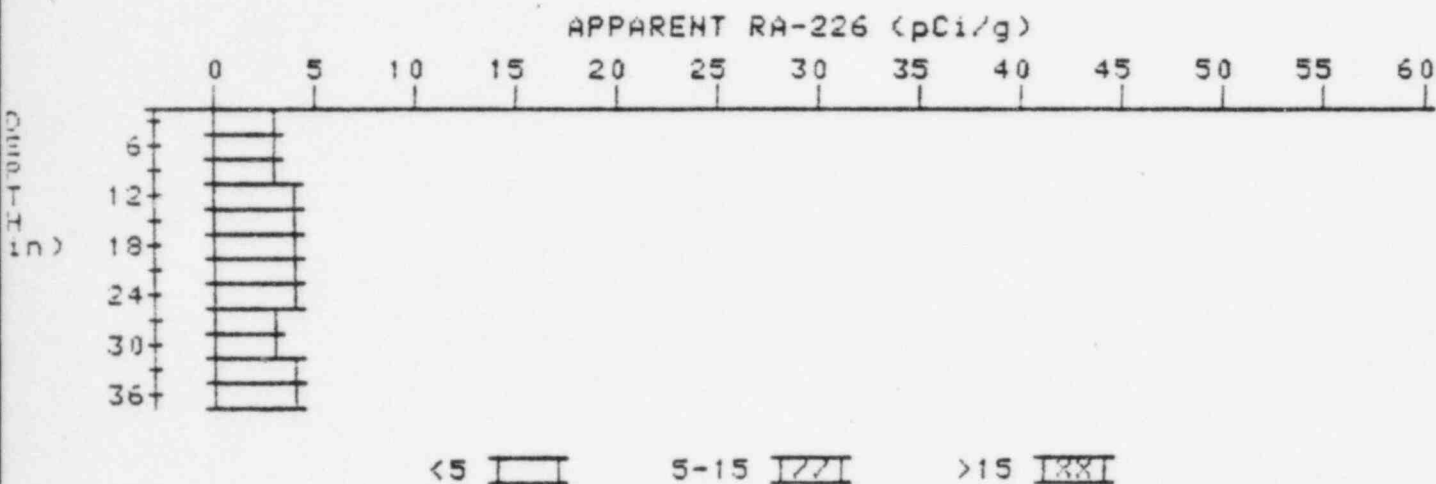
PROPERTY NUMBER: GJ-03077-R6 MR *mg 7.85*  
HOLE NUMBER: 14  
LOCATION: 215225

Depth (in)	Apparent Radium-226 (pCi/g) Undeconvolved	Apparent Radium-226 (pCi/g) Deconvolved
3	3.1	3.1
6	3.3	3.5
9	3.4	3.4
12	3.5	3.7
15	3.5	3.5
18	3.5	3.5
21	3.5	3.5
24	3.5	3.7
27	3.4	3.2
30	3.4	3.2
33	3.5	3.7
36	3.5	3.5

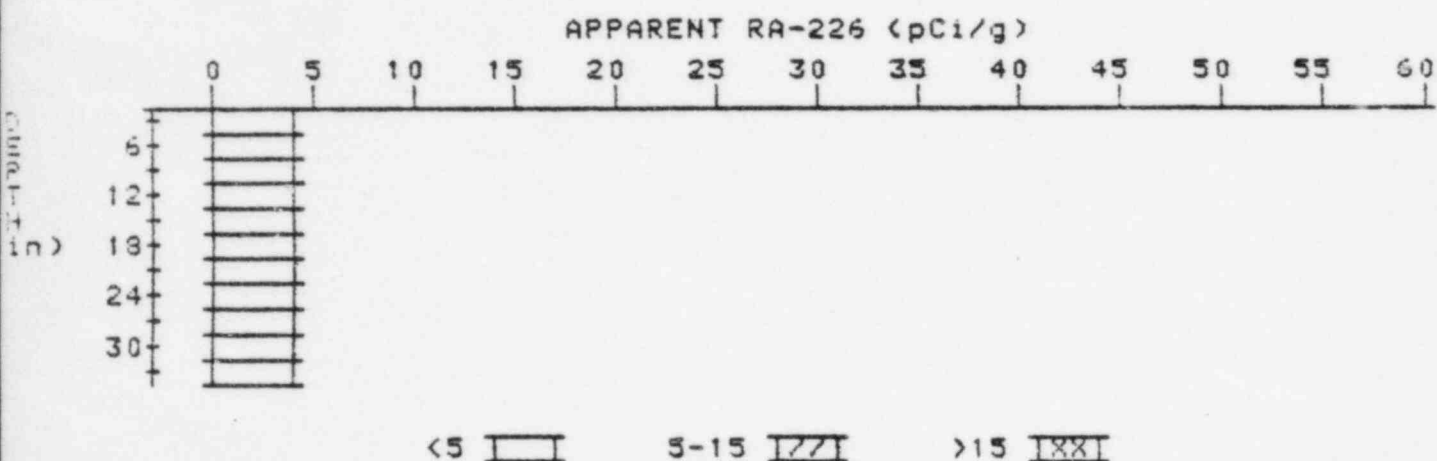
PROPERTY NUMBER: GJ-03077-RS-MR *mg 7.85*  
HOLE NUMBER: 16  
LOCATION: 222251

Depth (in)	Apparent Radium-226 (pCi/g) Undeconvolved	Apparent Radium-226 (pCi/g) Deconvolved
3	3.6	3.6
6	3.8	4.0
9	3.9	4.3
12	3.8	3.6
15	3.8	4.0
18	3.7	3.5
21	3.7	3.7
24	3.7	3.7
27	3.7	3.7
30	3.7	3.7
33	3.7	3.7

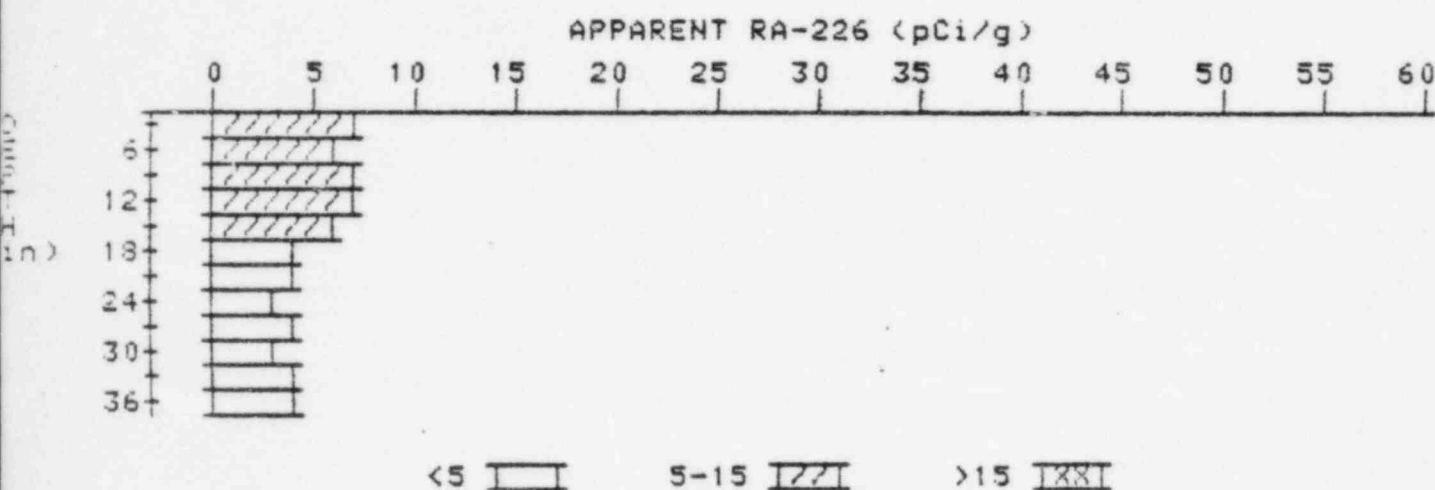
PROPERTY NUMBER: GJ-03077-R&MR *mg 7.85*  
HOLE NUMBER: 17  
LOCATION: 225235

Depth (in)	Apparent Radium-226 (pCi/g) Undeconvolved	Apparent Radium-226 (pCi/g) Deconvolved
3	6.8	6.8
6	6.5	5.8
9	6.6	7.1
12	6.4	7.5
15	5.6	5.8
18	4.7	4.2
21	4.1	3.6
24	3.8	3.4
27	3.7	3.7
30	3.6	3.2
33	3.7	3.7
36	3.8	3.8
