RADIOLOGIC AND ENGINEERING ASSESSMENT

DOE ID NO.: GJ-03936-RS  
ADDRESS: 2414 HALL AVENUE

AUGUST 1985

URANIUM MILL TAILINGS REMEDIAL ACTION PROJECT OFFICE

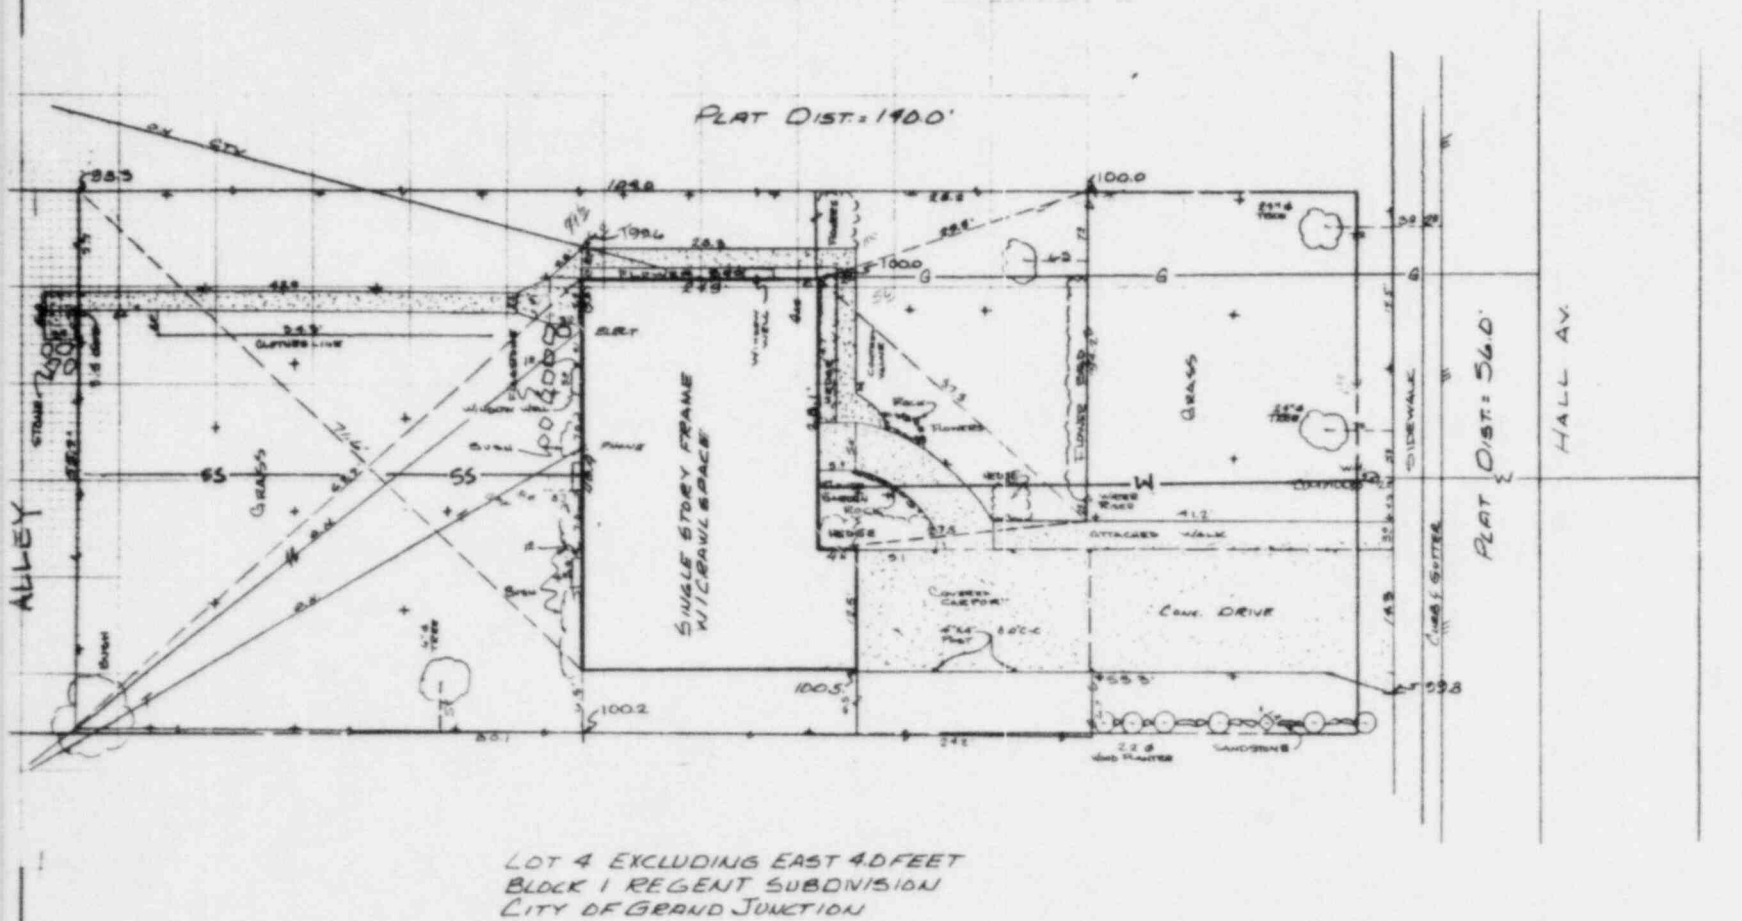
FIGURE 2.2 SITE PLAN

Structures, utilities, landscaping, and other special features of this property are included in Appendix Figure 2.2.
