**RADIOLOGIC AND ENGINEERING ASSESSMENT**

DOE ID NO.: GJ-03629-RM  
ADDRESS: 211 BELFORD AVENUE

AUGUST 1985

BENDIX FIELD ENGINEERING CORPORATION  
P.O. Box 1569  
Grand Junction, Colorado 81502

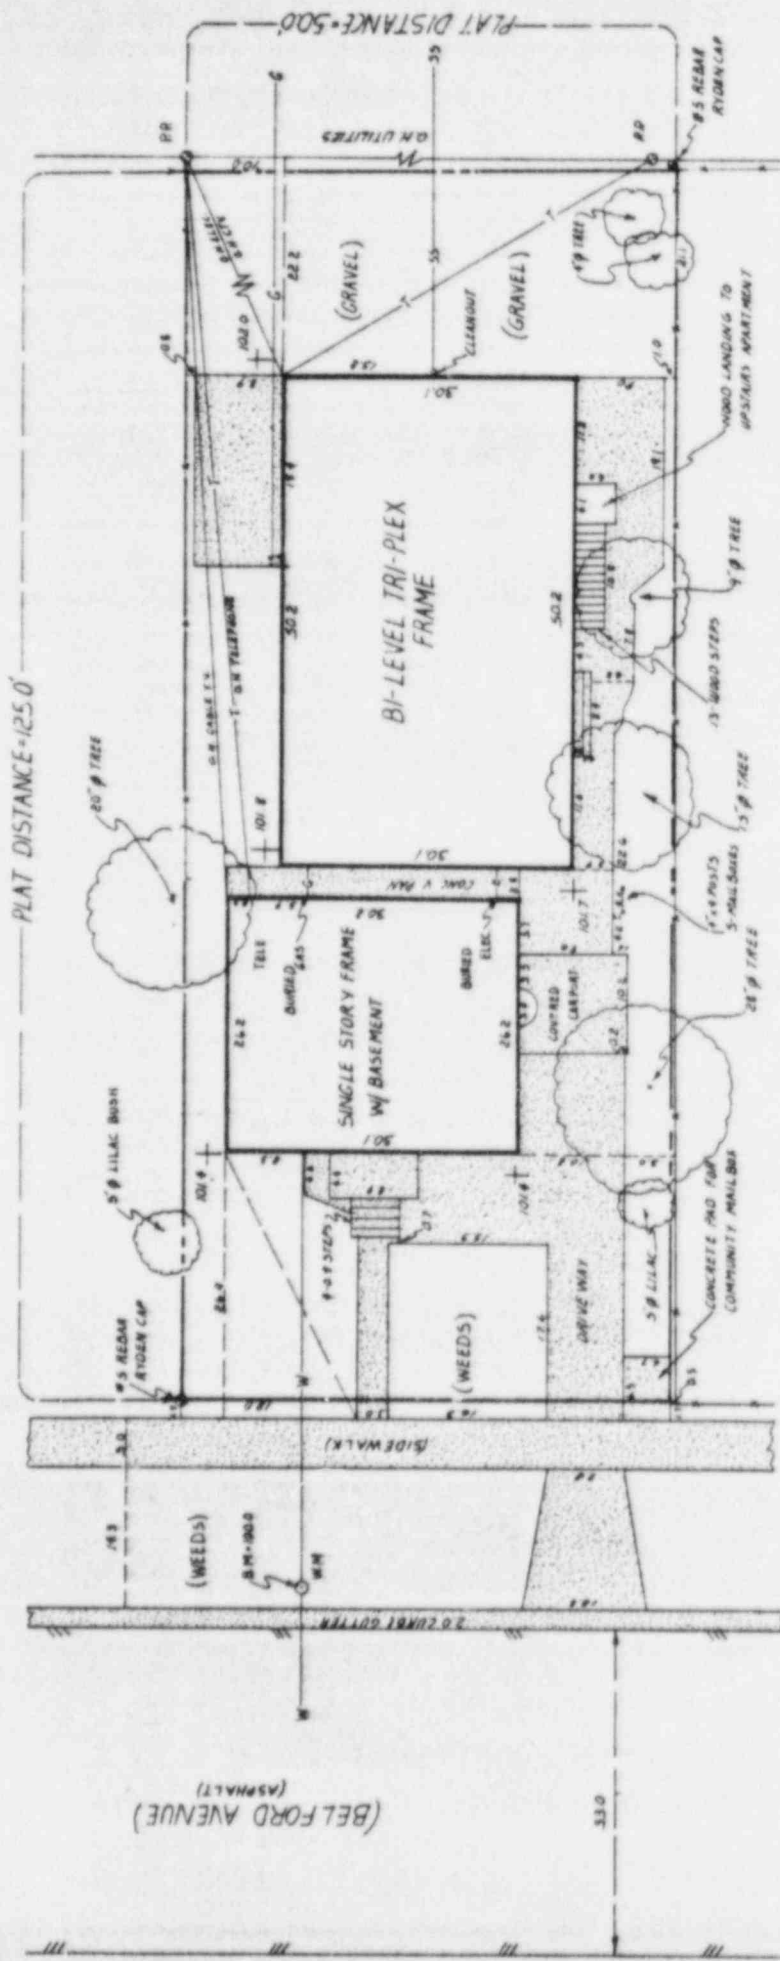
FIGURE 2.2 SITE PLAN

Utilities: Utility locations are shown in Appendix Figure 2.2.

Structures, utilities, landscaping, and other special features of this property are included in Appendix Figure 2.2.
