RADIOLOGIC AND ENGINEERING ASSESSMENT

DOE ID NO.: GJ-00599-RS
ADDRESS: 1944 NORTH 22ND STREET

AUGUST 1985

URANIUM MILL TAILINGS REMEDIAL ACTION PROJECT OFFICE

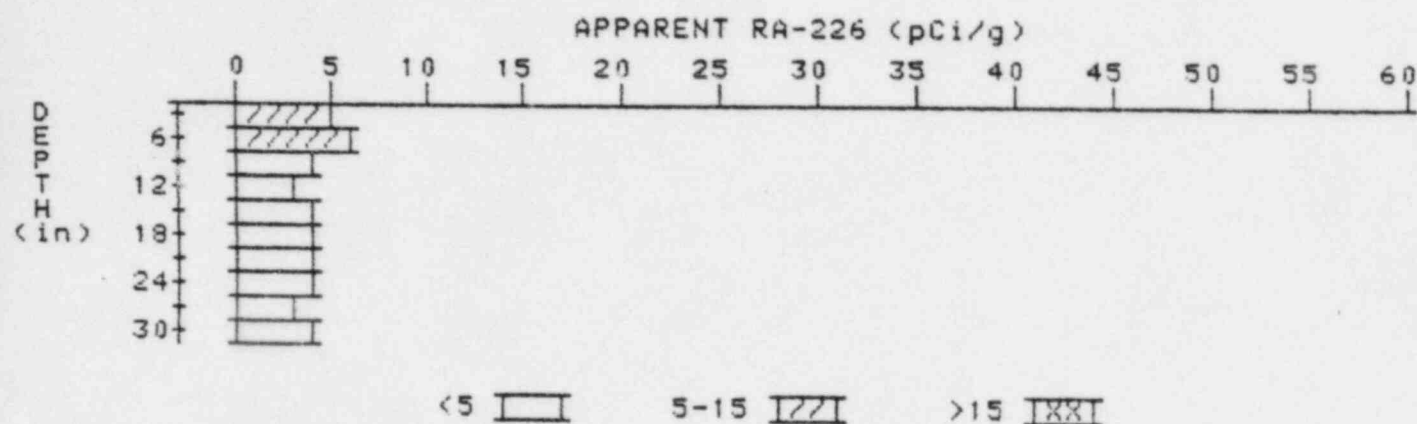
HOLE NUMBER: 8

Depth (in)	Apparent Radium-226 (pCi/g) Undeconvolved	Apparent Radium-226 (pCi/g) Deconvolved
3	5.3	5.3
6	5.0	5.5
9	4.4	4.0
12	4.0	3.5
15	3.9	3.7
18	3.9	4.1
21	3.8	3.8
24	3.7	3.7
27	3.6	3.4
30	3.6	3.6

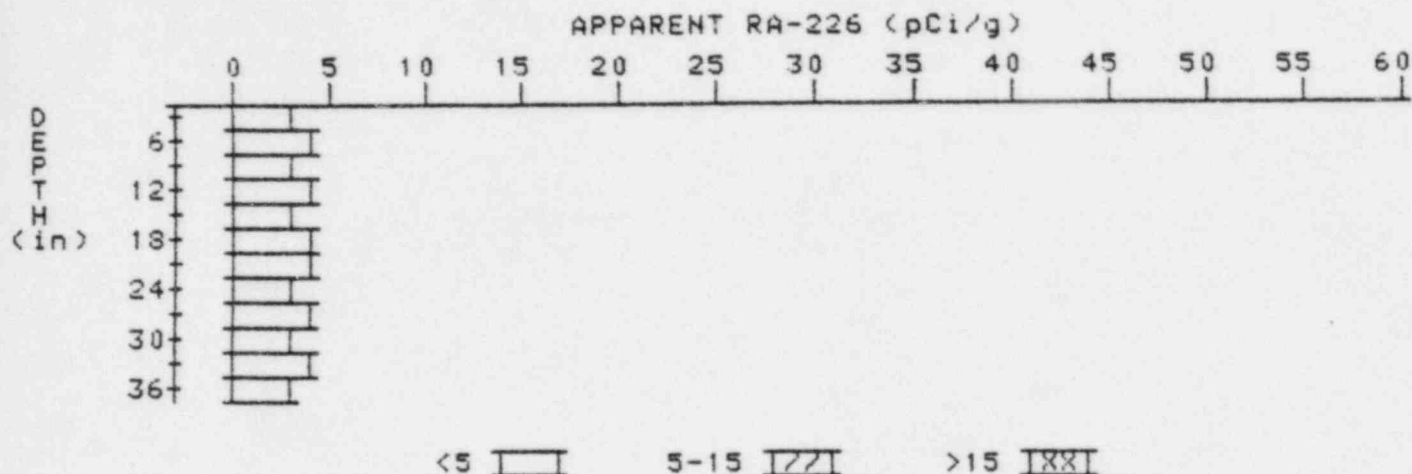
HOLE NUMBER: 13

Depth (in)	Apparent Radium-226 (pCi/g) Undeconvolved	Apparent Radium-226 (pCi/g) Deconvolved
3	2.7	2.7
6	3.2	3.9
9	3.3	3.3
12	3.4	3.6
15	3.4	3.2
18	3.5	3.7
21	3.5	3.7
24	3.4	3.2
27	3.4	3.6
30	3.3	2.9
33	3.4	3.8
36	3.3	3.3

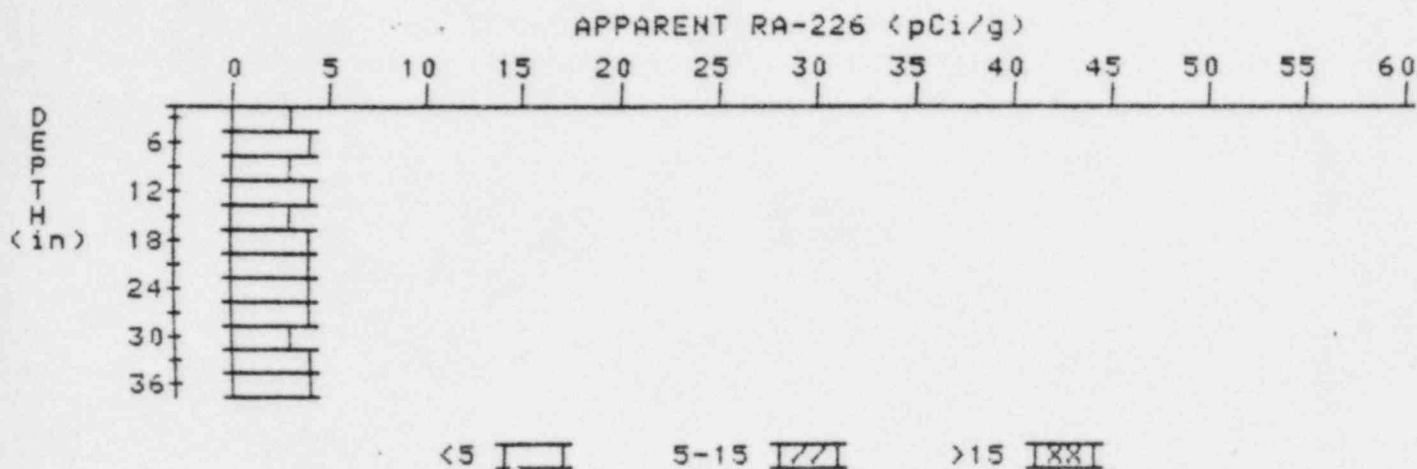
HOLE NUMBER: 14

Depth (in)	Apparent Radium-226 (pCi/g) Undeconvolved	Apparent Radium-226 (pCi/g) Deconvolved
3	2.9	2.9
6	3.2	3.6
9	3.3	3.1
12	3.5	3.9
15	3.5	3.3
18	3.6	3.8
21	3.6	3.6
24	3.6	3.6
27	3.6	3.6
30	3.6	3.4
33	3.7	4.1
36	3.6	3.6

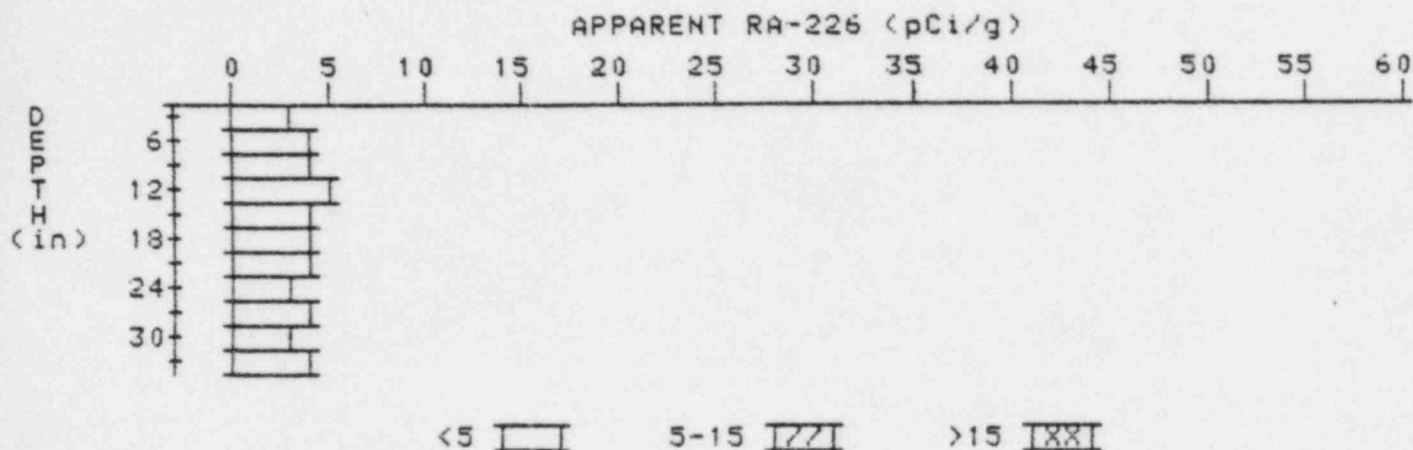
PROPERTY NUMBER: GJ-00599-RS
HOLE NUMBER: 17
LOCATION: 299293

Depth (in)	Apparent Radium-226 (pCi/g) Undeconvolved	Apparent Radium-226 (pCi/g) Deconvolved
3	3.2	3.2
6	3.6	3.8
9	3.9	4.1
12	4.1	4.8
15	3.9	3.5
18	3.9	4.1
21	3.8	4.0
24	3.6	3.1
27	3.7	4.1
30	3.6	3.4
33	3.6	3.6
