RADIOLOGIC AND ENGINEERING ASSESSMENT

DOE ID NO.: GJ-01293-MR
ADDRESS: 2236 TEXAS AVENUE

AUGUST 1985

URANIUM MILL TAILINGS REMEDIAL ACTION PROJECT OFFICE

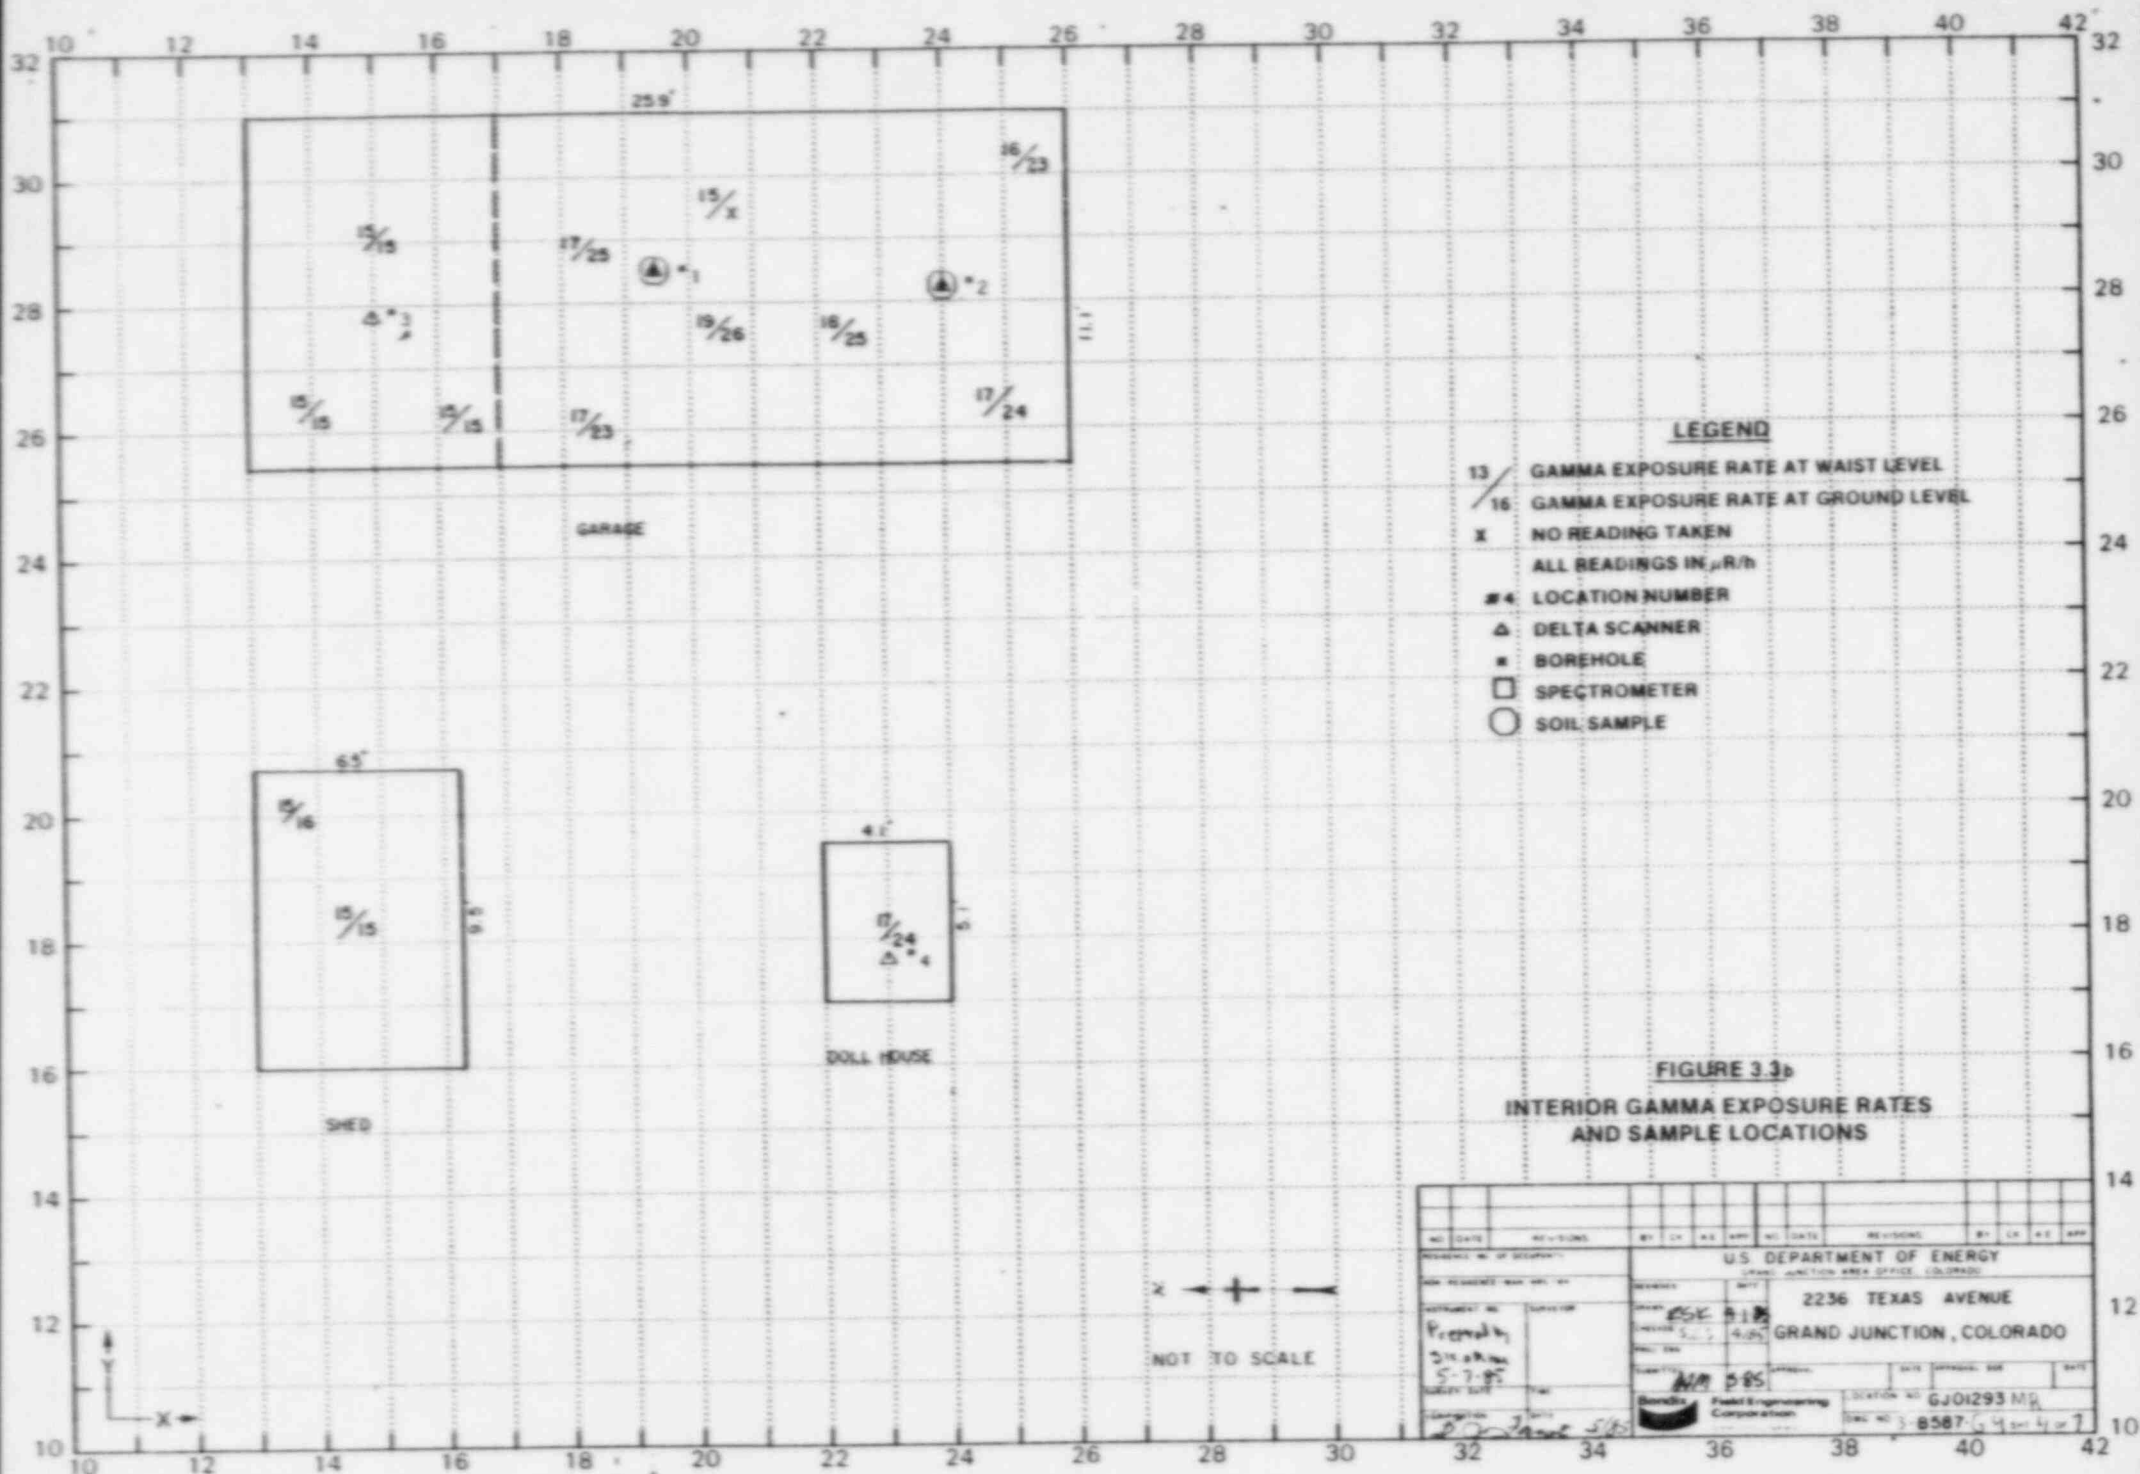
Areas which displayed elevated gamma levels were further investigated; these areas are shown in Appendix Figures 3.3b and 3.4.

* The CDH and ORNL data indicate the absence of interior contamination in the primary structure. This information was investigated by performing a walking gamma scan. These areas and the ranges of gamma measurements are shown in Appendix Figure 3.3a. Exposure rates in the garage, doll house, and shed are shown in Appendix Figure 3.3b.

Elevated readings were observed while performing an interior survey of the garage. Elevated readings were also observed during a survey of the dollhouse, which was located north of the garage. A pile of dirt approximately 4-feet high located in the backyard showed elevated readings.
