RADIOLOGIC AND ENGINEERING ASSESSMENT

DOE ID NO.: GJ-03566-RS  
ADDRESS: 1436 NORTH 23RD STREET

AUGUST 1985

URANIUM MILL TAILINGS REMEDIAL ACTION PROJECT OFFICE

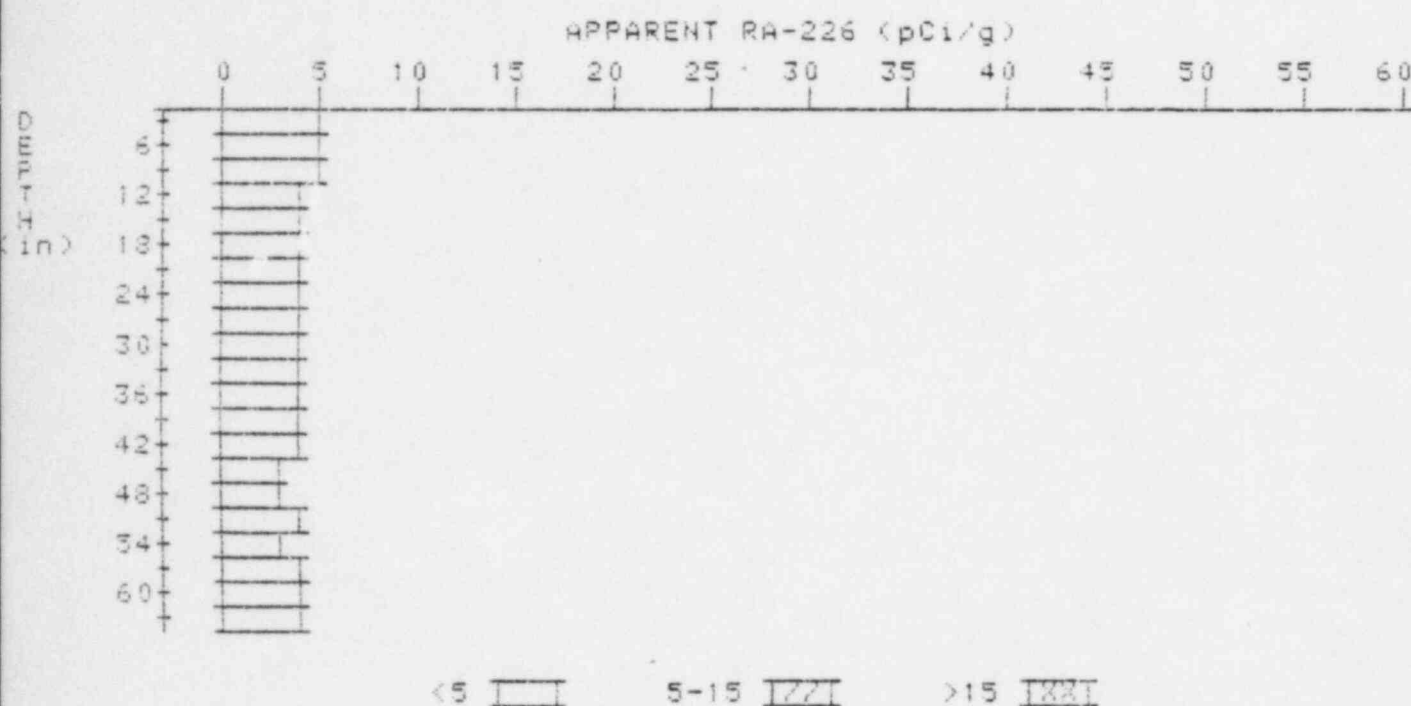
PROPERTY NUMBER: GJ-03566-R3  
HOLE NUMBER: 10  
LOCATION: 163250

# APPARENT RADIUM-226 CONCENTRATION 10 DECONVOLUTION GRAPH

Depth (in)	Apparent Radium-226 (pCi/g) Undeconvolved	Apparent Radium-226 (pCi/g) Deconvolved
3	4.8	4.8
6	4.7	4.9
9	4.5	4.7
12	4.2	3.8
15	4.1	4.1
18	4.0	3.8
21	4.0	4.2
24	3.9	3.7
27	3.9	4.1
30	3.8	3.6
33	3.8	3.6
36	3.9	4.3
39	3.8	3.8
42	3.7	3.9
45	3.5	3.1
48	3.3	3.3
51	3.6	4.0

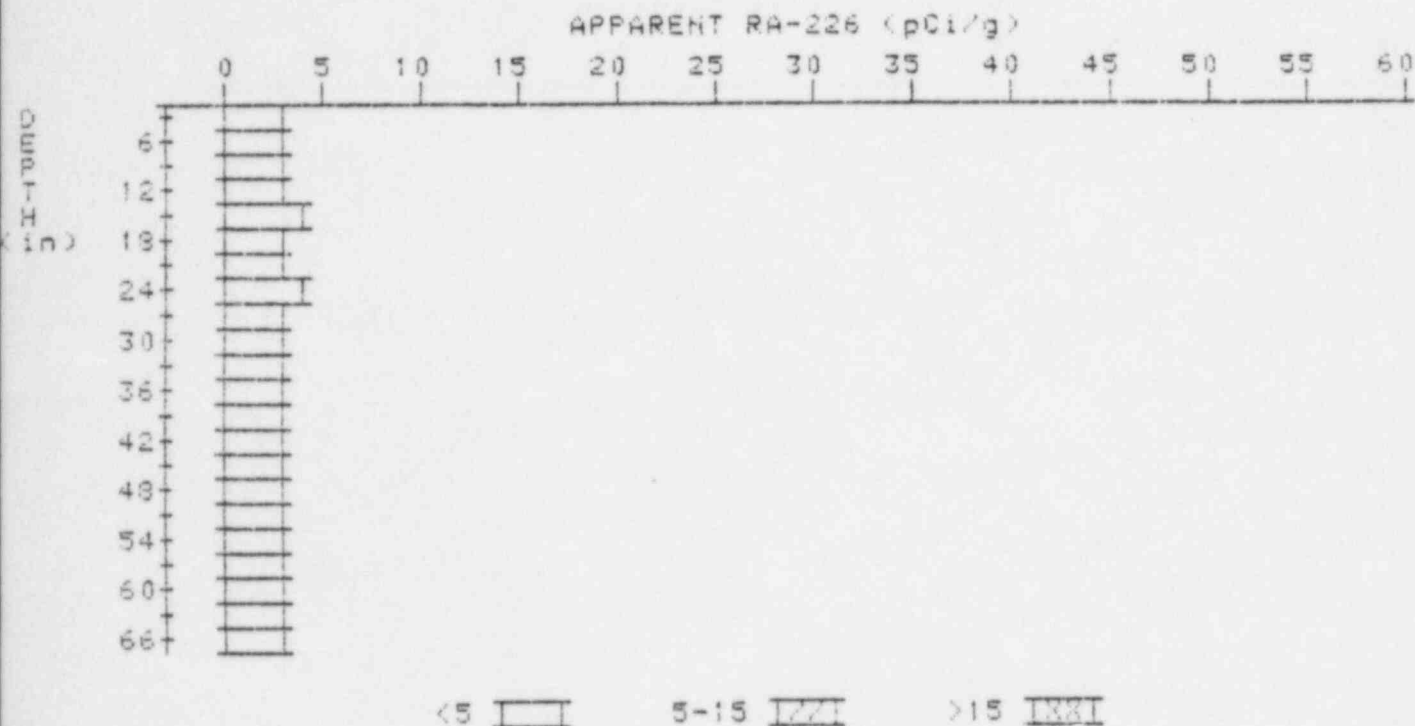
HOLE NUMBER: 19

Depth (in)	Apparent Radium-226 (pCi/g) Undeconvolved	Apparent Radium-226 (pCi/g) Deconvolved
3	2.6	2.6
6	2.8	2.8
9	3.0	3.2
12	3.1	3.1
15	3.2	3.6
18	3.1	2.9
21	3.1	2.9
24	3.2	3.6
27	3.1	3.1
30	3.0	2.9
33	3.0	3.0
36	3.0	3.0
39	3.0	3.0
42	3.0	3.2
45	2.9	2.6
48	3.0	3.4

51	2.9	2.5
54	3.0	3.0
57	3.1	3.3
60	3.1	3.1
63	3.1	3.1
66	3.1	3.1

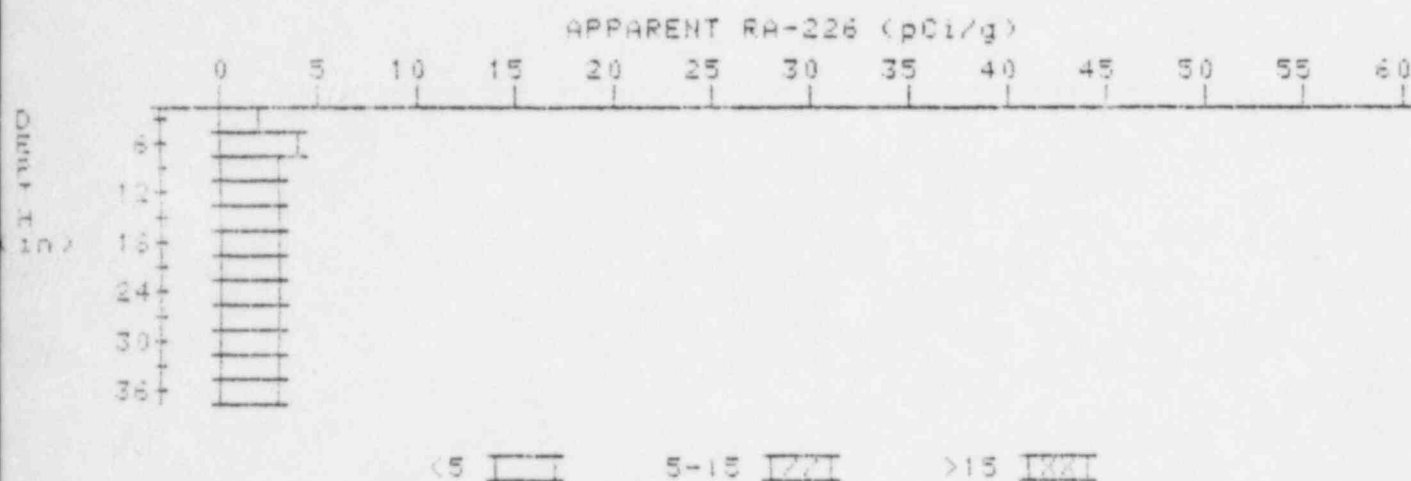
PROPERTY NUMBER: GJ-03566-RS  
HOLE NUMBER: 20  
LOCATION: 230260

# APPARENT RADIUM-226 CONCENTRATION 20 DECONVOLUTION GRAPH

Depth (in)	Apparent Radium-226 (pCi/g) Undeconvolved	Apparent Radium-226 (pCi/g) Deconvolved
3	2.4	2.4
6	2.9	3.6
9	3.0	2.8
12	3.2	3.4
15	3.3	3.5
18	3.3	3.3
21	3.3	3.5
24	3.2	3.0
27	3.2	3.2
30	3.2	3.4
33	3.1	2.9
36	3.1	3.1
