RADIOLOGIC AND ENGINEERING ASSESSMENT

DOE ID NO.: GJ-00712-RS  
ADDRESS: 1522 ELM AVENUE

APRIL 1985

BENDIX FIELD ENGINEERING CORPORATION  
P.O. Box 1569  
Grand Junction, Colorado 81502

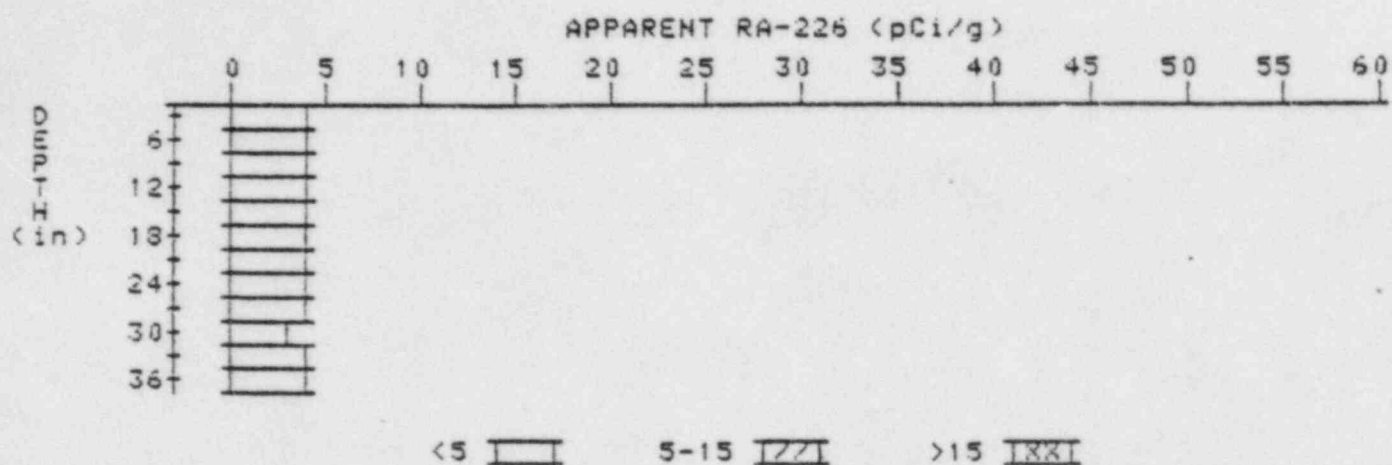
HOLE NUMBER: 4

Depth (in)	Apparent Radium-226 (pCi/g)	Apparent Radium-226 (pCi/g)
	Undeconvolved	Deconvolved
3	3.8	3.8
6	3.8	3.8
9	3.8	3.8
12	3.8	3.8
15	3.8	3.8
18	3.8	3.8
21	3.8	3.8
24	3.8	3.8
27	3.8	4.0
30	3.7	3.3
33	3.8	3.8
36	3.9	3.9

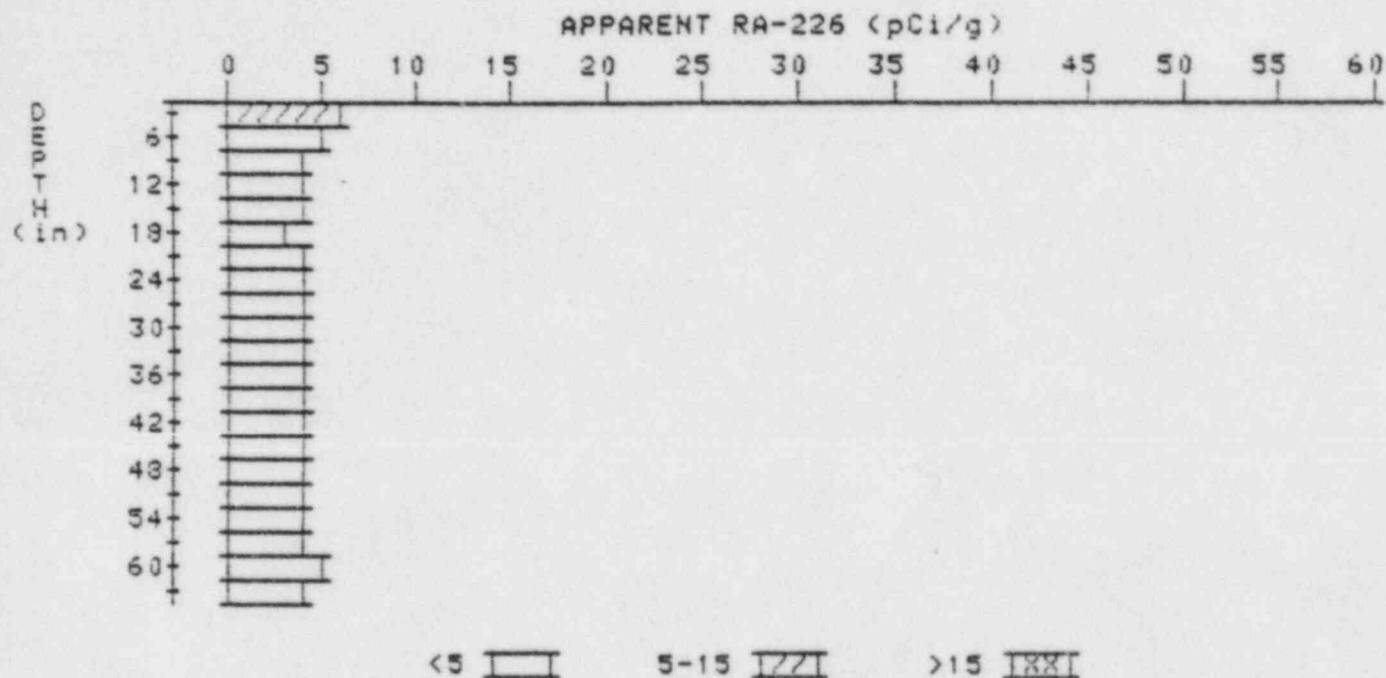
HOLE NUMBER: 6

—	Depth (in)	Apparent Radium-226 (pCi/g)	Apparent Radium-226 (pCi/g)
		Undeconvolved	Deconvolved
	3	5.6	5.6
	6	5.0	4.6
	9	4.6	4.4
	12	4.3	3.9
	15	4.2	4.4
	18	4.0	3.5
	21	4.1	4.5
	24	4.0	3.6
	27	4.1	4.5
	30	4.0	3.6
	33	4.1	4.3
	36	4.1	4.1
	39	4.1	4.1
	42	4.1	4.1
	45	4.1	4.1
	48	4.1	4.1
	51	4.1	4.1

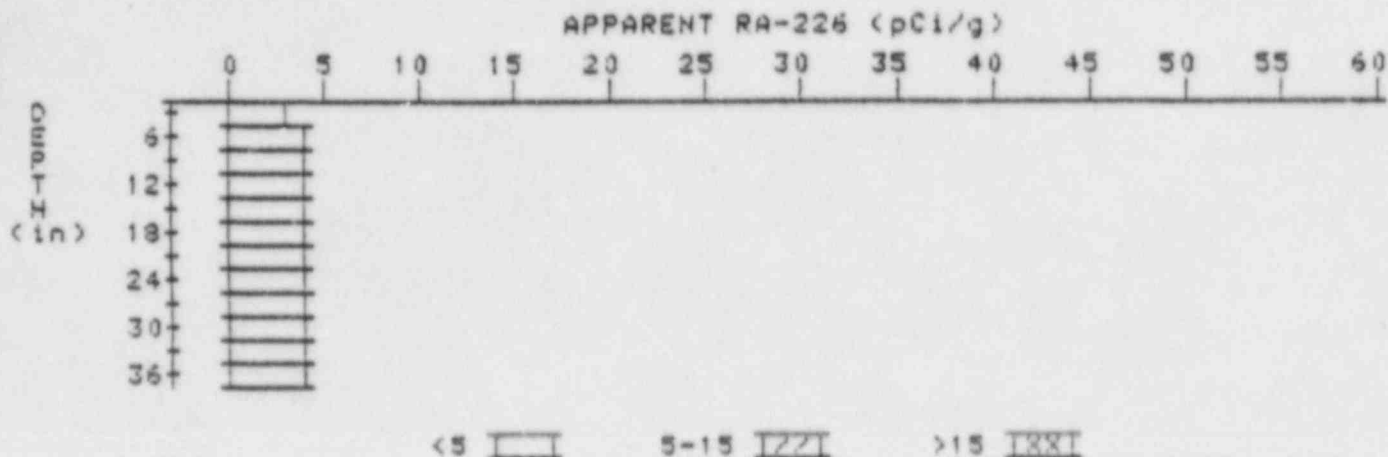
PROPERTY NUMBER: GJ-00712-RS  
HOLE NUMBER: 11  
LOCATION: 140280

Depth (in)	Apparent Radium-226 (pCi/g) Undeconvolved	Apparent Radium-226 (pCi/g) Deconvolved
3	3.3	3.3
6	3.5	3.5
9	3.7	3.9
12	3.8	3.8
15	3.9	4.1
18	3.9	3.9
21	3.9	3.7
24	4.0	4.0
27	4.1	4.3
30	4.1	4.1
33	4.1	4.5
36	3.9	3.9

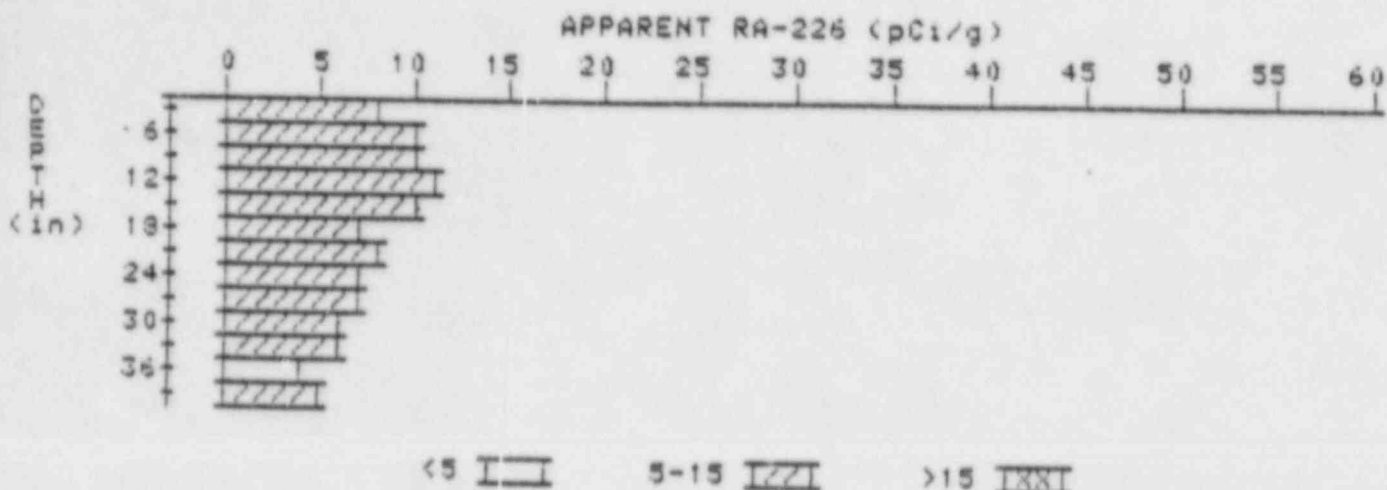
HOLE NUMBER: 15

Depth (in)	Apparent Radium-226 (pCi/g) Undeconvolved	Apparent Radium-226 (pCi/g) Deconvolved
3	8.4	8.4
6	9.3	10.4
9	9.6	9.8
12	9.8	11.0
15	9.3	10.4
18	8.2	7.1
21	7.7	7.7
24	7.2	7.0
27	6.8	7.0
30	6.3	6.3
33	5.8	6.0
36	5.2	4.3
39	5.1	5.1

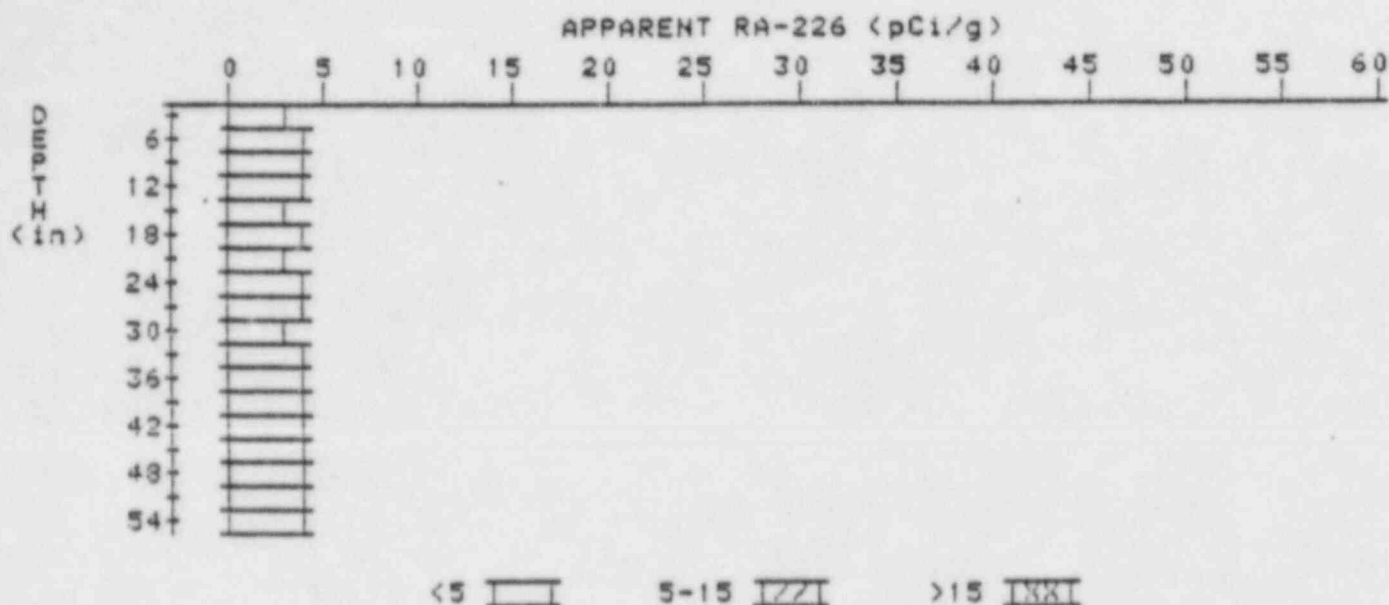
PROPERTY NUMBER: GJ-00712-RS  
HOLE NUMBER: 18  
LOCATION: 155295

Sewer line was further investigated  
at the suggestion of C.D.B. Location  
20 was drilled deeper, locations  
17 and 18 were added. No different  
deposits were found in the sewer  
line

Depth (in)	Apparent Radium-226 (pCi/g) Undeconvolved	Apparent Radium-226 (pCi/g) Deconvolved
3	2.8	2.8
6	3.3	3.7
9	3.6	4.0
12	3.7	4.1
15	3.6	3.2
18	3.7	3.9
21	3.7	3.3
24	3.9	4.3
27	3.9	4.3
30	3.7	3.3
33	3.7	3.5
36	3.8	3.8
39	3.9	4.1
42	3.9	3.5
45	4.1	4.5
48	4.1	4.1
51	4.1	3.7
54	4.3	4.3

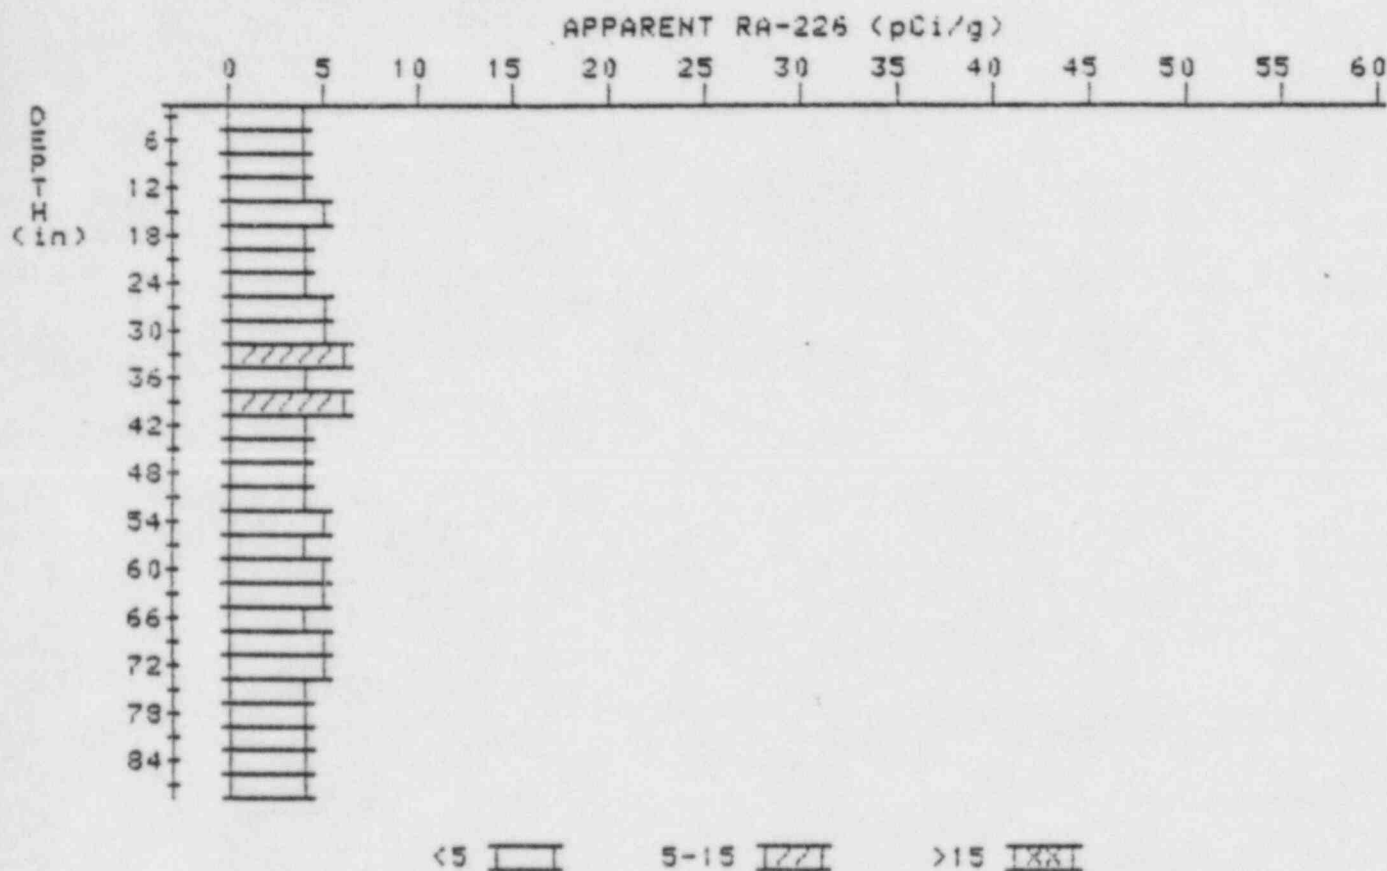
HOLE NUMBER: 19

Depth (in)	Apparent Radium-226 (pCi/g) Undeconvolved	Apparent Radium-226 (pCi/g) Deconvolved
3	3.6	3.6
6	3.8	4.0
9	3.9	3.9
12	4.1	3.8
15	4.2	4.6
18	4.2	4.4
21	4.1	3.6
24	4.3	4.1
27	4.6	5.0
30	4.7	4.5
33	4.9	5.3

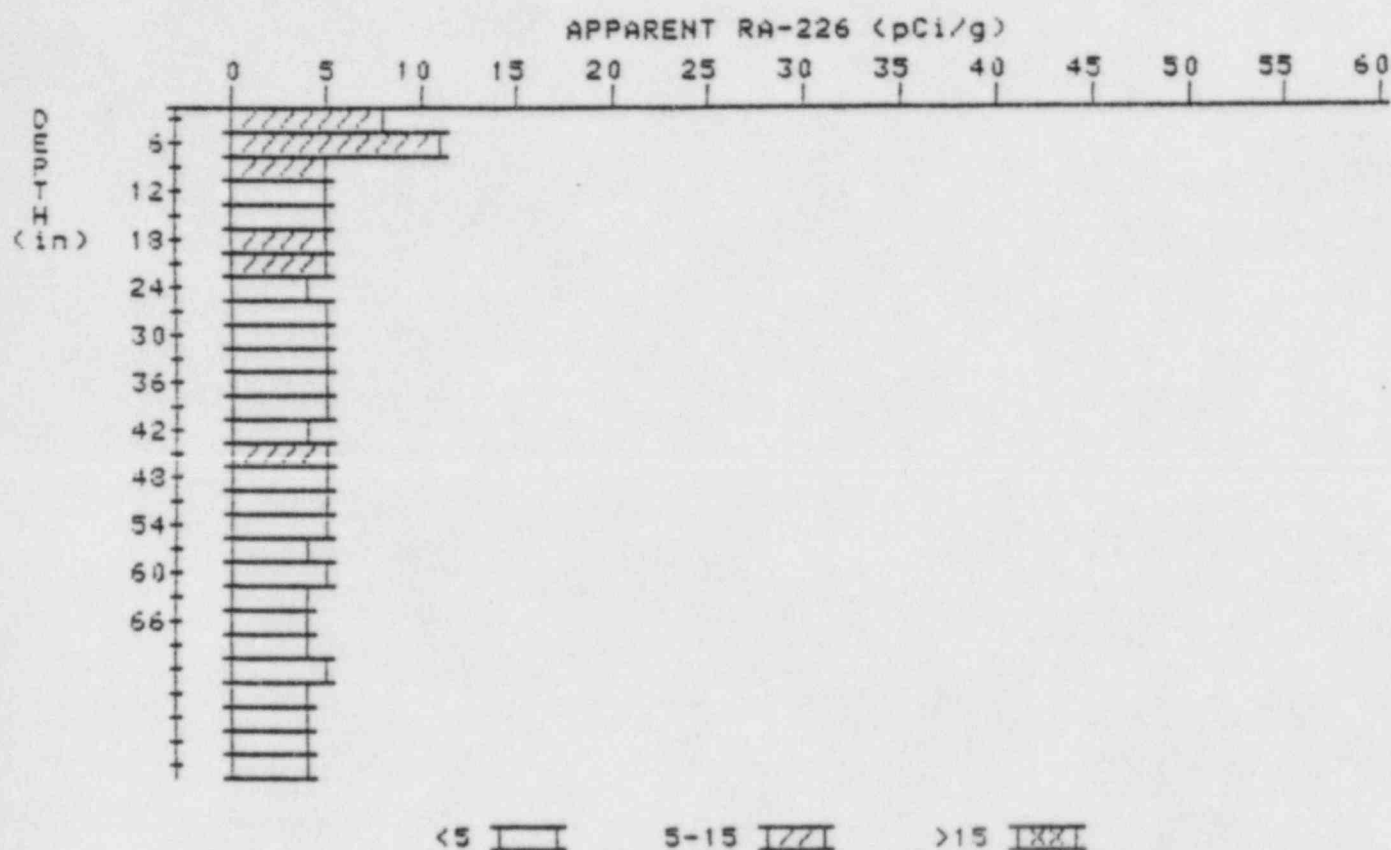
HOLE NUMBER: 20

Depth (in)	Apparent Radium-226 (pCi/g) Undeconvolved	Apparent Radium-226 (pCi/g) Deconvolved
3	7.5	7.5
6	7.9	11.1
9	6.5	5.4
12	5.7	5.0
15	5.3	4.3
18	5.2	5.4
21	5.0	5.2
24	4.7	4.2
27	4.7	4.7
30	4.7	4.7
33	4.7	4.5
36	4.3	5.0

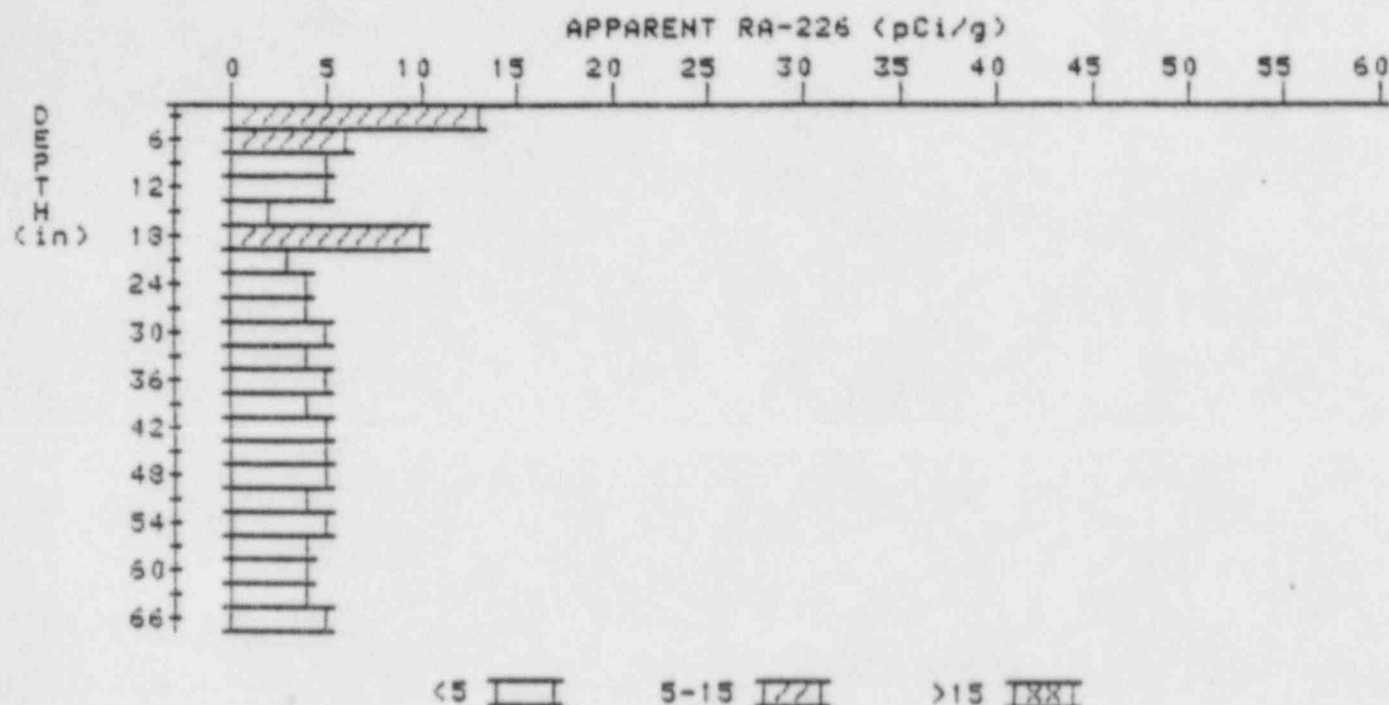
PROPERTY NUMBER: GJ-00712-RS  
HOLE NUMBER: 24  
LOCATION: 170170

Depth (in)	Apparent Radium-226 (pCi/g) Undeconvolved	Apparent Radium-226 (pCi/g) Deconvolved
3	13.1	13.1
6	8.9	5.5
9	6.6	4.6
12	5.4	4.5
15	4.7	1.7
18	5.7	9.6
21	4.5	2.5
24	4.4	4.2
27	4.4	4.4
30	4.4	4.6
33	4.3	3.9
36	4.4	4.6
39	4.4	4.2
42	4.5	4.7
45	4.5	4.5
48	4.5	4.7

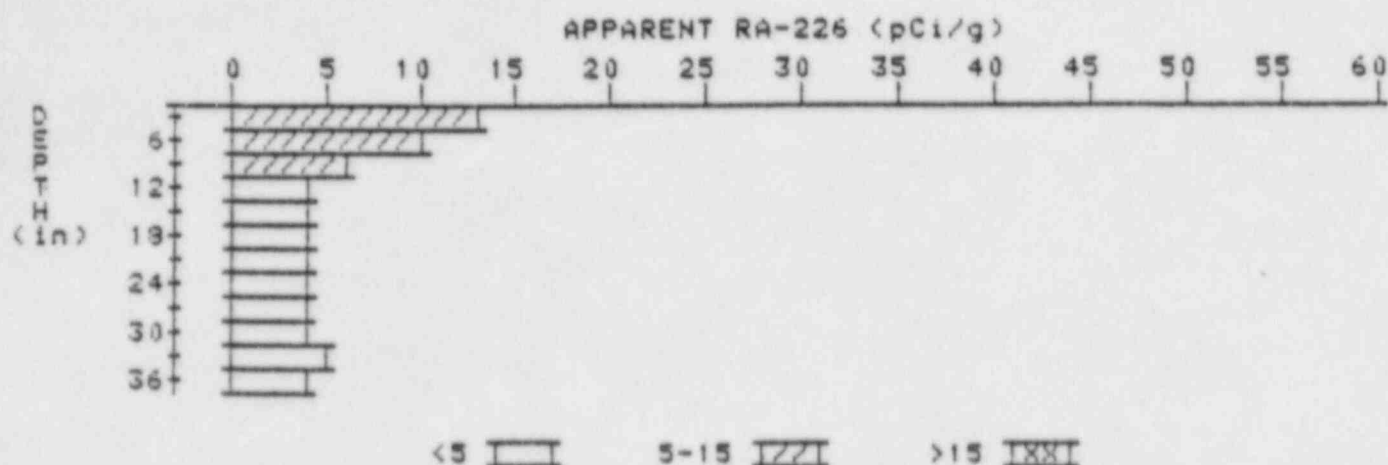
HOLE NUMBER: 28

Depth (in)	Apparent Radium-226 (pCi/g) Undeconvolved	Apparent Radium-226 (pCi/g) Deconvolved
3	13.1	13.1
6	10.1	9.6
9	7.4	5.6
12	5.7	4.1
15	4.9	4.0
18	4.6	4.4
21	4.4	4.2
24	4.3	4.1
27	4.3	4.3
30	4.3	4.1
33	4.4	4.6
36	4.4	4.4

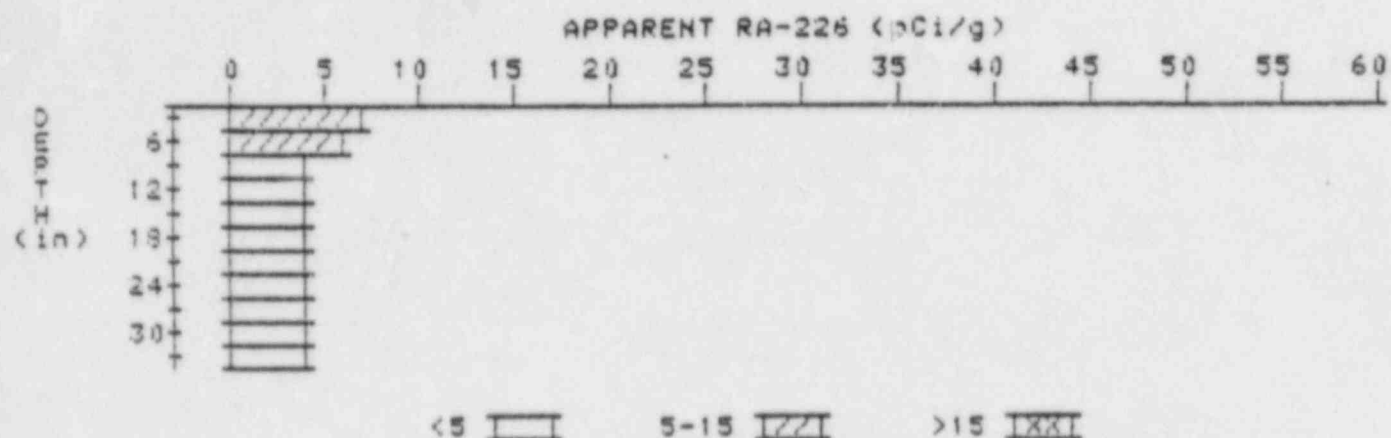
HOLE NUMBER: 29

Depth (in)	Apparent Radium-226 (pCi/g) Undeconvolved	Apparent Radium-226 (pCi/g) Deconvolved
3	6.5	6.5
6	5.7	5.7
9	4.9	4.2
12	4.5	4.1
15	4.3	4.1
18	4.2	4.0
21	4.2	4.0
24	4.3	4.5
27	4.3	4.3
30	4.3	4.5
33	4.2	4.2

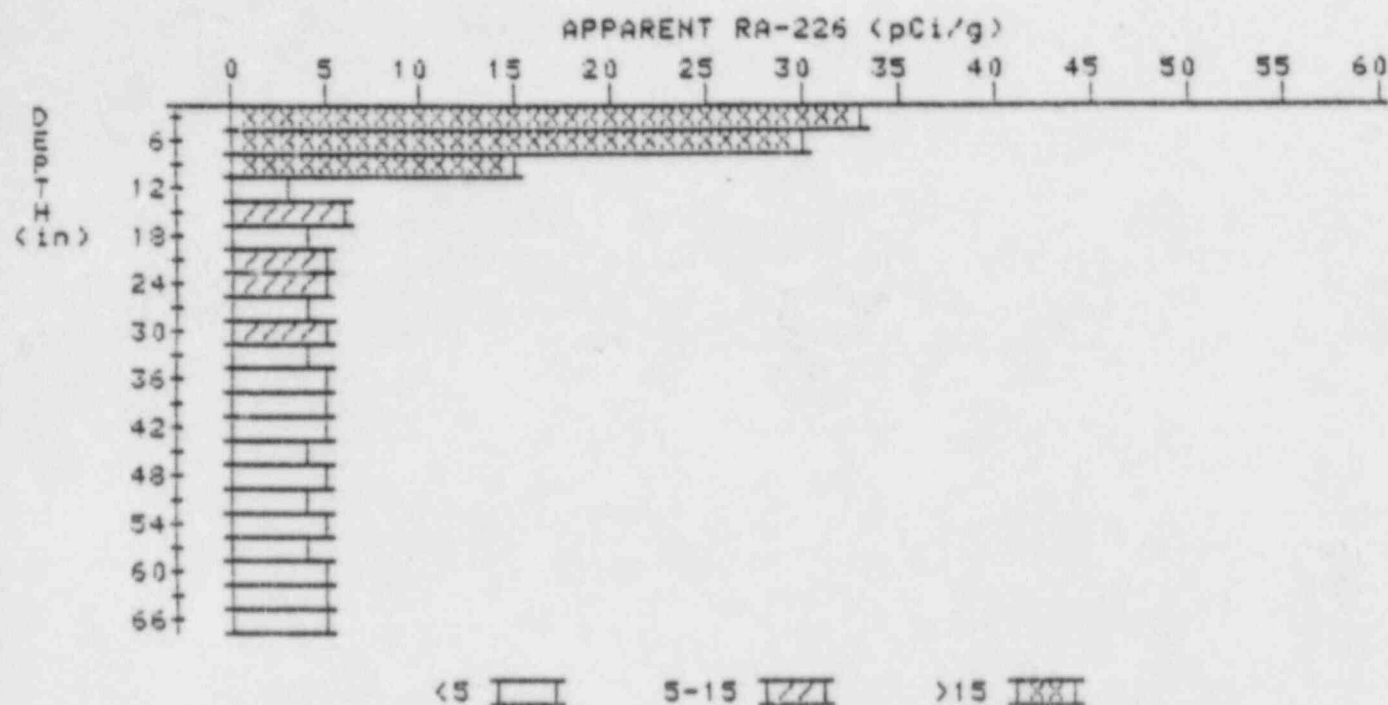
HOLE NUMBER: 31

Depth (in)	Apparent Radium-226 (pCi/g) Undeconvolved	Apparent Radium-226 (pCi/g) Deconvolved
3	33.2	33.2
6	26.6	30.3
9	17.9	15.2
12	10.7	2.7
15	8.0	6.2
18	6.3	4.3
21	5.7	3.3
24	5.3	3.1
27	5.0	4.5
30	5.0	3.4
33	4.8	4.4
36	4.8	3.0
39	4.7	4.7
42	4.6	4.6
45	4.5	4.3
48	4.5	4.7

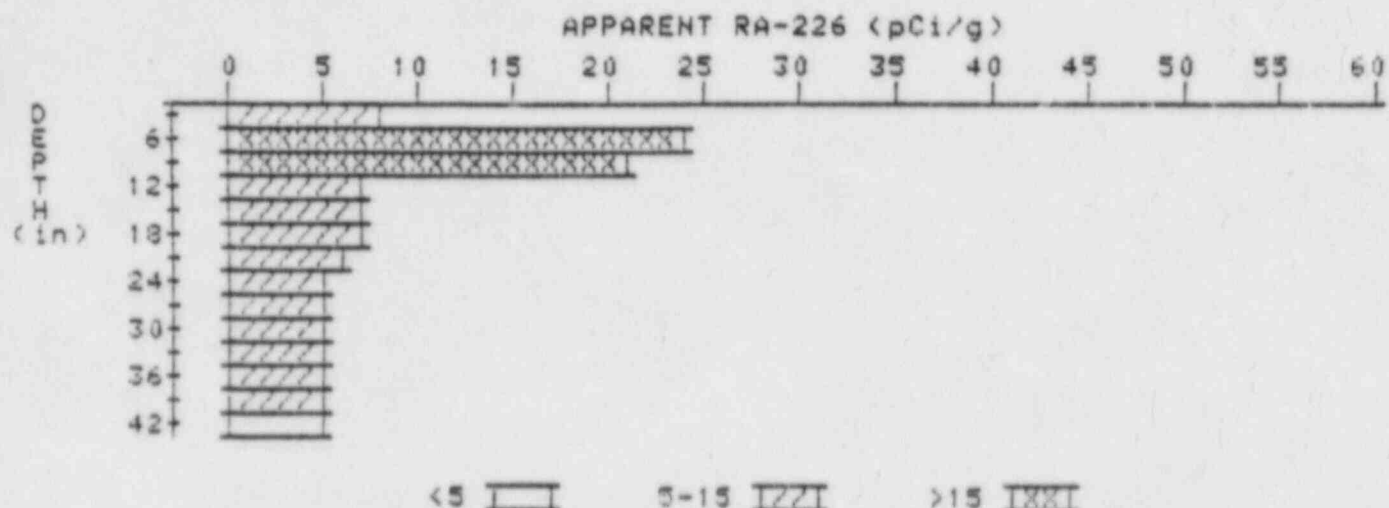
HOLE NUMBER: 33

Depth (in)	Apparent Radium-226 (pCi/g) Undeconvolved	Apparent Radium-226 (pCi/g) Deconvolved
3	7.8	7.8
6	13.7	23.8
9	13.9	20.7
12	10.3	7.5
15	8.3	6.5
18	7.3	6.9
21	6.5	6.1
24	5.9	5.5
27	5.6	5.4
30	5.4	5.4
33	5.2	5.0
36	5.1	5.1
39	5.0	5.0
42	4.9	4.9

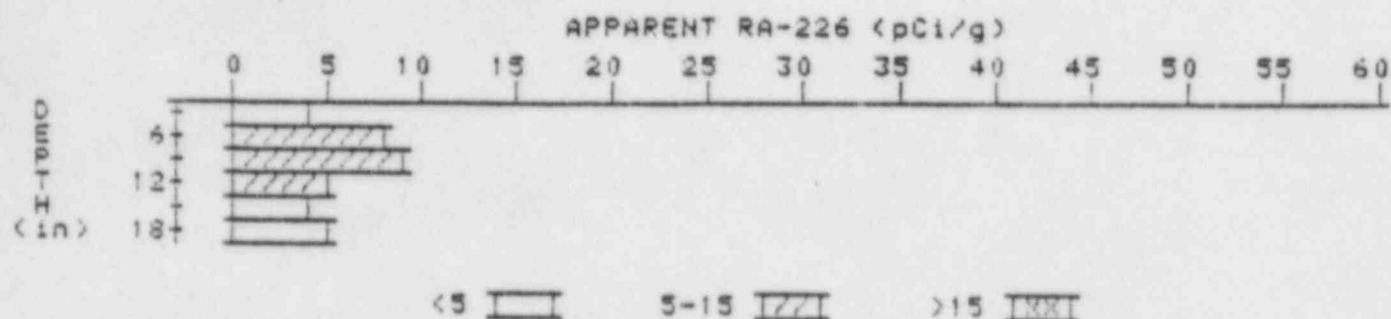
PROPERTY NUMBER: GJ-00712-RS  
HOLE NUMBER: 35  
LOCATION: 202198

Depth (in)	Apparent Radium-226 (pCi/g) Undeconvolved	Apparent Radium-226 (pCi/g) Deconvolved
3	4.2	4.2
6	6.0	3.5
9	6.4	3.5
12	5.6	5.4
15	4.9	4.0
18	4.7	4.7

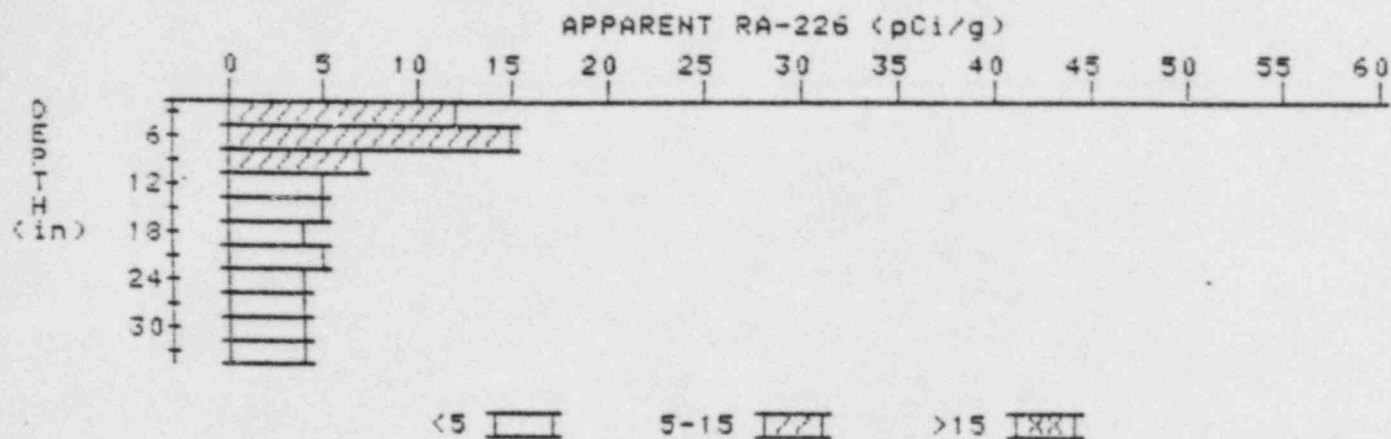
PROPERTY NUMBER: GJ-00712-R3  
HOLE NUMBER: 38  
LOCATION: 205202

Depth (in)	Apparent Radium-226 (pCi/g) Undeconvolved	Apparent Radium-226 (pCi/g) Deconvolved
3	11.9	11.9
6	11.2	14.8
9	8.5	7.3
12	6.5	4.9
15	5.4	4.5
18	4.3	4.1
21	4.6	4.8
24	4.3	3.8
27	4.3	4.5
30	4.2	4.0
33	4.2	4.2
