**SEISMIC AND STRUCTURAL REVIEW OF ADVANCED MEDICAL SYSTEMS
LABORATORY FACILITIES**

by
James E. Beavers, Ph.D., P.E.
Vice President

June 6, 1996

AN ASSESSMENT

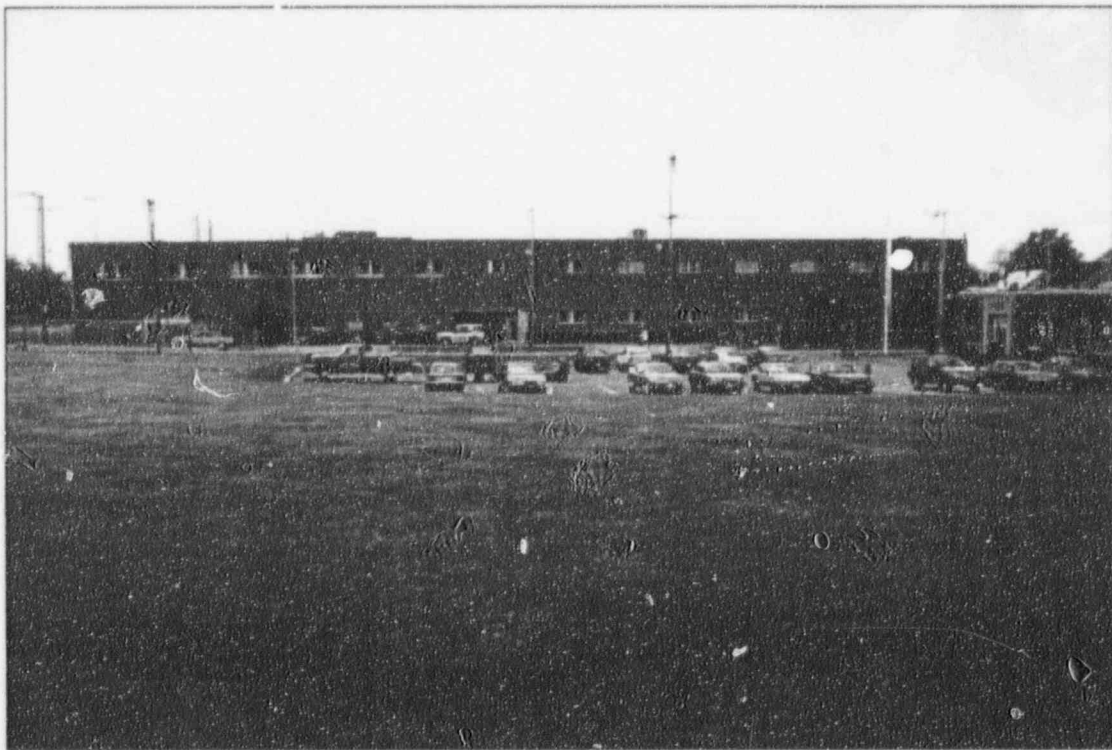
Figure 1. Advanced Medical Systems Laboratory Facility (looking west).

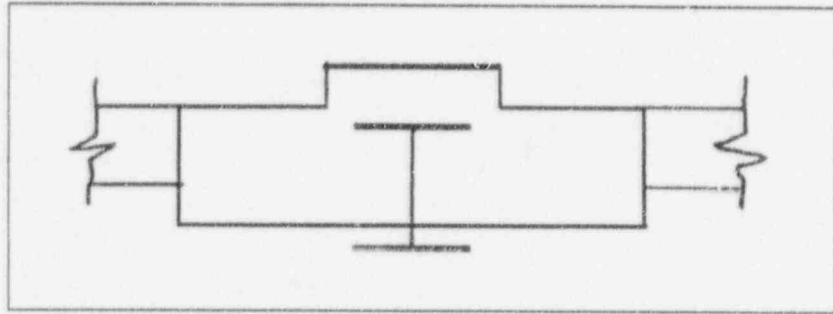
3.1 RESPONSE: The warehouse/industrial building referred to is not a complete load bearing masonry wall building with steel trusses, although at first glance it may appear to be. The building was constructed in 1934 as rectangular in shape. The east-west walls, the walls in the longer dimension (~100 ft), are non-load bearing masonry in-filled walls between steel-riveted columns that support the steel trusses. Some small amount of roof load between the trusses was originally carried by the east-west masonry wall, but this load was one-half of a purlin load, thus the wall typically would not be considered a load bearing wall. The tops of the east-west walls are basically unsupported in the out-of-plane direction except at the columns. At the columns, the masonry is placed flush with the column webs and a pilaster is built around the column flanges facing the original exterior of the building, with about six inches of brick covering the flanges. The sketch in Figure A-1 demonstrates the construction. Based on research done in the last 10 years (Henderson, et al., 1995), unreinforced masonry in-filled buildings provide excellent seismic resistance in low to moderate seismic zones. Although the 1935 building is not a true in-fill since the upper masonry walls are not confined by beams, the fact that they are in-filled within the floor and columns should provide lateral capacity of the building superior to a typical unreinforced load bearing wall. This is especially true where the old windows were filled in with masonry.

Figure A-1. Masonry pilasters and steel columns.

The north-south walls, the short dimension (~60 ft) of the building, are also constructed in the same fashion as the east-west walls. The only difference is the vertical columns at pilasters do not support any vertical load and the wall itself, between columns, supports one-half of the roof load that the trusses and columns support.

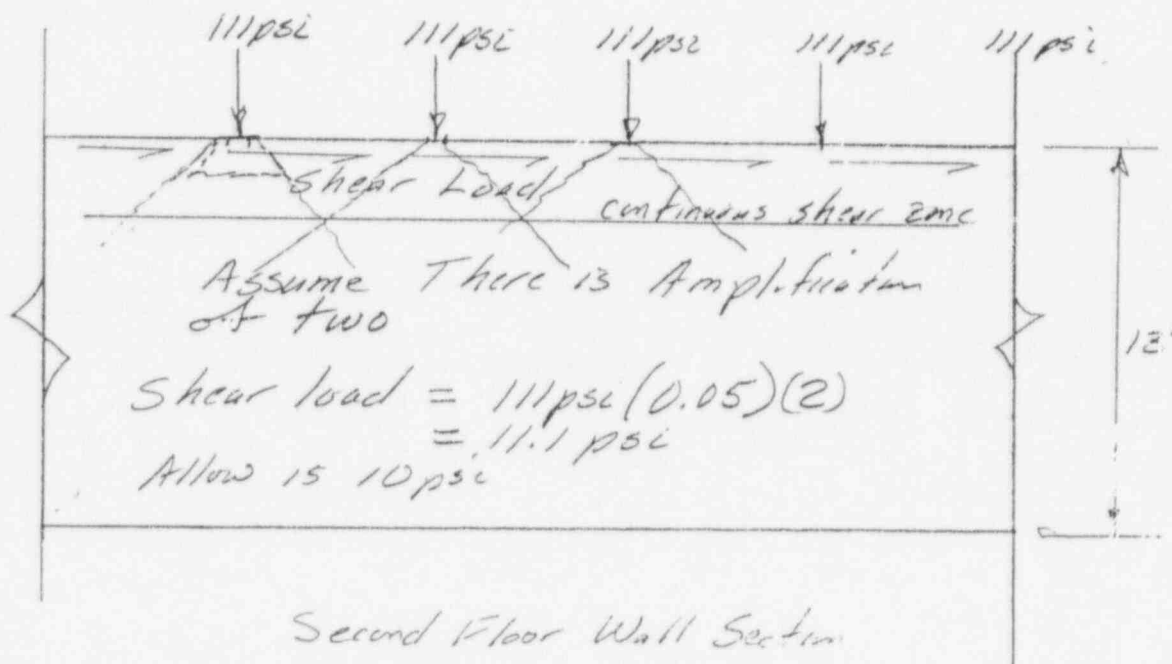
$$\text{Wall stress} = \frac{6240}{7 \times 8} = 111 \text{ psi}$$

Allowable Shear Load In Unreinforced Masonry is 10 psi

Gross Area Supporting Purlin Load is approximately $8' \times 8' \times 12" = 768 \text{ in}^2$
