**RESPONSE TO FREEDOM OF
INFORMATION ACT (FOIA) REQUEST****JIA - 96-351**

**NRC Question/Response ton/Response Tracking Form 93-81
Request for Failed Parts Listing for Relay Driver Board WSN-0133**

ROD CONTROL SYSTEM - FAILED COMPONENTS STATUS

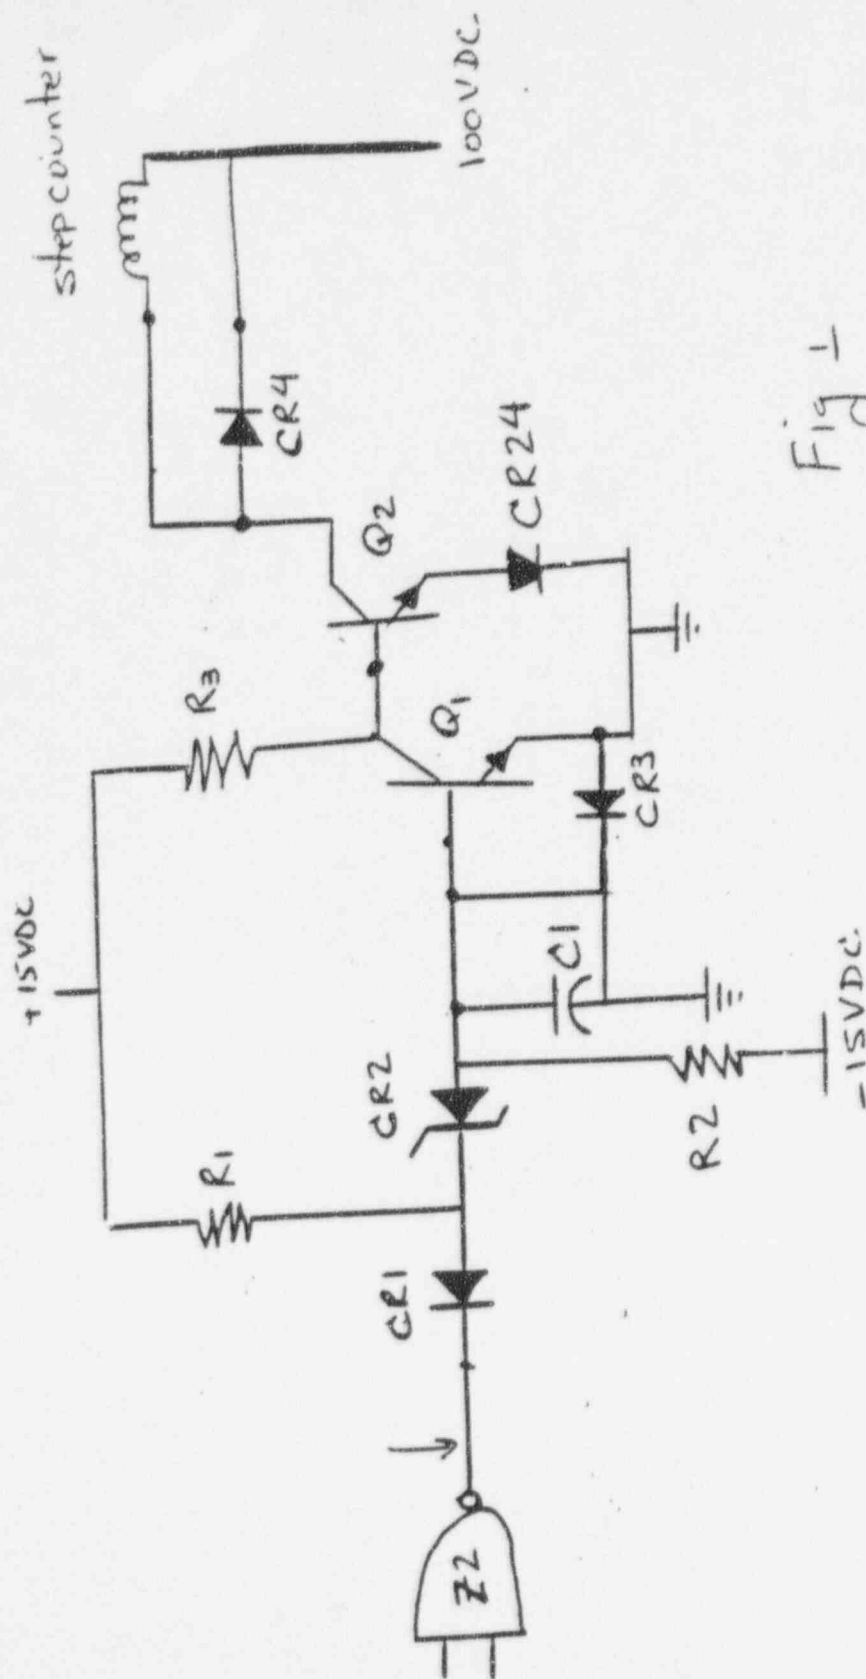
Fig 1

100VDC was shorted to -15VDC through
circuit components failures (Fig 1)

SIMPLIFIED CIRCUIT FOR DATA LOGGER AND RELAY DRIVER CARDS
