**Oyster Creek Core Spray System  
Inspection Program - 16R**

**Topical Report No. TR-110  
Project No. 328382**

OYSTER CREEK CORE SPRAY SPARGER SYSTEM  
INSPECTION PROGRAM

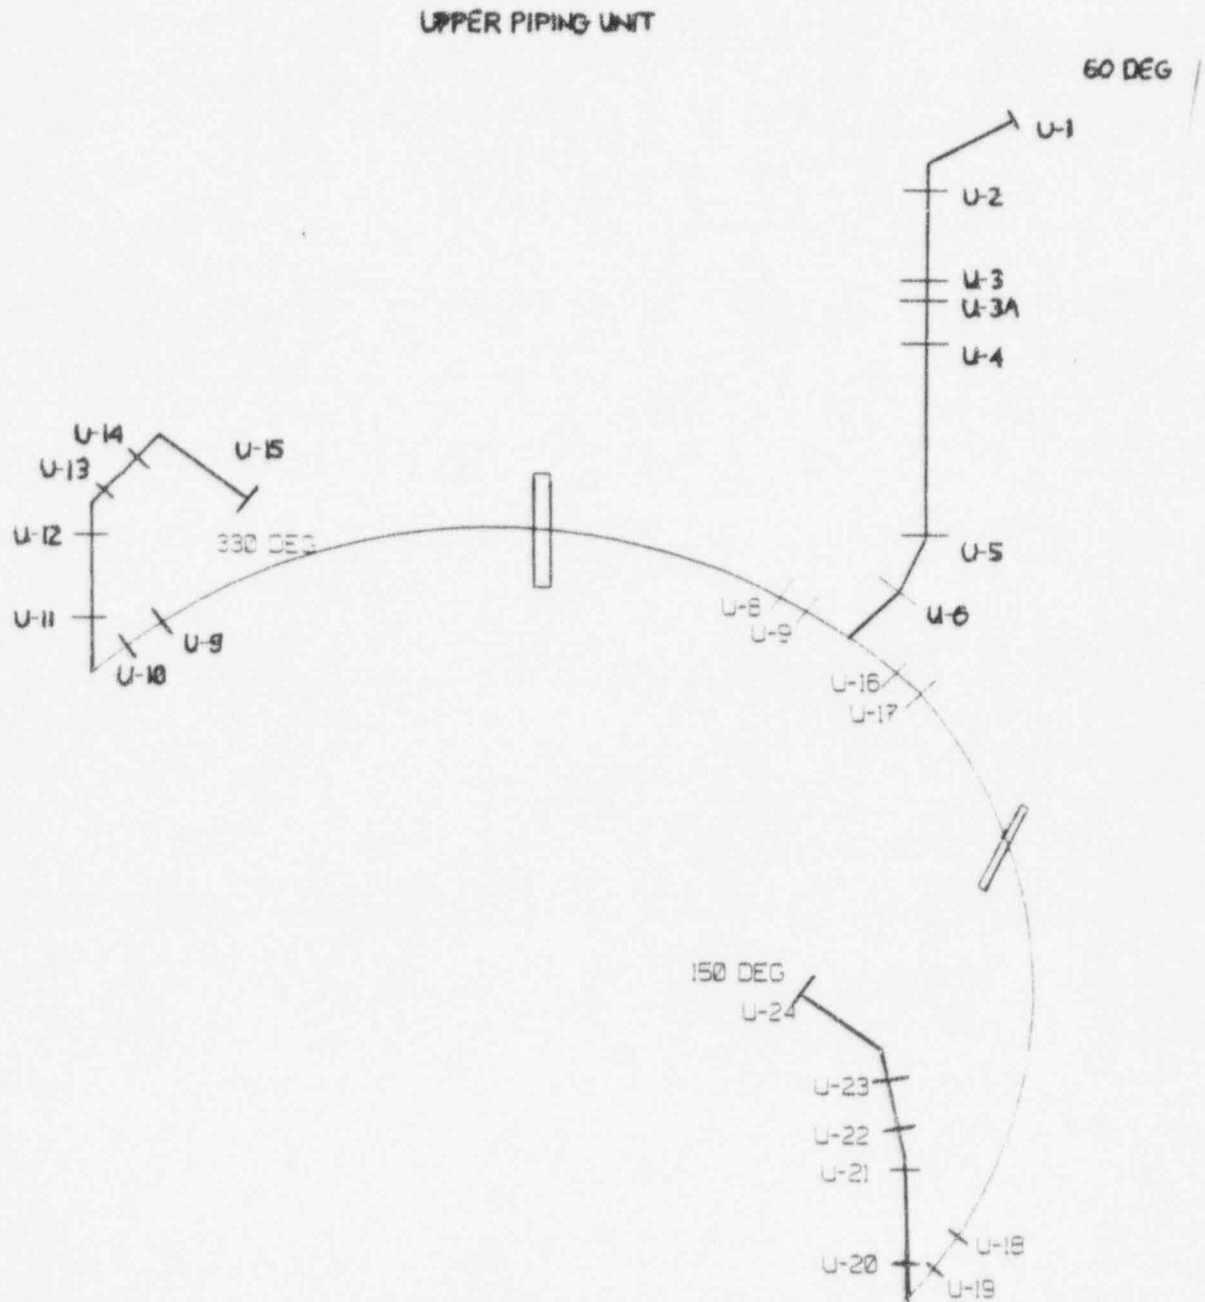
FIGURE 3

Accessible portions of the Core Spray Annulus Piping welds (Figures 3 through 7) were cleaned using a nylon brush and visual inspections performed utilizing the EVT-1 technique. All accessible portions of the piping and attachments were visually inspected. Inspections were performed using the ETV-1250 camera system. No new relevant indications were noted during the inspection or subsequent review of the video tapes.
