ARKANSAS POWER AND LIGHT  
ARKANSAS NUCLEAR ONE - UNIT 1  
CONTROL ROOM DESIGN REVIEW  
FINAL SUMMARY REPORT  
HUMAN ENGINEERING DISCREPANCIES  
VOLUME 2  
AUGUST 14, 1985

Category 1 HEDs

CORRECTIVE ACTIONS

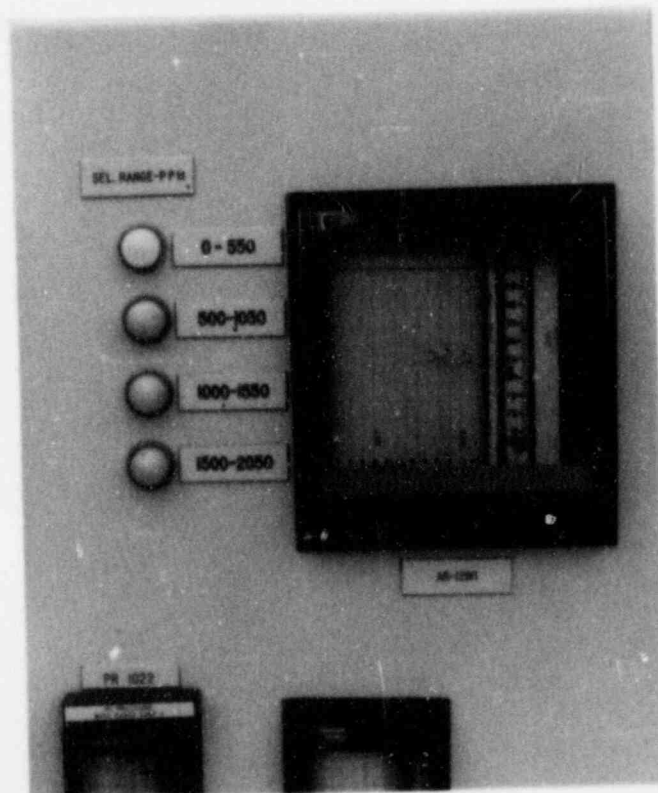
The identified recorder is not utilized in conjunction with the operation of the letdown controls. It is primarily a monitoring display not directly associated with control devices. The current location provides for convenient viewing and does not create operator problems. Therefore, no further action is planned to address this HED.

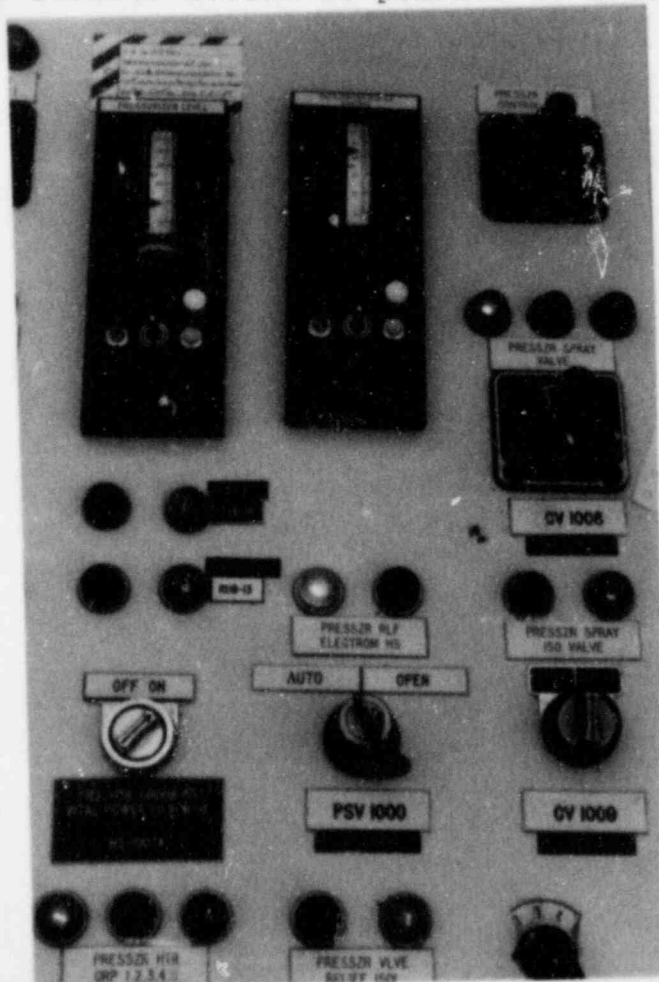
HED NO.: CK:1.018

The pressurizer level controller (LIC-1000) is not functionally associated with the pressurizer spray valve control (CV-1008). Therefore, no further action is planned to address this HED.

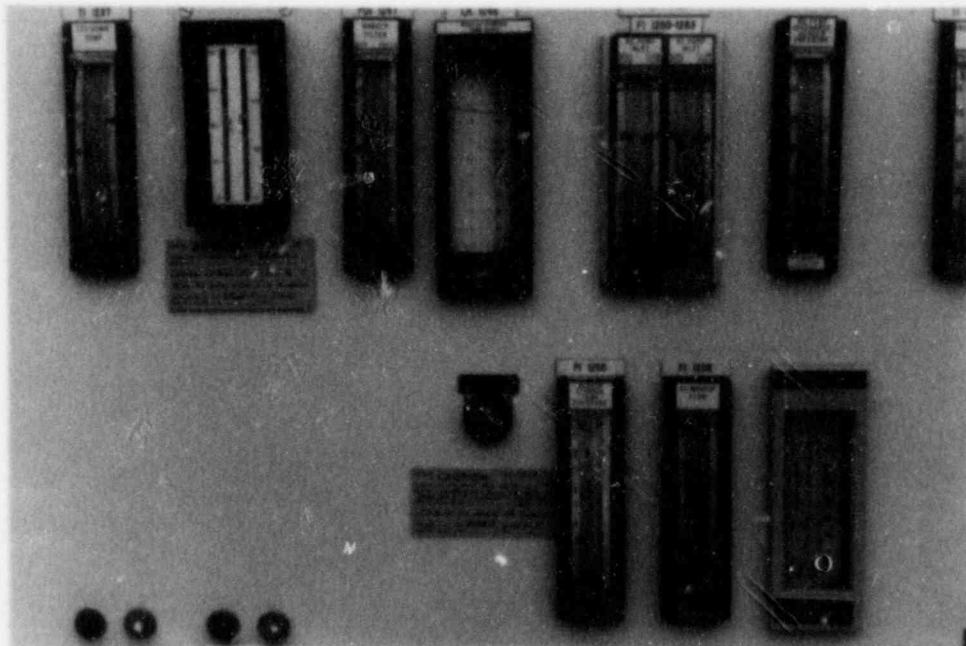
The identified displays are not used for comparison purposes (i.e., mass balance checks) since they are not accurate enough for that purpose. They are used in conjunction with controllers located below the displays such that the existing location is appropriate. Therefore, no further action is planned to address this HED.

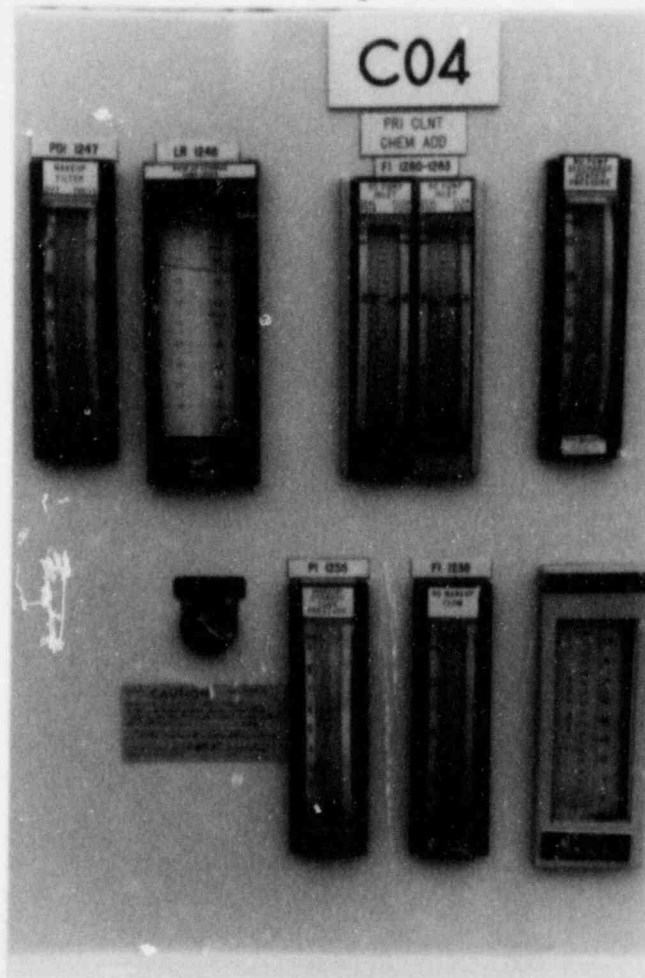
HED NO.: CK:8-1.020

The identified non-adjacent indicators are not related. Therefore, no further action is planned to address this HED.

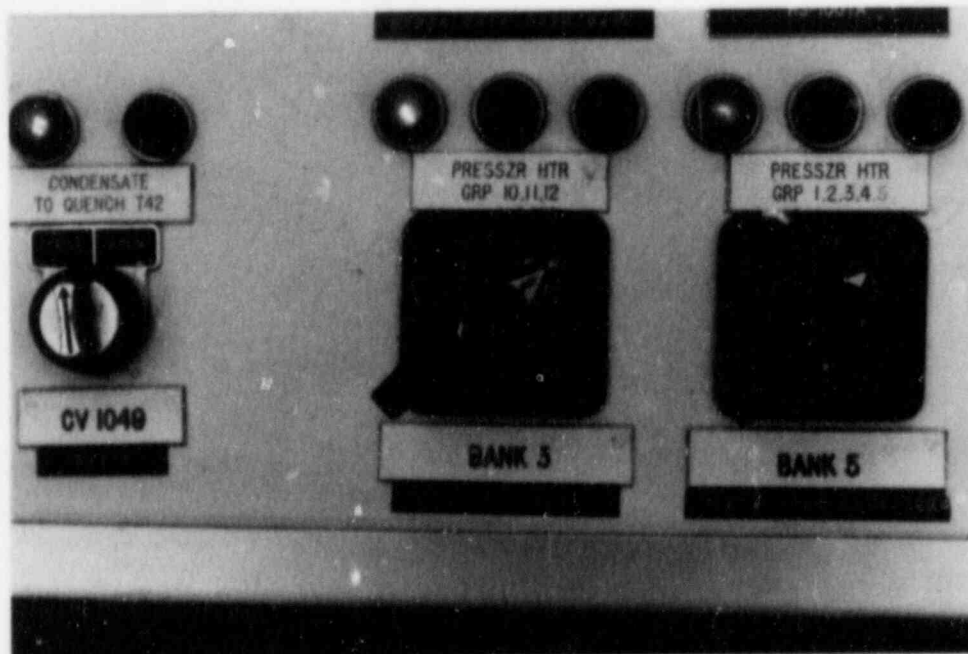
HED NO.: CK:8-1.024

The identified J-handle controls are not operated simultaneously and are not located such that inadvertent actuation is a problem. The controls are easily accessible even though they violate the 3 inch minimum separation. Therefore, due to a lack of justification for change, no further action is planned to address this HED.

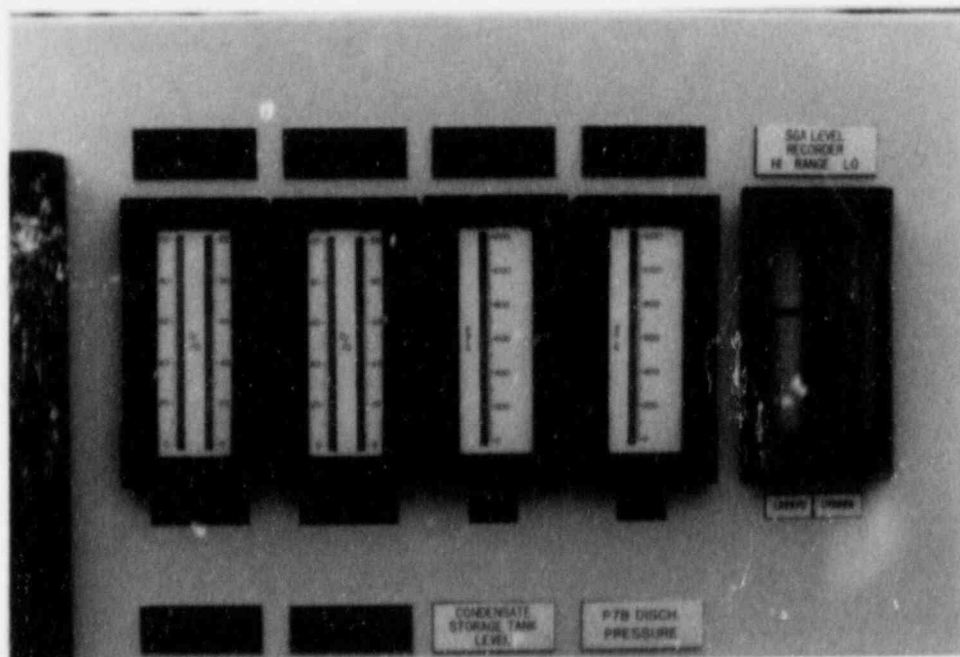
HED NO.: CK:8-1.028

The steam generator level recorders and level meters are not used for comparison purposes. The level meters are used to get a reading of the level on an instantaneous basis while the recorders are used to get a trend of the level changes over a period of time. Therefore, due to a lack of justification for change, no further action is planned to address this HED.

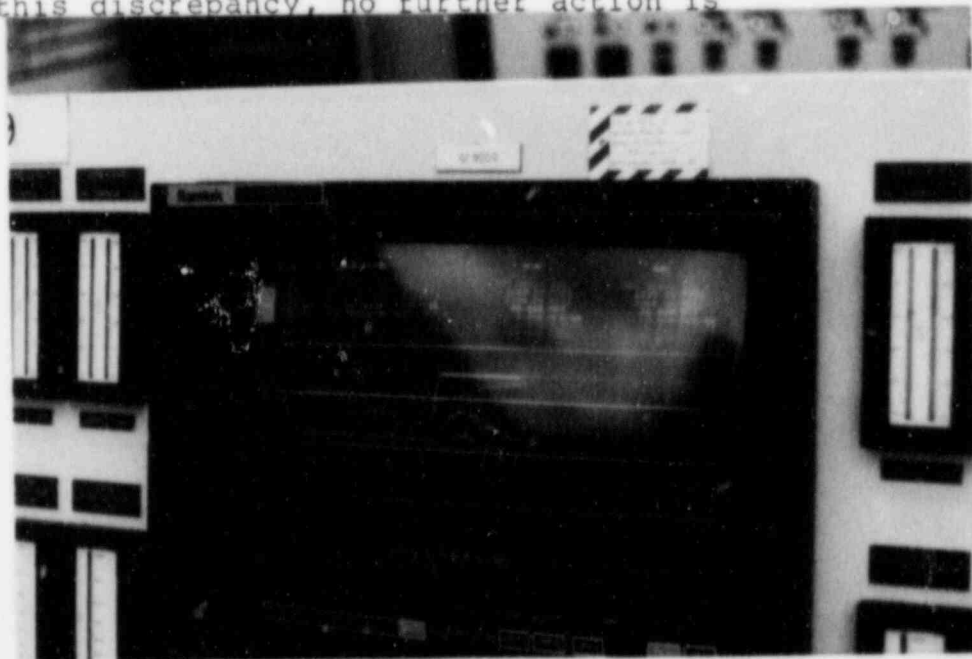
The original plant design had the "A" emergency feedwater pump supplying the "B" steam generator and the "B" emergency feedwater pump supplying the "A" steam generator. Due to this arrangement the steam generator components were arranged in reverse alphabetical order to correspond to the plant layout. Since that time, the emergency feedwater system has been redesigned and the emergency feedwater pumps supply both steam generators. Therefore, the reason for the reverse orientation of the steam generator components on the C-09 has been eliminated. However, due to the fact that the instrumentation is consistently arranged in reverse alphabetical order for the steam generators and due to the major panel rearrangement necessary to correct this discrepancy, no further action is planned.

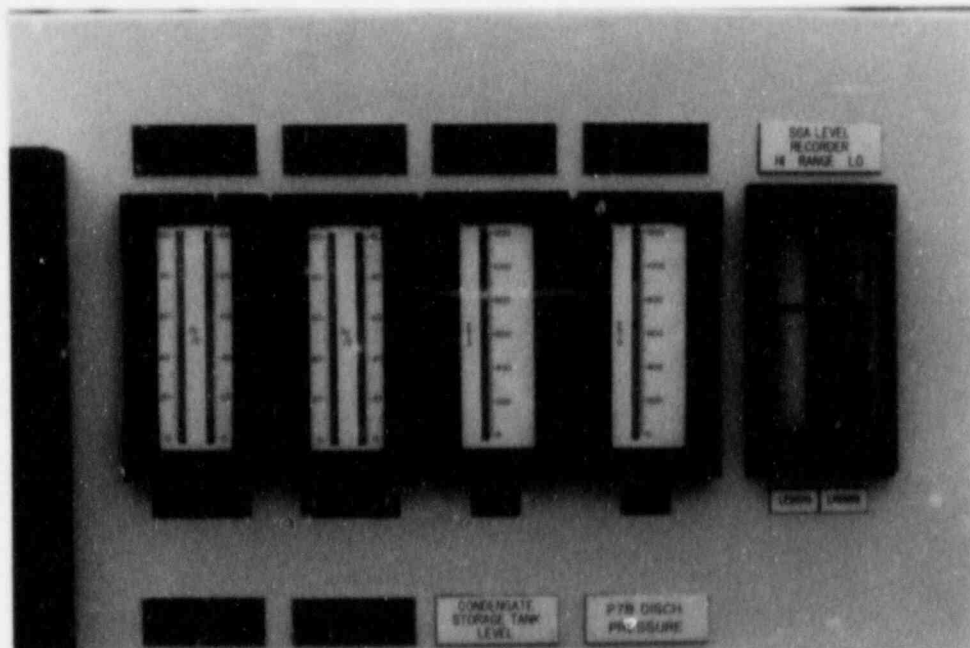
HED NO.: CK:8-1.031GUIDE NO.: 8.2.3.a;bRATING: 3FINDING:

The use of mirror imaging on panel C-09 was done to make the comparison of indicators easier when standing in front of the SPDS display. The operator uses the SPDS display as a center point and reads outward to his left and right to get information on the steam generators and EFW pumps. This arrangement is considered beneficial by the plant operators. Therefore, due to a lack of justification for change, no further action is planned to address this HED.

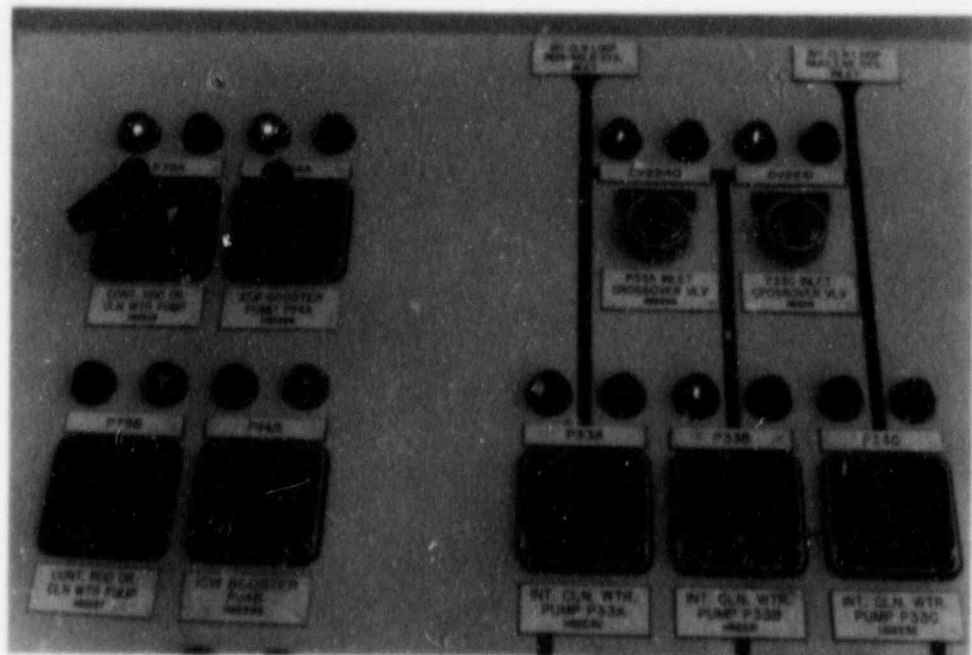
The identified J-handle controls are not operated simultaneously and do not cause operator difficulty in using them. They are arranged to facilitate mimics and to optimize use of the limited available space. Therefore, due to a lack of justification for change, no further action is planned to address this HED.

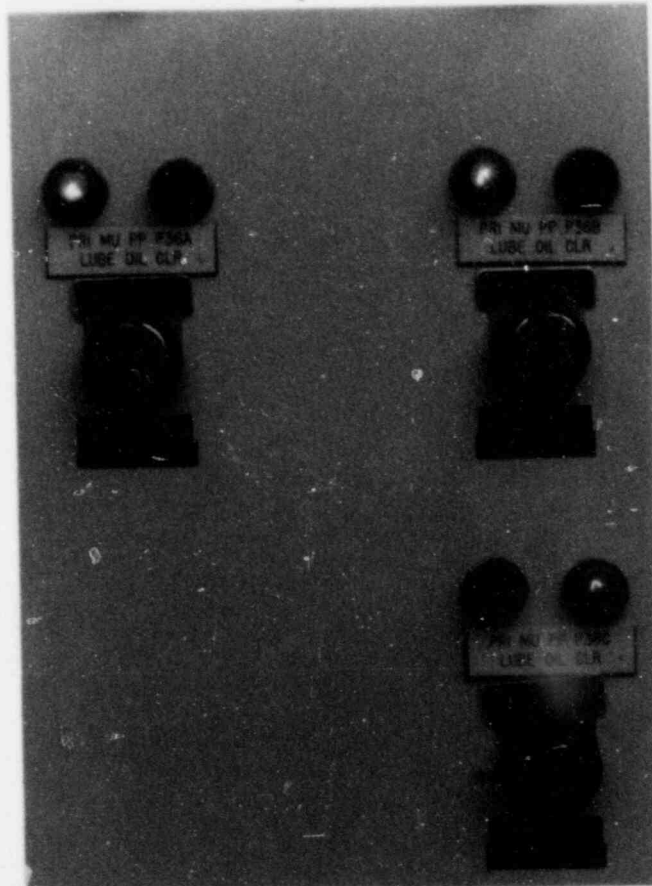
The identified components are arranged in left to right and top to bottom sequence. The arrangement does not present any difficulty for the operator to locate or actuate these controls. Therefore, due to a lack of justification for change, no further action is planned to address this HED.

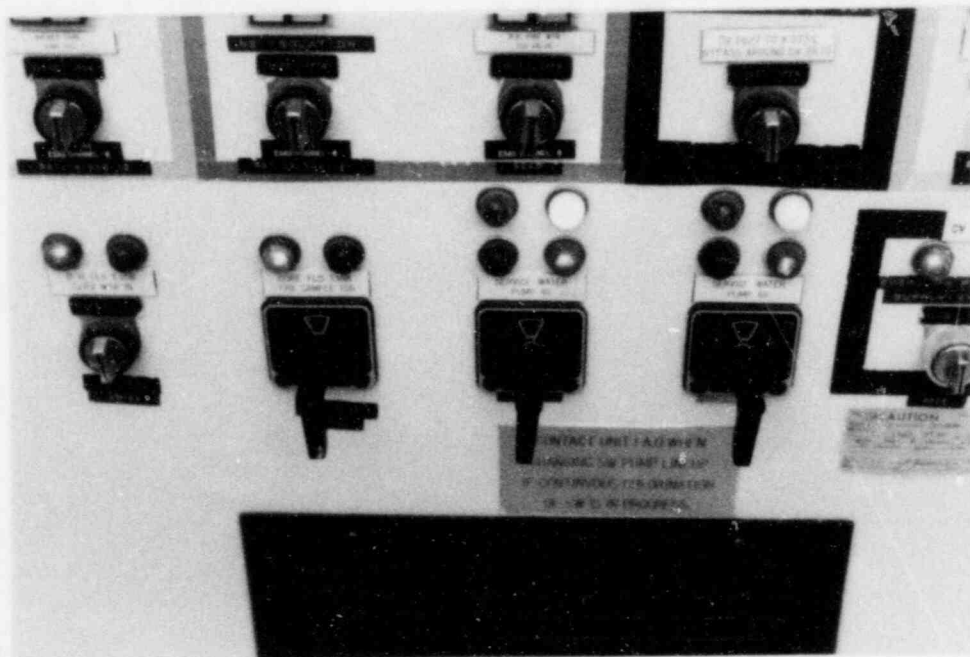
The subject service water pump controls are not used very often by the plant operators. Therefore, being located low on the panel does not create undue difficulty for actuation and no further action is planned to address this HED.

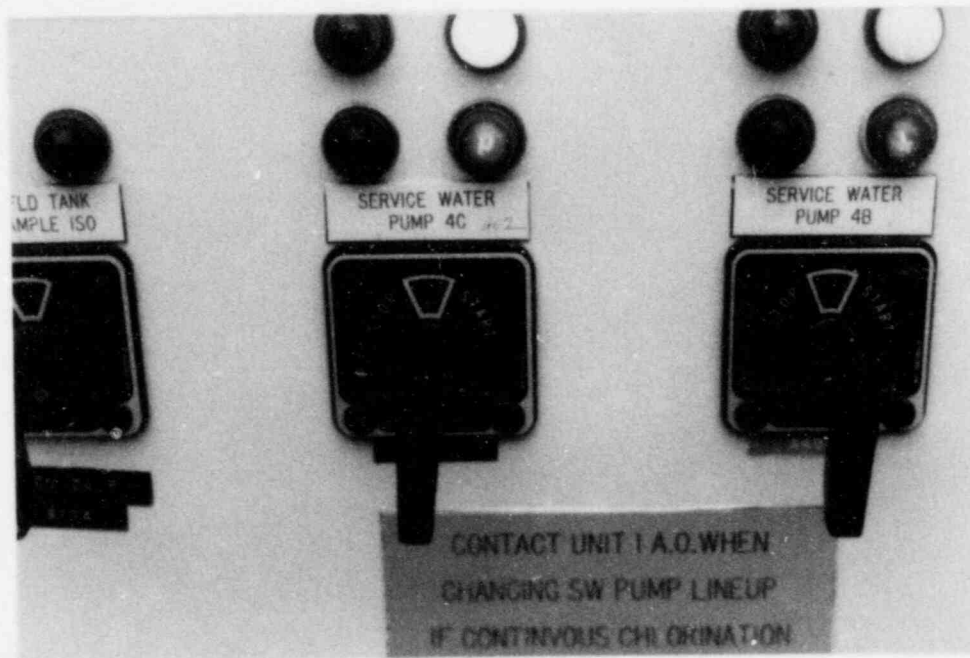
The "B" pumps for the service water and HPI system are the "swing" pumps and are consistently located to the right of the "dedicated" pump controls. Therefore, for these pumps, the existing arrangement is logical to the plant operators. The HPI block valve controls, however, will be evaluated for possible arrangement.

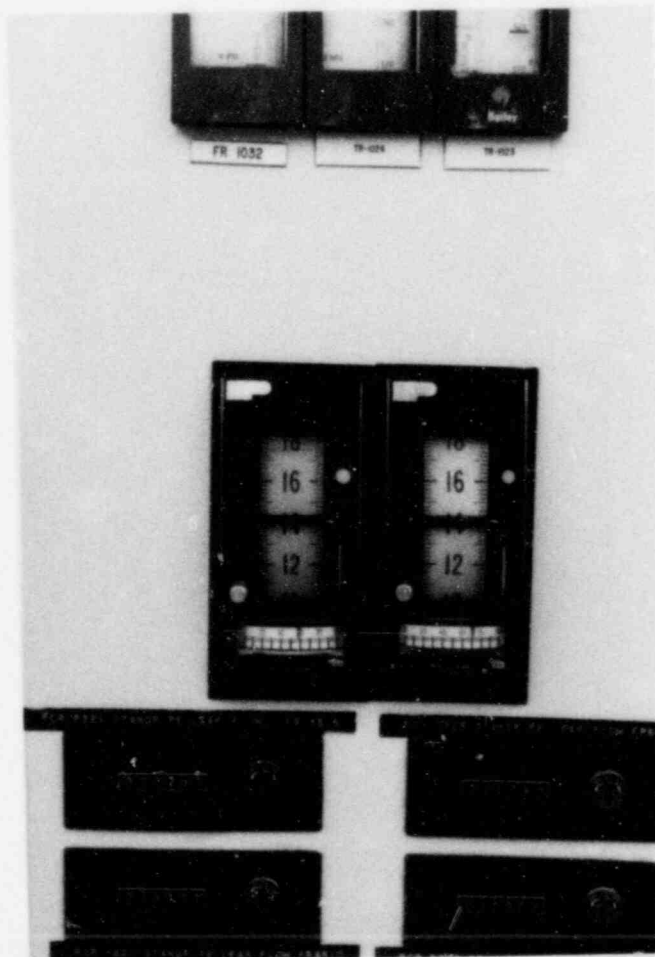
R.C. leak pump and R.C. leak pump alternator controls are separated from RCP instrumentation and located within S.G./FW instrumentation on panel C-13.

The identified components are not associated with the ICS section of the panel. However, the components will be evaluated for possible relocation to Panel C-12 from Panel C-13.

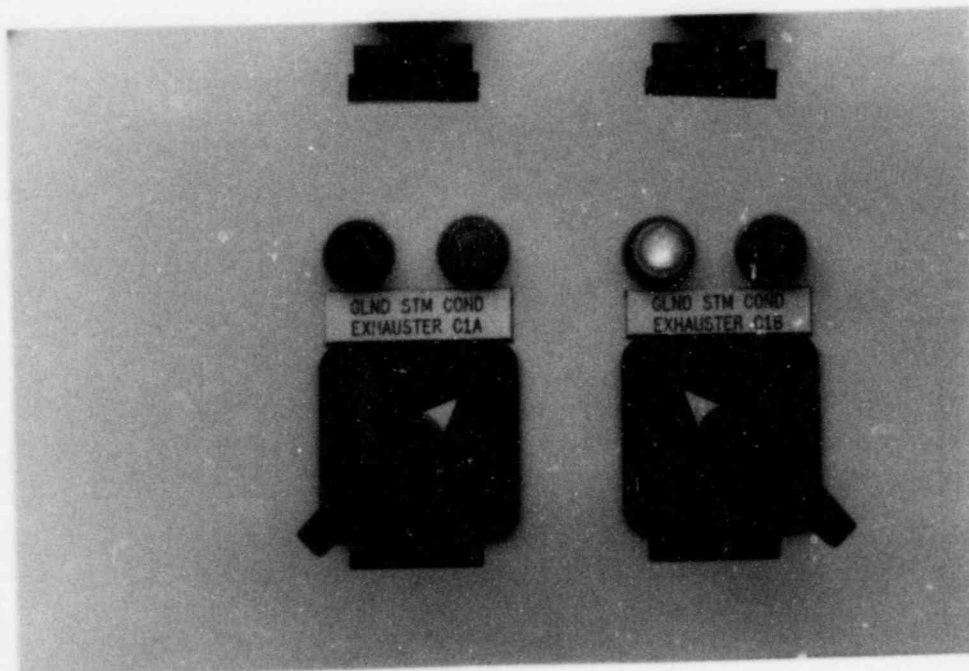
HED NO.: CK:8-1.064

Water box vacuum pump and gland steam condenser exhaustor controls violate minimum separation distance and are not spring return. May cause interference.

The identified J-handle controls are not operated simultaneously and do not cause operator difficulty during operation. Therefore, due to a lack of justification for change, no further action is planned to address this HED.

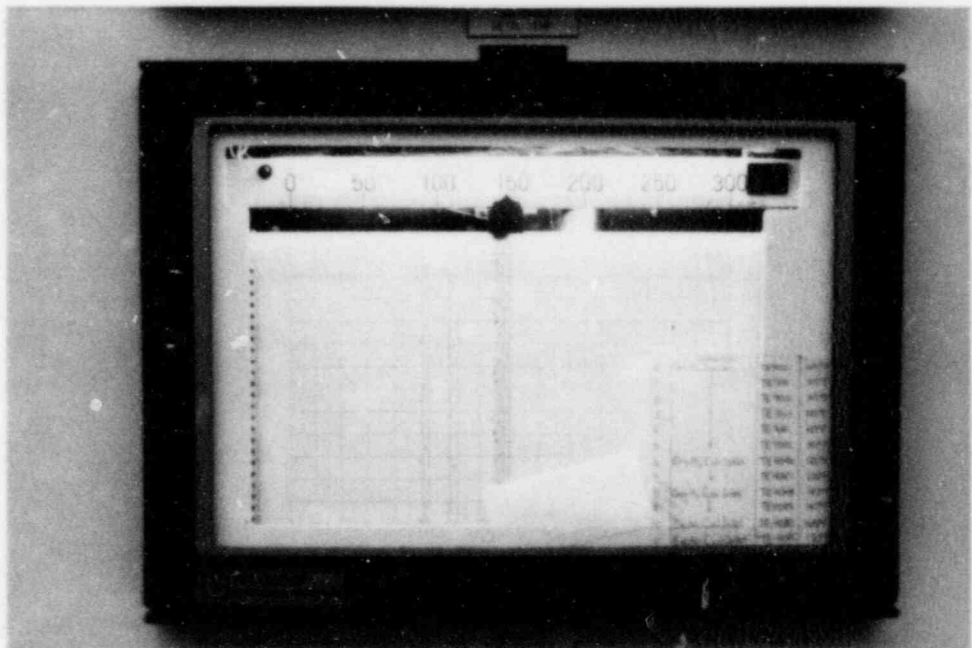
HED NO.: CK:8-1.065

The identified recorder is not required to be visible from panel C-01 since the recorded parameters are primarily associated with controls on C-19. Furthermore, the recorder is used for trending of data that is not needed as immediate feedback for operation of controls. Therefore, due to the limited space available on the control panels and the lack of need for immediate feedback from this recorder, the present location is appropriate. No further action is planned to address this HED.

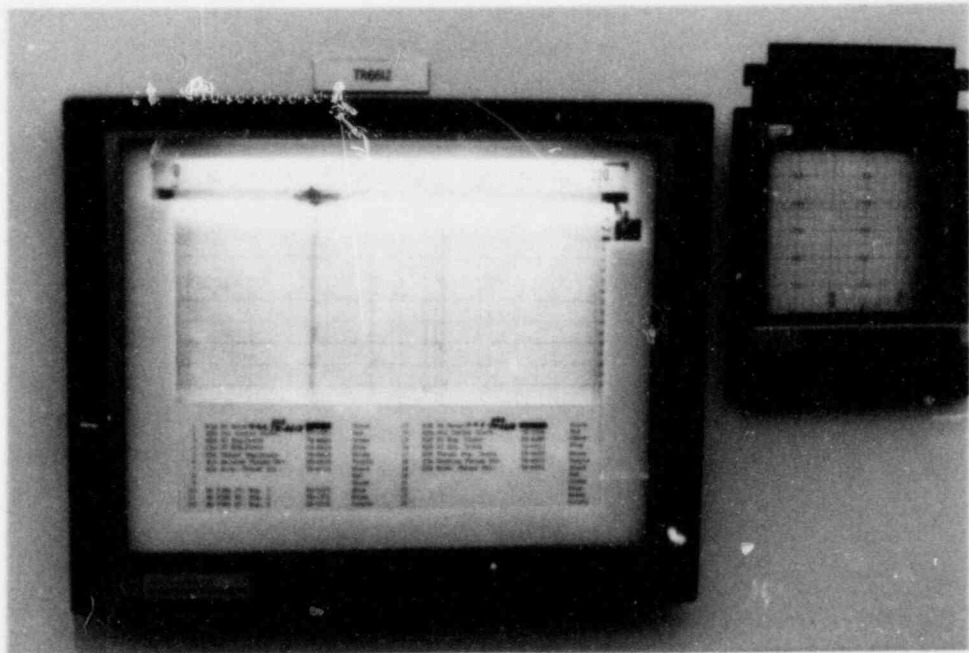
HED NO.: CK:9-1.003GUIDE NO.: 9.2.3.bRATING: 3FINDING:

The identified recorders are not required to be visible from panel C-02 since the operation of controls on C-02 do not rely on feedback from these recorders. The recorder TR-6612 is located appropriately for the intended use. The recorder TR-6613 is not used by the plant operators and is to be evaluated for deletion per HED No.: QS:A4.9-1.064. Therefore, due to a lack of justification for change, no further action is planned to address this HED.

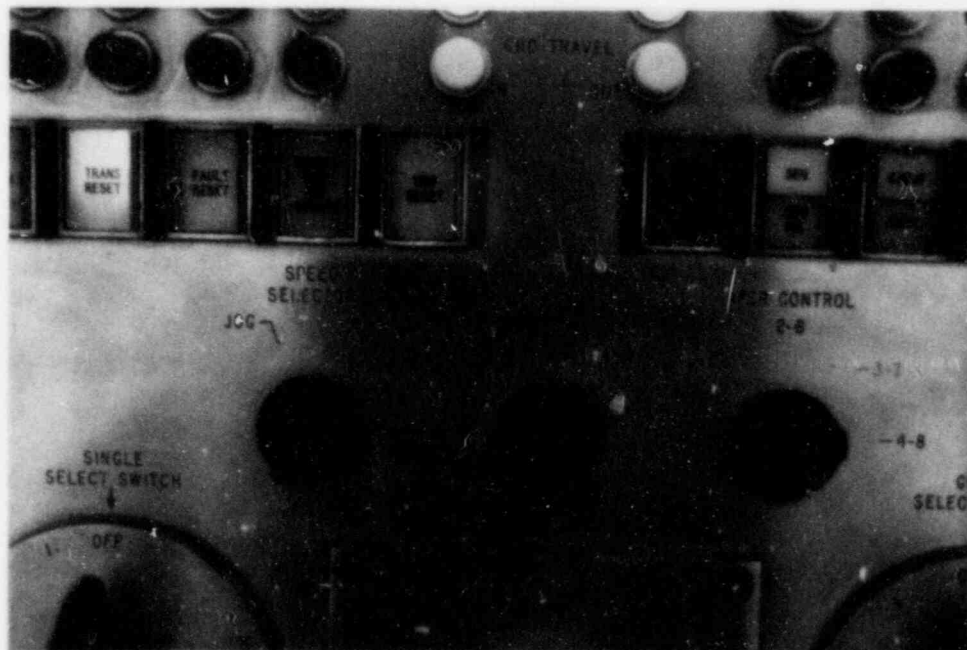
HED NO.: CK:9-1.004GUIDE NO.: 9.1.1.c(1)RATING: 3FINDING:

The identified control is not used routinely by the plant operators in conjunction with the group average indication meters. The back panel rod position is the source of rod position information relied upon by the operators which is readily visible and the association is clear through operator training. Therefore, due to a lack of justification for change, no further action is planned to address this HED.

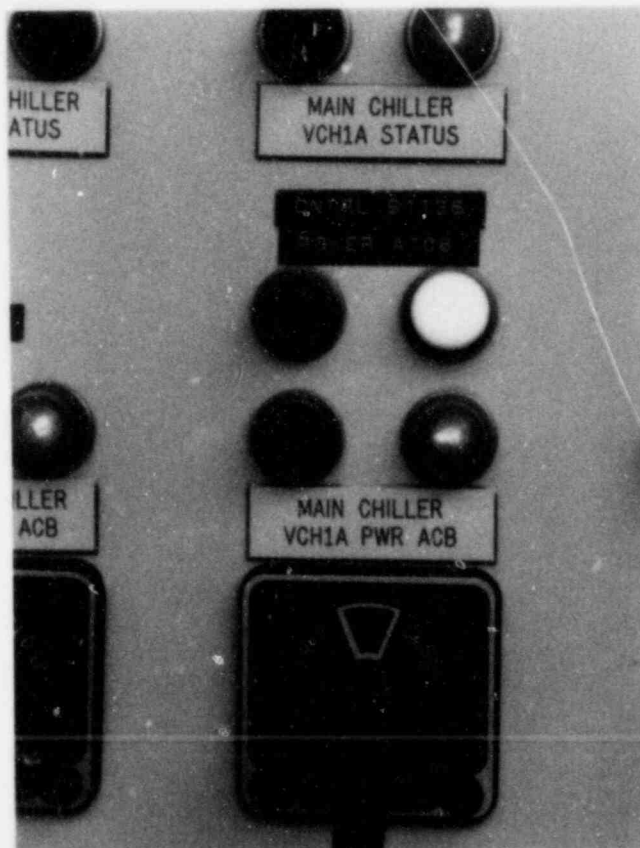
HED NO.: CK:9-1.010

The identified lights are not labeled since they are arranged as part of the standard convention for breaker indicators such that operators know what they mean. It would not add to the meaning of the light to label them since their color and arrangement meets the standard convention. Therefore, no further action is planned to address this HED.

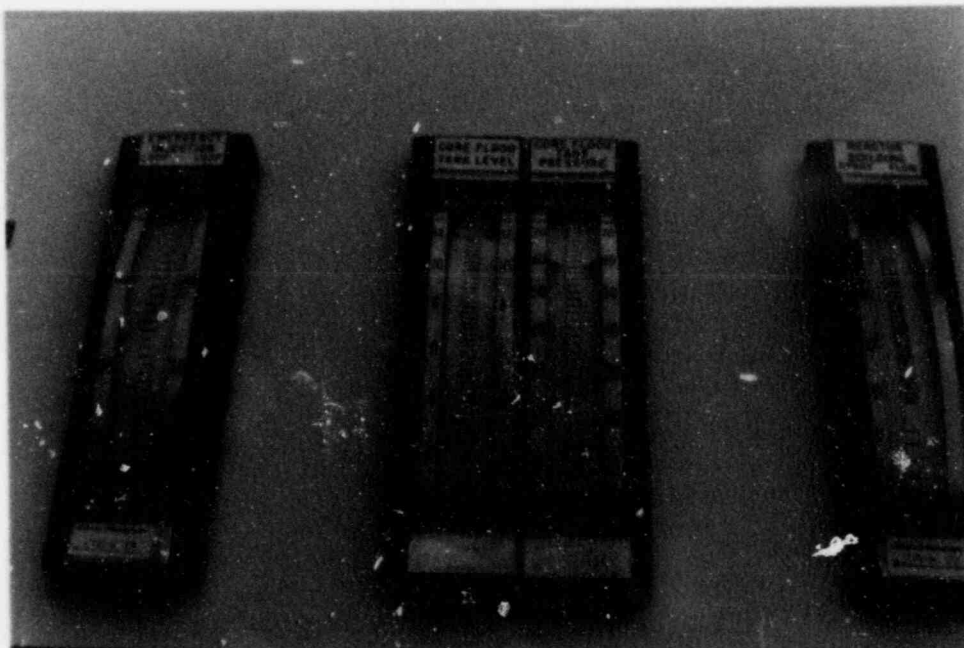
HED NO.: CK:9-1.011

Top row of meters on C-16/C-18, used in control operations, is too high on panel and cause parallax problem.

The identified meters have been or will be corrected as follows:

- The emergency injection, reactor building spray flow, and decay heat removal flow meters were replaced with "sigma" type meters that are less susceptible to parallax since they have flat display faces. This design change was initiated prior to the evaluation of this HED are part of AP&L's on-going commitment to the practical application of human factors's principles. Therefore, this part of the HED has been corrected by a design change.
- The core flood tank level and pressure displays are to be evaluated for possible replacement.
- The reactor building pressure meter does not require accurate readings that would be impacted by parallax. Therefore, the existing meter is acceptable and no further action is planned to address this part of the HED. (See HED VL:1-1.005)
