**EXAMINATION OF A BOLT WITH BORIC ACID ATTACK  
FROM THREE MILE ISLAND NUCLEAR GENERATING STATION**

**February 1995**

**Environmental and Waste Technology Center  
Department of Advanced Technology  
Brookhaven National Laboratory  
Upton, New York 11973**

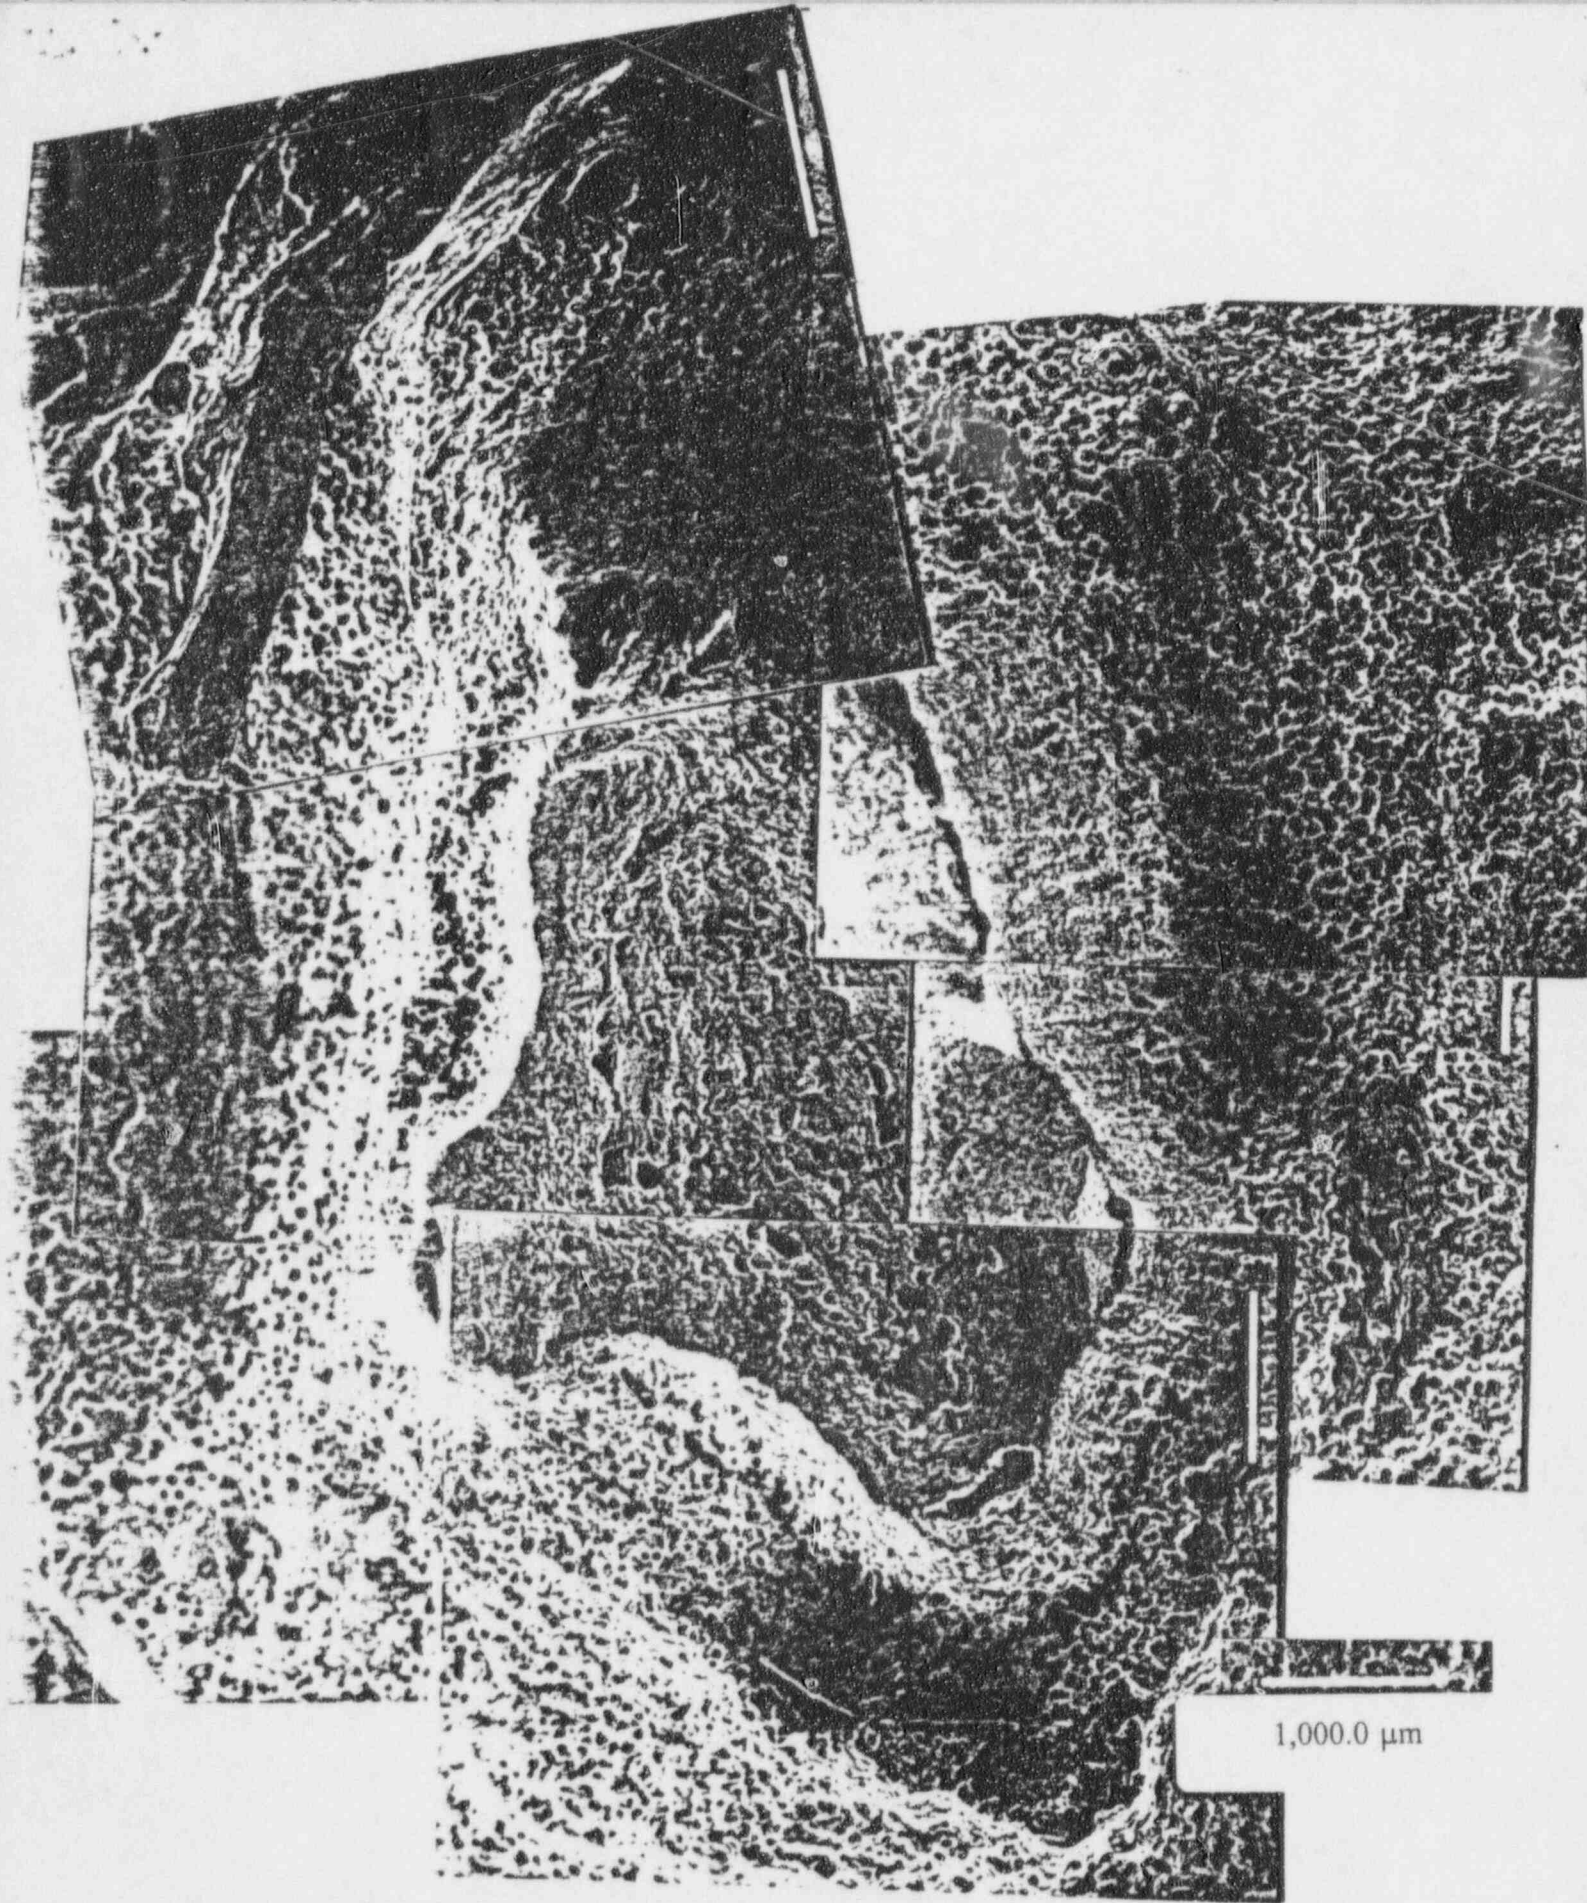
Figure 7. SEM photomicrograph of stud fracture face A (25 kV, 22 x magnification)

SEM photomicrographs of the fracture faces are shown in Figures 6 and 7 (both at 22X magnification). Fracture face B (Figure 6) has two areas with ripple marks which suggest a fatigue-assisted failure. The non-corroded portions of both faces A and B indicate ductile rupture. The SEM micrographs of both fracture faces confirm that they are from two separate studs.

Visual and SEM examination of the two fractures confirm the presence of general corrosion in both pieces which contributed to the failure of the studs. Face A appears to have undergone more corrosion and some wear before failure, which seems to have been induced by tensile stress. In Face A, the wear before failure is evidenced by the stretched and missing threads on the stud. Face B, in addition to the possible fatigue marks in two locations, has indications of a torsional stress in its overall appearance. It may have failed when the stud was removed.
