Advanced Medical Systems, Inc.

Re: Application to Amend USNRC License No. 34-19089-01 to Clarify Provision 23(J)

**RESPONSE TO NOTICE OF VIOLATION FROM
ROUTINE USNRC INSPECTION OF ADVANCED MEDICAL SYSTEMS, INC.**

AN ASSESSMENT

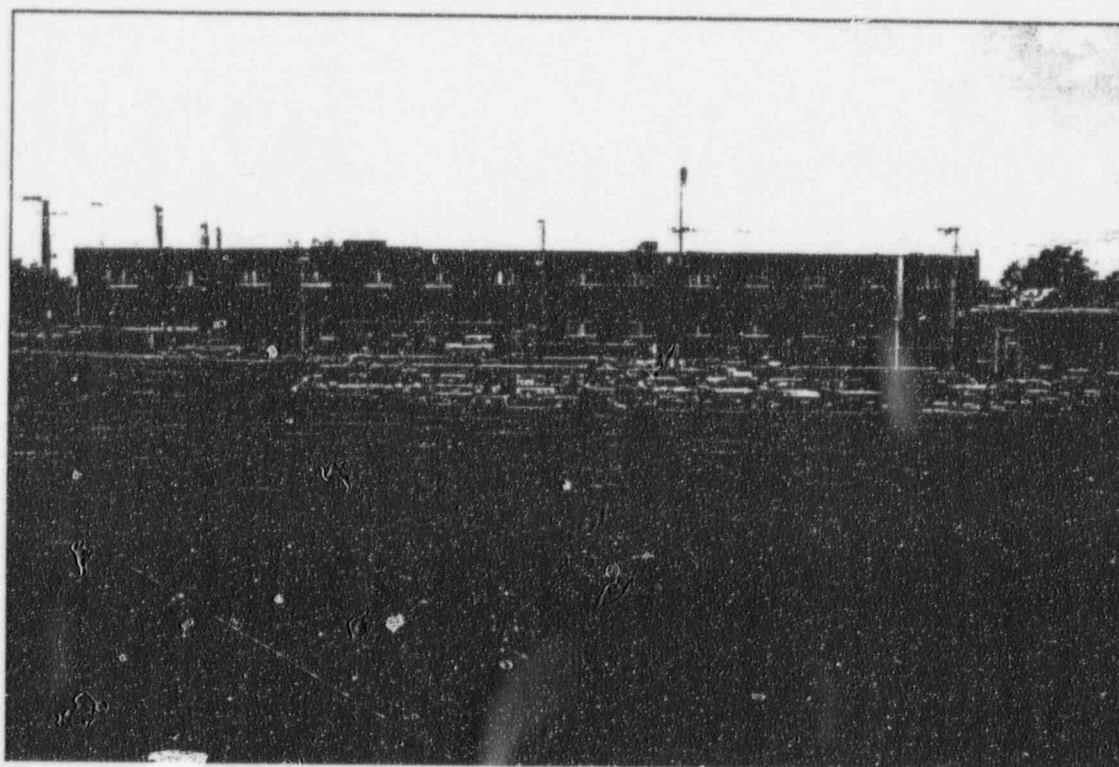
There were five areas addressed in the March 12, 1996, Nuclear Regulatory Commission letter (Wright 1996) concerning structurally distressed areas of the Advanced Medical Systems Laboratory Facility (AMSLF) shown in Figure 1. In the letter's attachment, a list of detailed concerns was provided for each of the five areas. Attachment I provides a response to those concerns. The five major areas of concern and this reviewer's response to them are provided below. Attachment II addresses seismic and tornado issues.

Figure 1. Advanced Medical Systems Laboratory Facility (looking west).

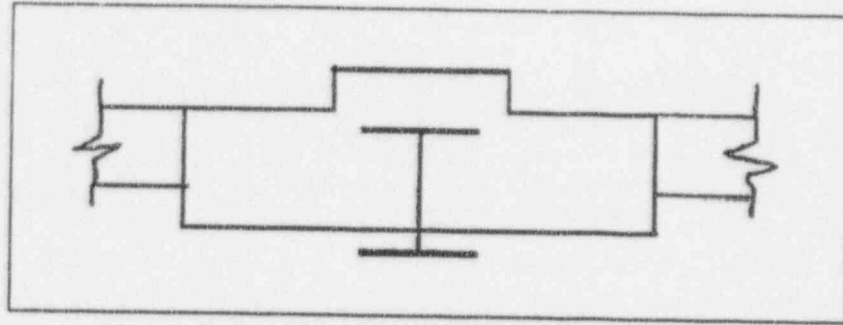
3.1 RESPONSE: The warehouse/industrial building referred to is not a complete load bearing masonry wall building with steel trusses, although at first glance it may appear to be. The building was constructed in 1934 as rectangular in shape. The east-west walls, the walls in the longer dimension (~100 ft), are non-load bearing masonry in-filled walls between steel-riveted columns that support the steel trusses. Some small amount of roof load between the trusses was originally carried by the east-west masonry wall, but this load was one-half of a purlin load, thus the wall typically would not be considered a load bearing wall. The tops of the east-west walls are basically unsupported in the out-of-plane direction except at the columns. At the columns, the masonry is placed flush with the column webs and a pilaster is built around the column flanges facing the original exterior of the building, with about six inches of brick covering the flanges. The sketch in Figure A-1 demonstrates the construction. Based on research done in the last 10 years (Henderson, et al., 1995), unreinforced masonry in-filled buildings provide excellent seismic resistance in low to moderate seismic zones. Although the 1935 building is not a true in-fill since the upper masonry walls are not confined by beams, the fact that they are in-filled within the floor and columns should provide lateral capacity of the building superior to a typical unreinforced load bearing wall. This is especially true where the old windows were filled in with masonry.

Figure A-1. Masonry pilasters and steel columns.

The north-south walls, the short dimension (~60 ft) of the building, are also constructed in the same fashion as the east-west walls. The only difference is the vertical columns at pilasters do not support any vertical load and the wall itself, between columns, supports one-half of the roof load that the trusses and columns support.

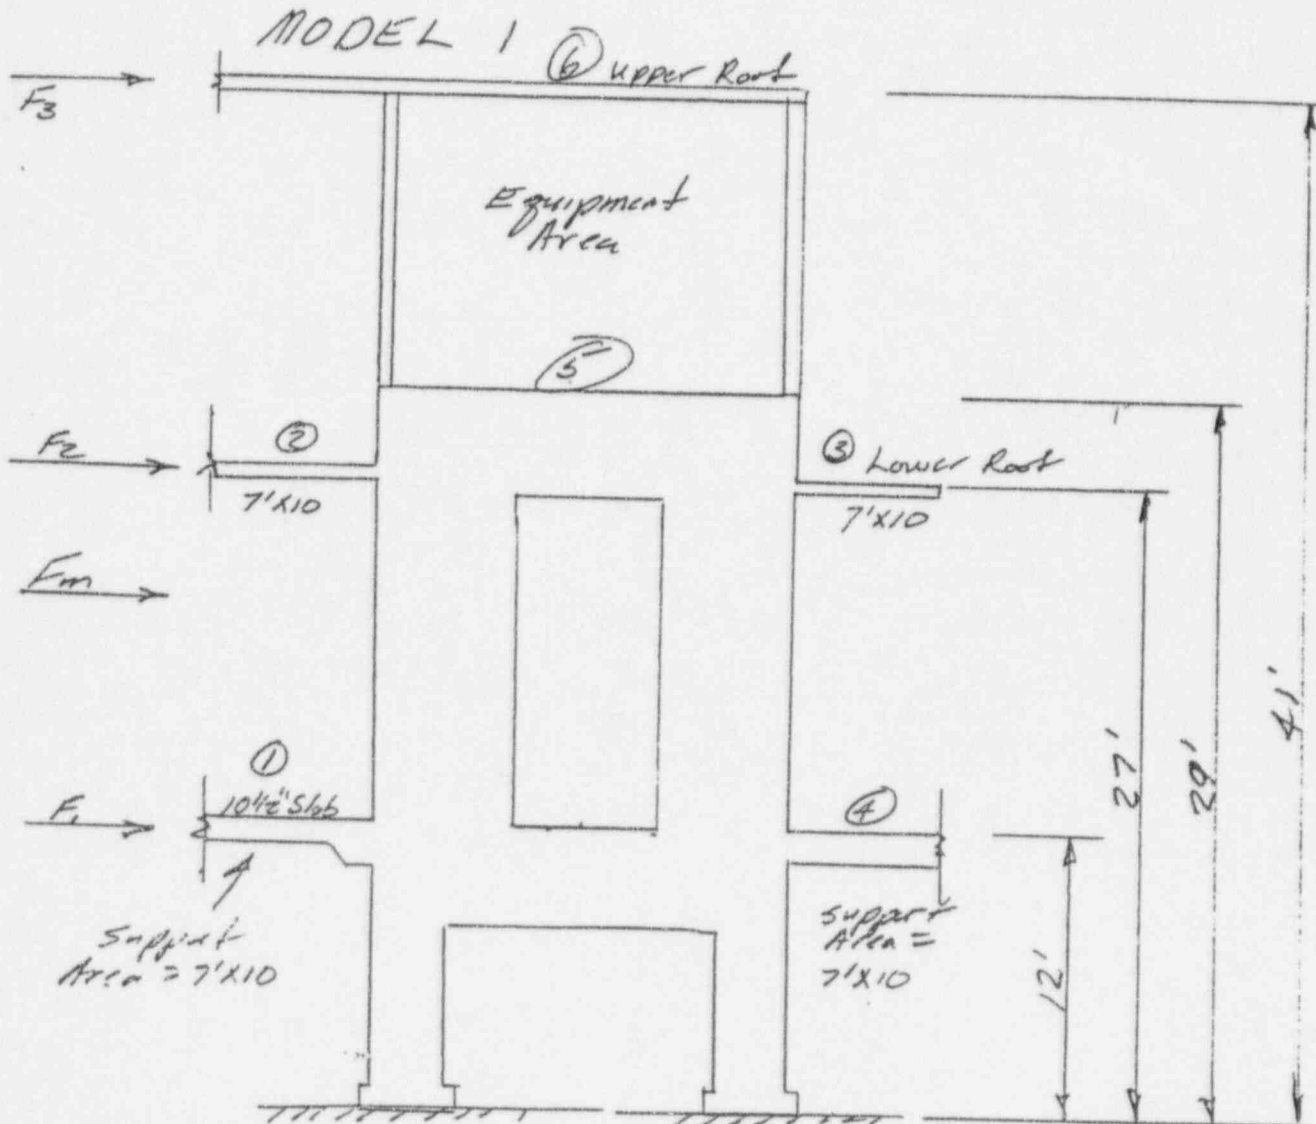
From Section A-A Dwg A-5
East West Section

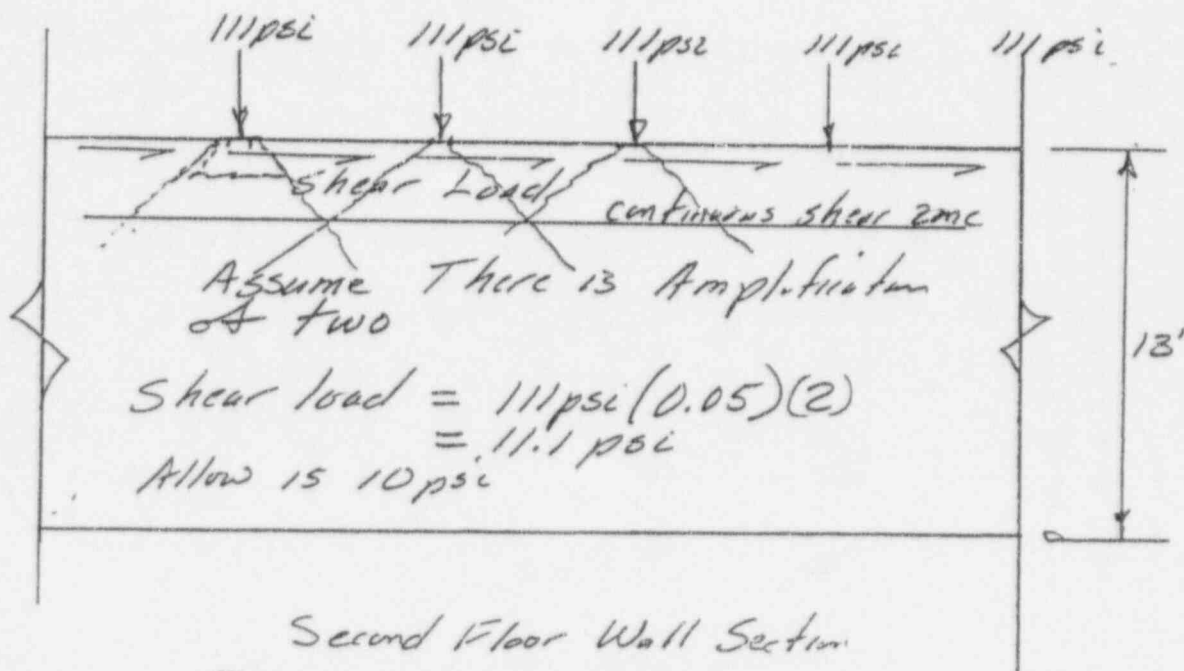
$$\text{Wall stress} = \frac{6240}{7 \times 8} = 111 \text{ psi}$$

Allowable Shear Load In Unreinforced Masonry is 10 psi

Gross Area Supporting Purlin Load is approximately $8' \times 8' \times 12" = 768 \text{ in}^2$
