RADIOLOGIC AND ENGINEERING ASSESSMENT

DOE ID NO.: GJ-00767-RS
ADDRESS: 1425 HALL AVENUE

AUGUST 1985

BENDIX FIELD ENGINEERING CORPORATION
P.O. Box 1569
Grand Junction, Colorado 81502

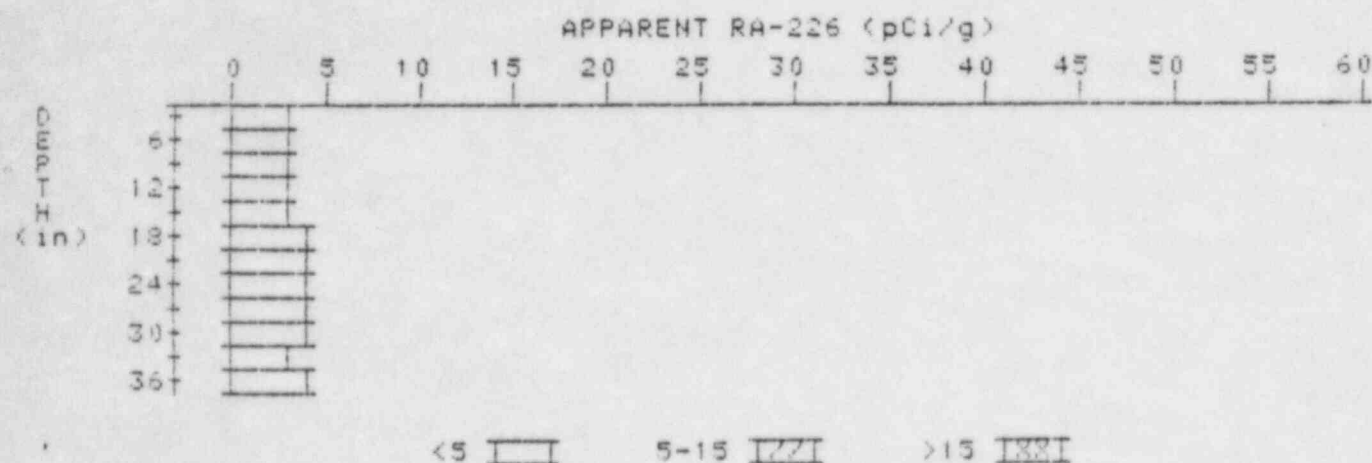
HOLE NUMBER: 1

Depth (in)	Apparent Radium-226 (pCi/g) Undeconvolved	Apparent Radium-226 (pCi/g) Deconvolved
3	2.7	2.7
6	3.0	3.2
9	3.2	3.4
12	3.3	3.3
15	3.4	3.4
18	3.5	3.5
21	3.6	3.6
24	3.6	3.6
27	3.6	3.6
30	3.6	3.6
33	3.5	3.3
36	3.5	3.5

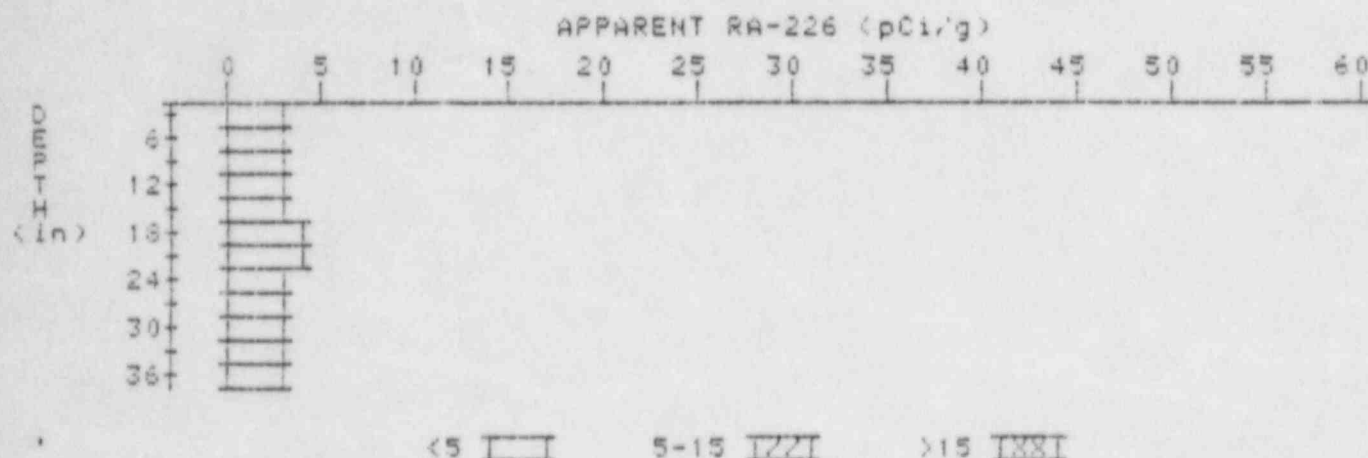
HOLE NUMBER: 11

Depth (in)	Apparent Radium-226 (pCi/g) Undeconvolved	Apparent Radium-226 (pCi/g) Deconvolved
3	2.6	2.6
6	3.0	3.4
9	3.2	3.4
12	3.3	3.3
15	3.4	3.4
18	3.5	3.7
21	3.8	3.7
24	3.4	3.2
27	3.4	3.4
30	3.4	3.4
33	3.4	3.4
36	3.4	3.4
