RADIOLOGIC AND ENGINEERING ASSESSMENT

DOE ID NO.: GJ-01167-RM
ADDRESS: 626 GUNNISON AVENUE

AUGUST 1985

BENDIX FIELD ENGINEERING CORPORATION
P.O. Box 1569
Grand Junction, Colorado 81502

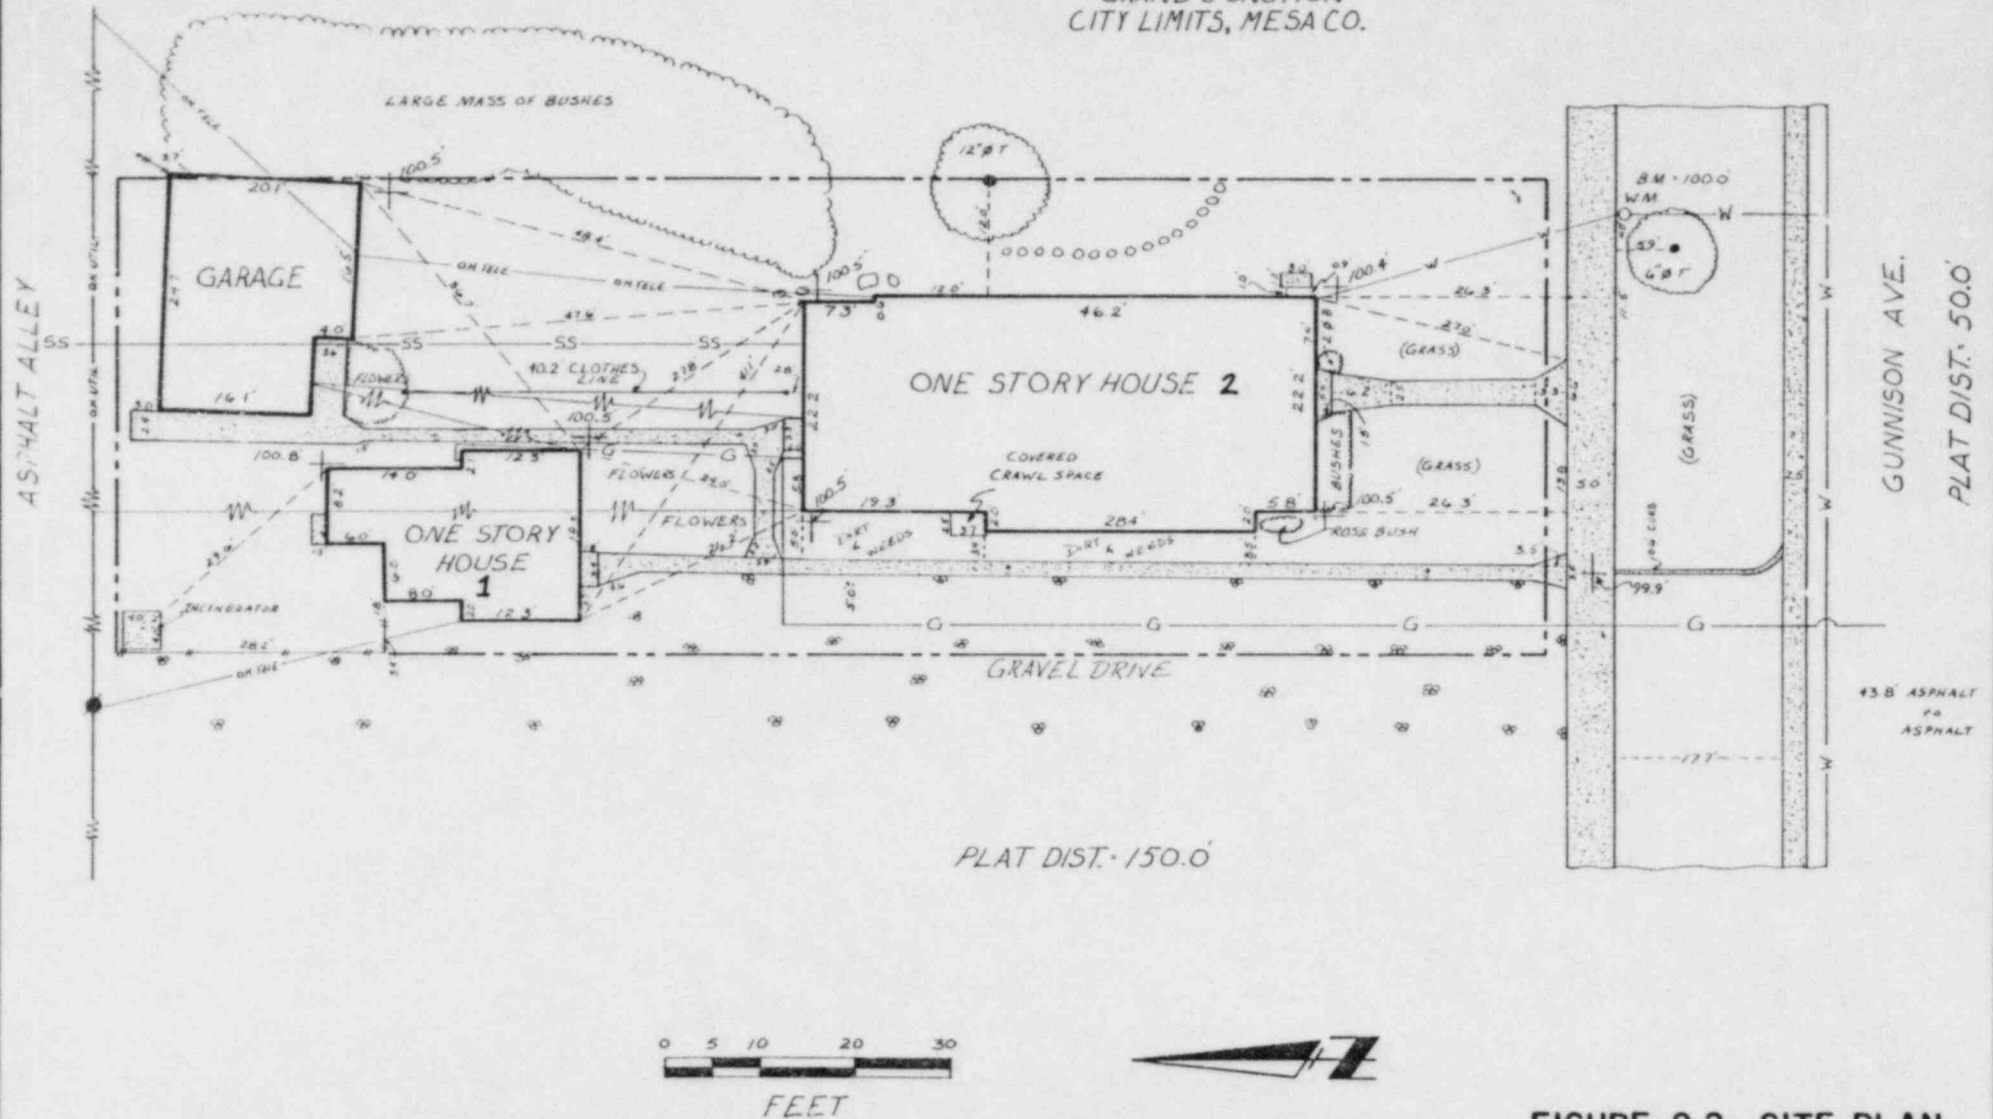
FIGURE 2.2 SITE PLAN

Utilities: Utility locations are shown in Appendix Figure 2.2.

Structures, utilities, landscaping, and other special features of this property are included in Appendix Figure 2.2.
