RADIOLOGIC AND ENGINEERING ASSESSMENT

DOE ID NO.: GJ-30306-CS
ADDRESS: 922 NORTH 1ST STREET

AUGUST 1985

BENDIX FIELD ENGINEERING CORPORATION
P.O. Box 1569
Grand Junction, Colorado 81502

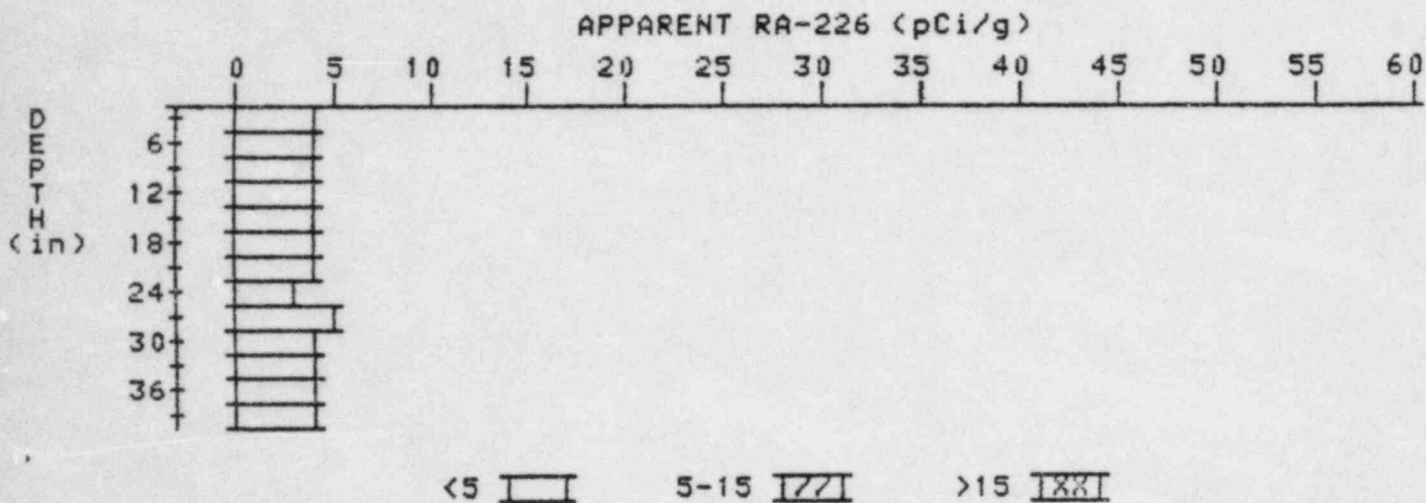
HOLE NUMBER: 19

Depth (in)	Apparent Radium-226 (pCi/g) Undeconvolved	Apparent Radium-226 (pCi/g) Deconvolved
3	4.2	4.2
6	4.1	4.1
9	4.0	3.8
12	4.0	4.0
15	4.0	4.0
18	4.0	4.2
21	3.9	3.9
24	3.8	3.3
27	4.0	4.5
30	3.9	3.9
33	3.8	3.6
36	3.8	4.0
39	3.7	3.7

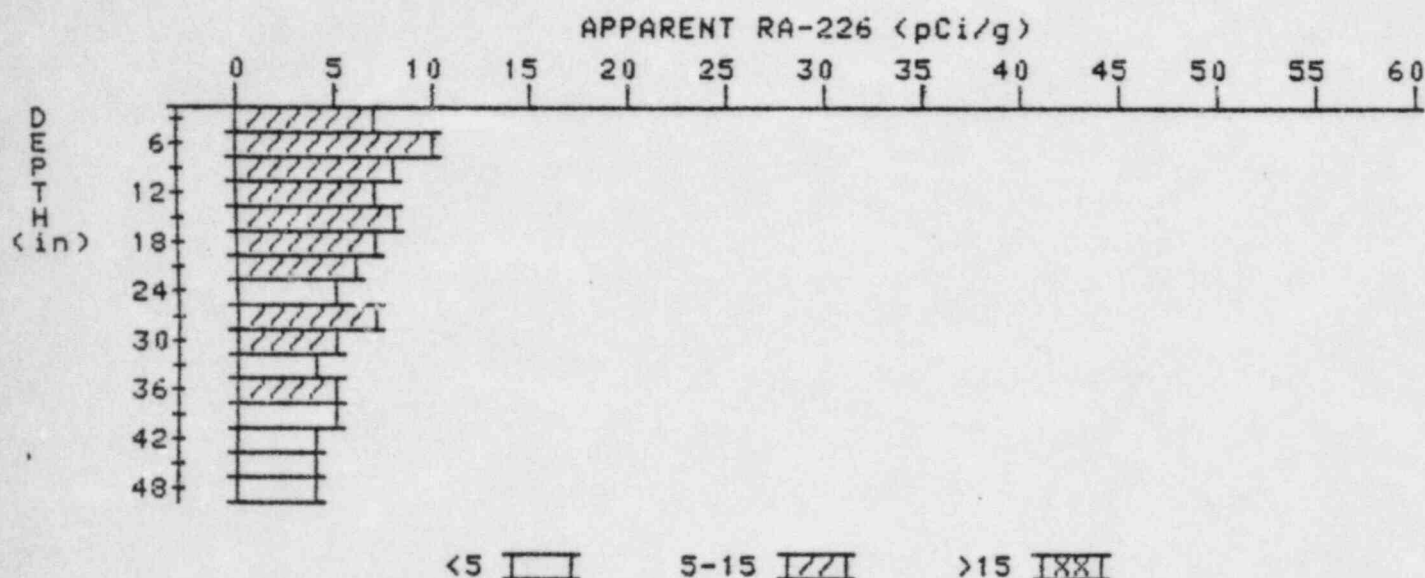
HOLE NUMBER: 23

Depth (in)	Apparent Radium-226 (pCi/g) Undeconvolved	Apparent Radium-226 (pCi/g) Deconvolved
3	7.3	7.3
6	8.1	9.9
9	7.9	8.3
12	7.5	7.3
15	7.2	7.6
18	6.7	6.5
21	6.3	6.5
24	5.8	4.9
27	5.8	6.7
30	5.3	5.1
33	4.9	4.4
36	4.8	5.2
39	4.5	4.5
42	4.2	4.2
45	3.9	3.5
48	3.8	3.8

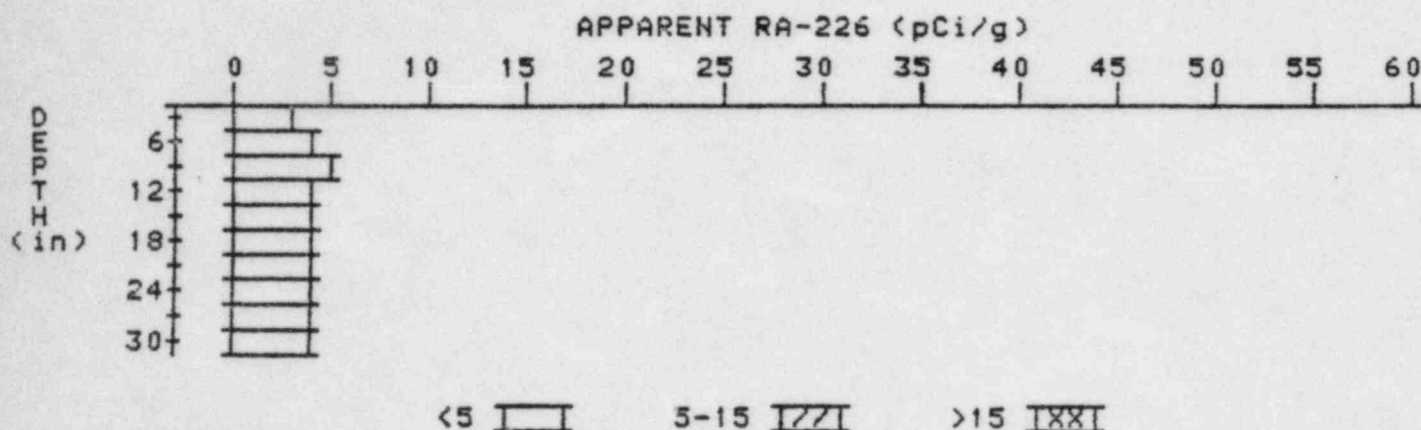
HOLE NUMBER: 30

Depth (in)	Apparent Radium-226 (pCi/g) Undeconvolved	Apparent Radium-226 (pCi/g) Deconvolved
3	2.9	2.9
6	3.5	3.9
9	3.9	4.6
12	3.9	3.7
15	4.0	4.4
18	3.9	3.5
21	4.0	4.4
24	3.9	3.7
27	3.9	4.1
30	3.8	3.8
