RADIOLOGIC AND ENGINEERING ASSESSMENT

DOE ID NO.: GJ-05975-CS  
ADDRESS: 3256.5 F ROAD  
CLIFTON, COLORADO

MAY 1985

BENDIX FIELD ENGINEERING CORPORATION  
P.O. Box 1569  
Grand Junction, Colorado 81502

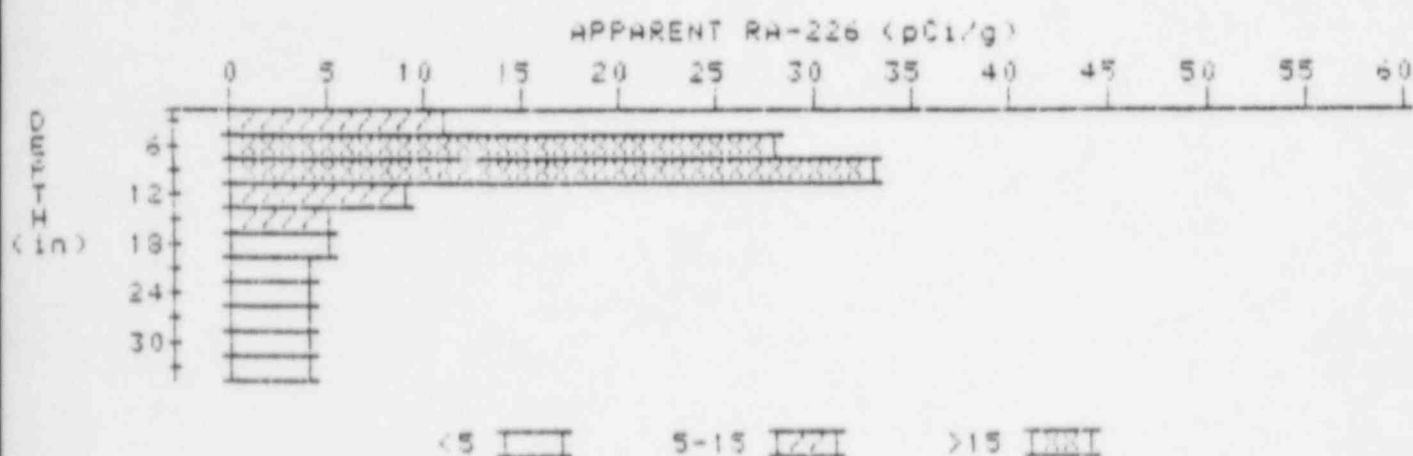
HOLE NUMBER: 2

Depth (in)	Apparent Radium-226 (pCi/g) Undeconvolved	Apparent Radium-226 (pCi/g) Deconvolved
3	10.5	10.5
6	17.9	28.1
9	19.3	33.2
12	13.0	9.3
15	9.8	5.4
18	6.5	4.5
21	5.3	4.2
24	4.7	4.3
27	4.3	3.9
30	4.1	3.7
33	4.1	4.1

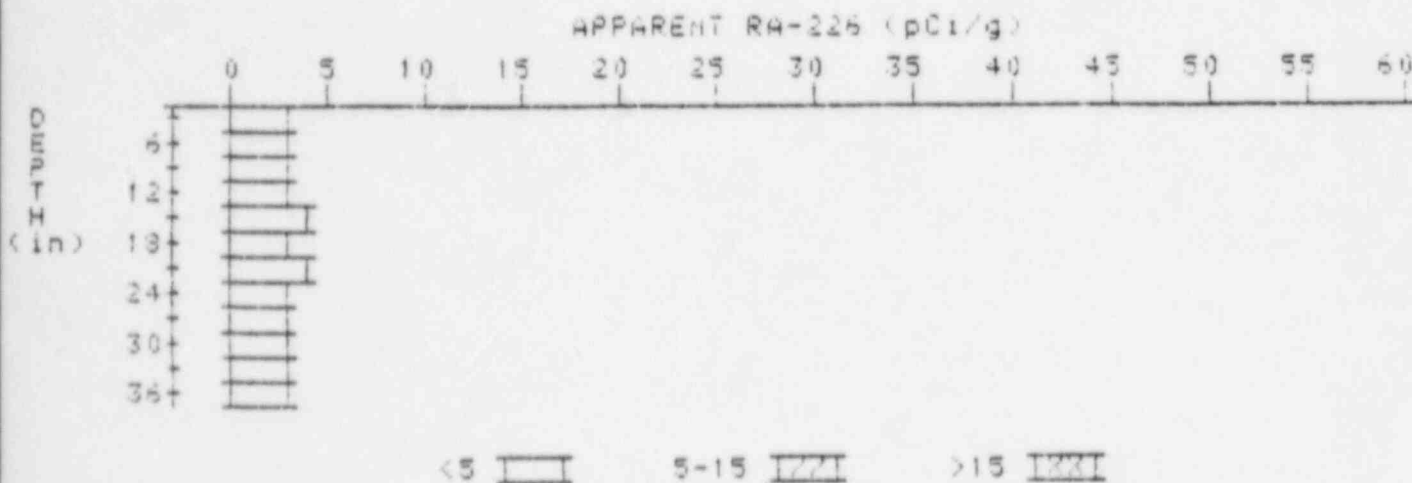
PROPERTY NUMBER: GJ-05975-05  
HOLE NUMBER: 4  
LOCATION:

Depth (in)	Apparent Radium-226 (pCi/g) Undeconvolved	Apparent Radium-226 (pCi/g) Deconvolved
3	2.8	2.8
6	3.1	3.3
9	3.3	3.5
12	3.4	3.4
15	3.5	3.9
18	3.4	3.0
21	3.8	3.9
24	3.4	3.4
27	3.3	3.1
30	3.4	3.3
33	3.3	3.3
36	3.3	3.3

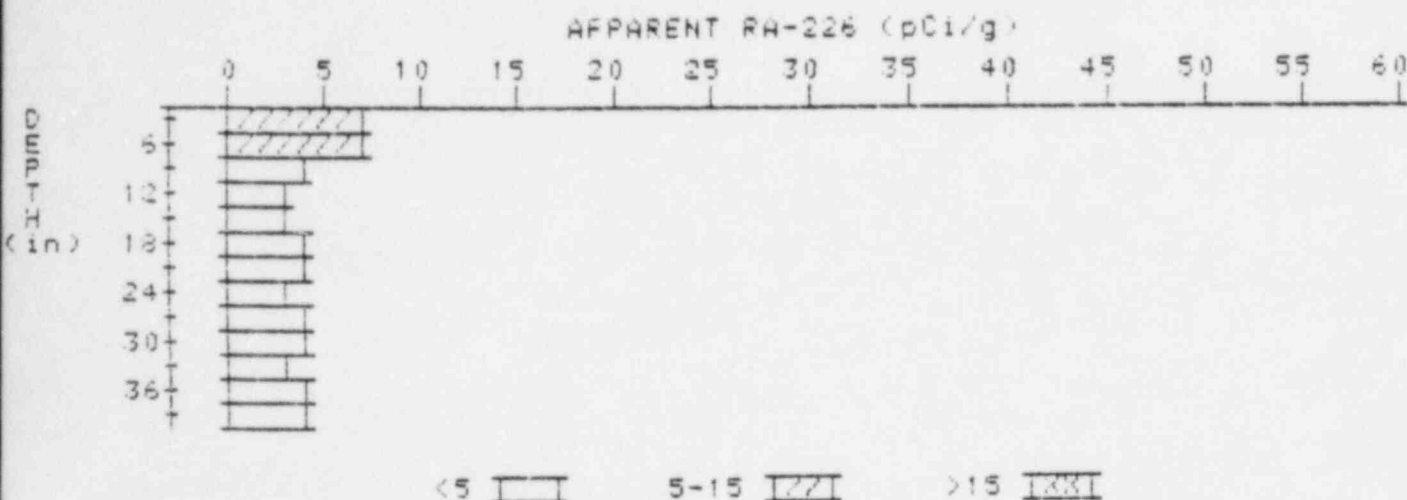
HOLE NUMBER: 7

Depth (in)	Apparent Radium-226 (pCi/g) Undeconvolved	Apparent Radium-226 (pCi/g) Deconvolved
3	7.1	7.1
6	6.3	7.2
9	5.0	4.3
12	4.1	3.0
15	3.8	3.4
18	3.7	3.5
21	3.7	3.9
24	3.6	3.2
27	3.7	4.1
30	3.6	3.6
33	3.5	3.1
36	3.6	4.0
39	3.5	3.5

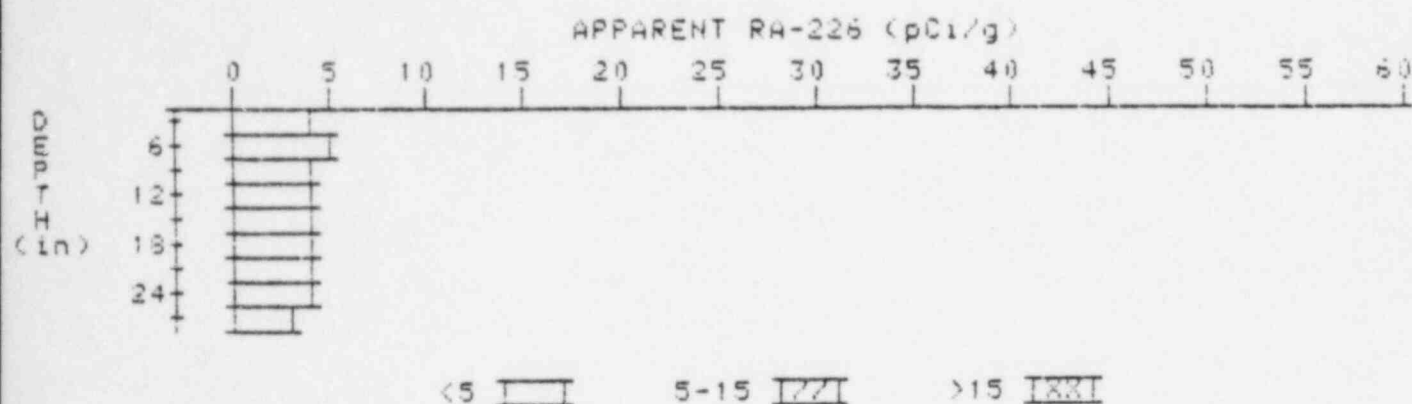
HOLE NUMBER: 8

Depth (in)	Apparent Radium-226 (pCi/g) Undeconvolved	Apparent Radium-226 (pCi/g) Deconvolved
3	4.3	4.3
6	4.3	4.7
9	4.1	4.1
12	3.9	3.7
15	3.8	3.8
18	3.7	3.7
21	3.6	3.6
24	3.5	3.5
27	3.4	3.4

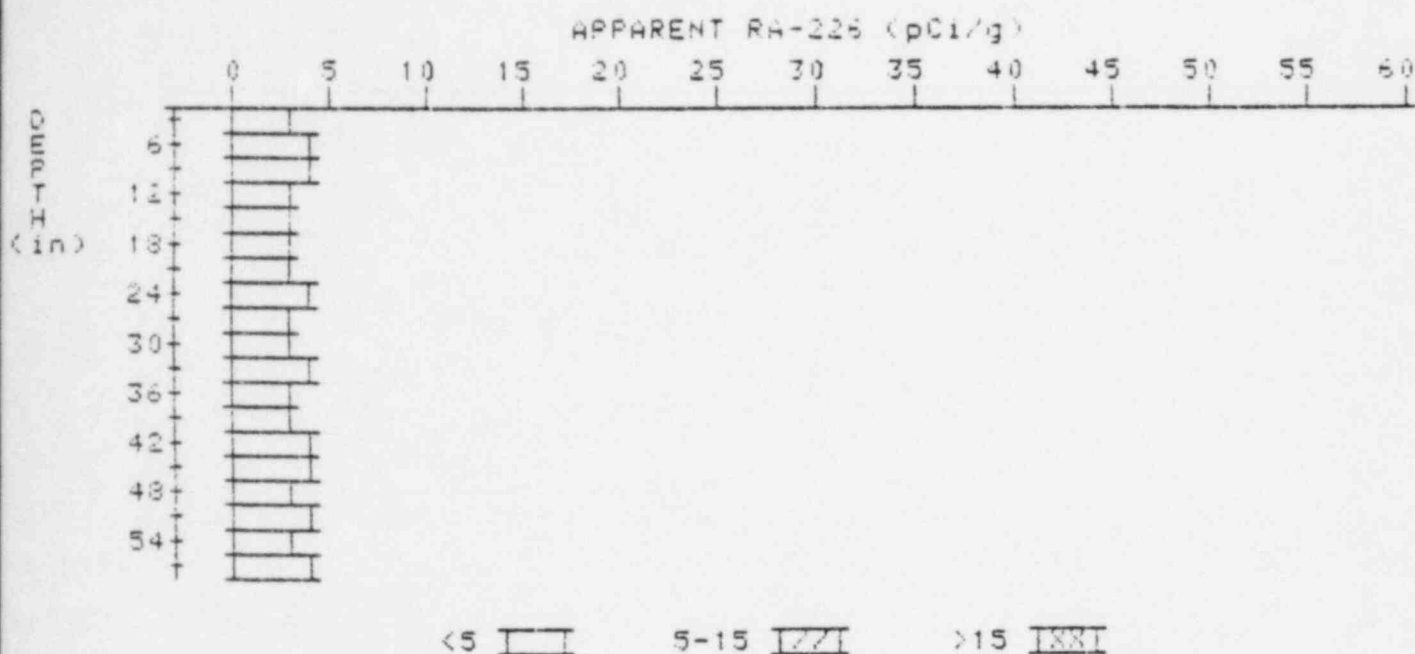
HOLE NUMBER: 9

Depth (in)	Apparent Radium-226 (pCi/g) Undeconvolved	Apparent Radium-226 (pCi/g) Deconvolved
3	3.2	3.2
6	3.4	3.6
9	3.5	3.9
12	3.4	3.2
15	3.4	3.4
18	3.4	3.4
21	3.4	3.4
24	3.4	3.6
27	3.3	3.1
30	3.3	3.1
33	3.4	3.6
36	3.4	3.4
39	3.4	3.2
42	3.5	3.7
45	3.5	3.7
48	3.4	3.0
51	3.5	3.7
54	3.5	3.3

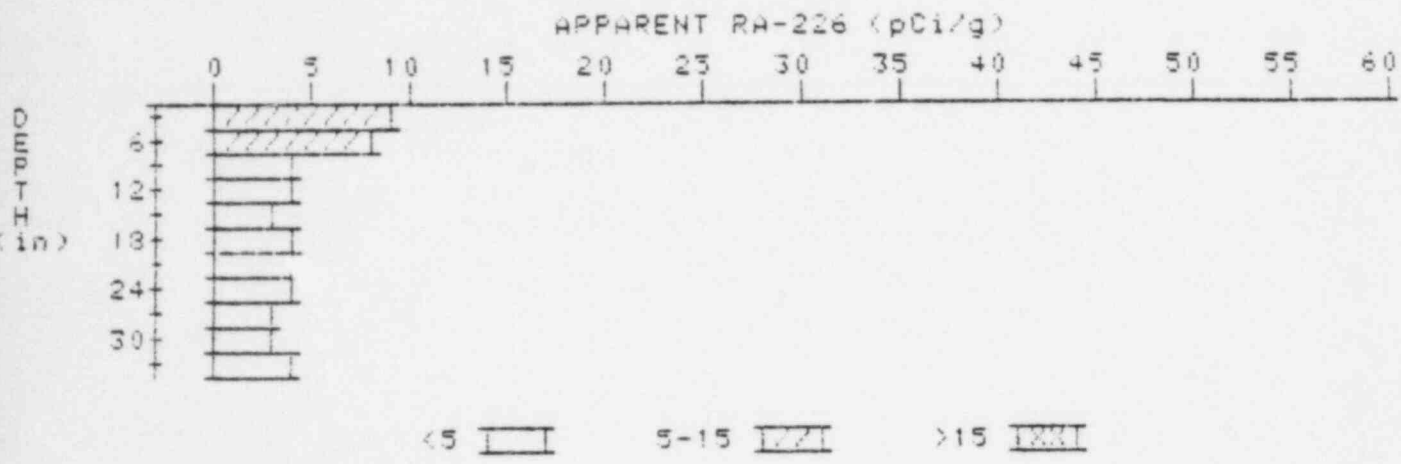
PROPERTY NUMBER: GJ-05975-C9  
HOLE NUMBER: 11  
LOCATION: 207273

Depth (in)	Apparent Radium-226 (pCi/g) Undeconvolved	Apparent Radium-226 (pCi/g) Deconvolved
3	9.4	9.4
6	7.6	7.6
9	5.8	4.4
12	4.8	4.4
15	4.0	2.9
18	3.8	3.6
21	3.7	3.7
24	3.6	3.6
27	3.5	3.3
30	3.5	3.3
33	3.6	3.6

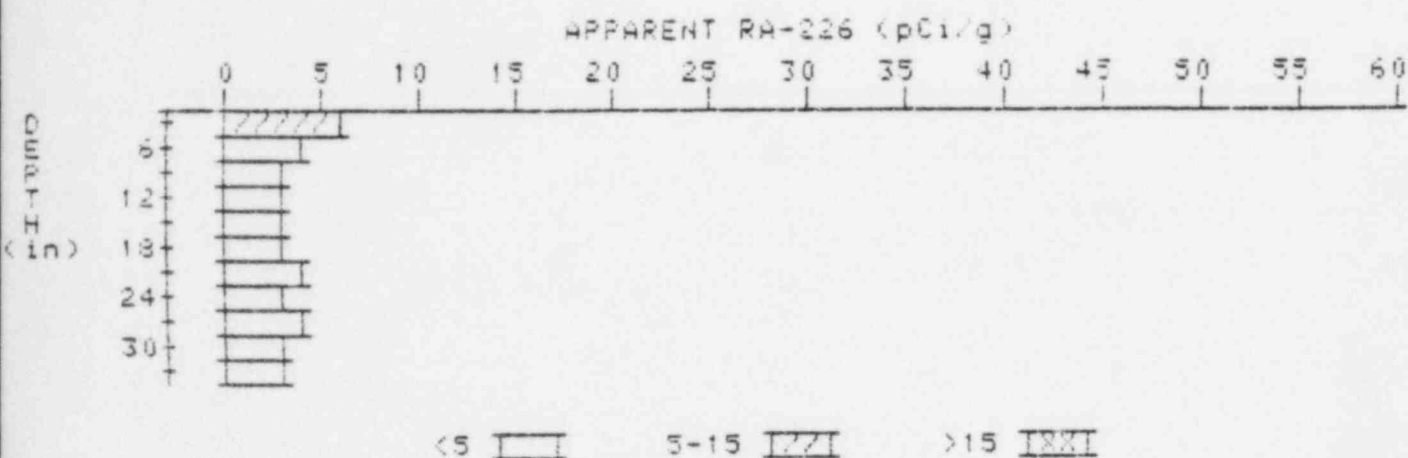
HOLE NUMBER: 14

Depth (in)	Apparent Radium-226 (pCi/g) Undeconvolved	Apparent Radium-226 (pCi/g) Deconvolved
3	6.4	6.4
6	5.0	3.9
9	4.2	3.5
12	3.8	3.4
15	3.6	3.4
18	3.5	3.3
21	3.5	3.7
24	3.4	3.0
27	3.5	3.9
30	3.4	3.4
33	3.3	3.3

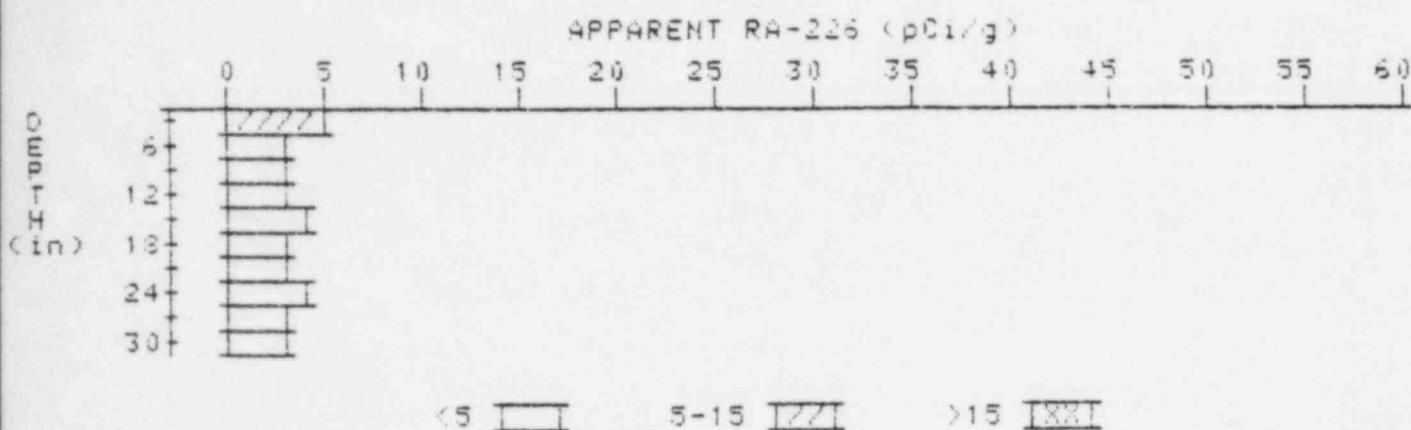
HOLE NUMBER: 15

Depth (in)	Apparent Radium-226 (pCi/g) Undeconvolved	Apparent Radium-226 (pCi/g) Deconvolved
3	5.2	5.2
6	4.2	3.1
9	3.8	3.4
12	3.6	3.4
15	3.5	3.5
18	3.4	3.2
21	3.4	3.4
24	3.4	3.6
27	3.3	3.1
30	3.3	3.3

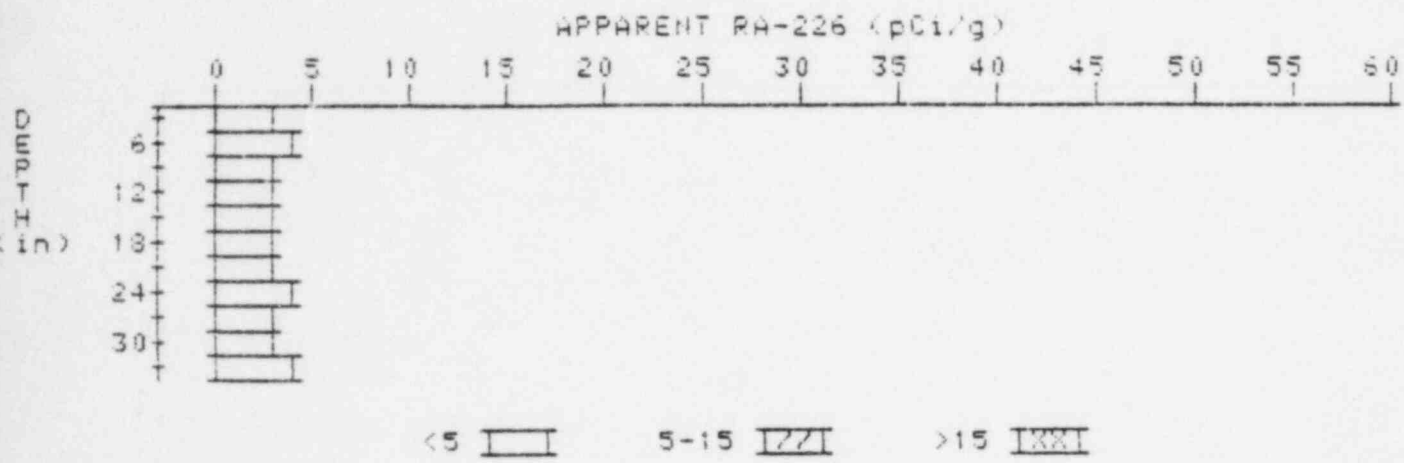
PROPERTY NUMBER: GJ-05975-08  
HOLE NUMBER: 16  
LOCATION: 230300

Depth (in)	Apparent Radium-226 (pCi/g) Undeconvolved	Apparent Radium-226 (pCi/g) Deconvolved
3	3.0	3.0
6	3.2	3.6
9	3.2	3.2
12	3.2	3.0
15	3.3	3.5
18	3.3	3.3
21	3.3	3.1
24	3.4	3.6
27	3.4	3.4
30	3.4	3.2
33	3.5	3.5
