RADIOLOGIC AND ENGINEERING ASSESSMENT

DOE ID NO.: GJ-00316-RS
ADDRESS: 2428 HALL AVENUE

AUGUST 1985

BENDIX FIELD ENGINEERING CORPORATION
P.O. Box 1569
Grand Junction, Colorado 81502

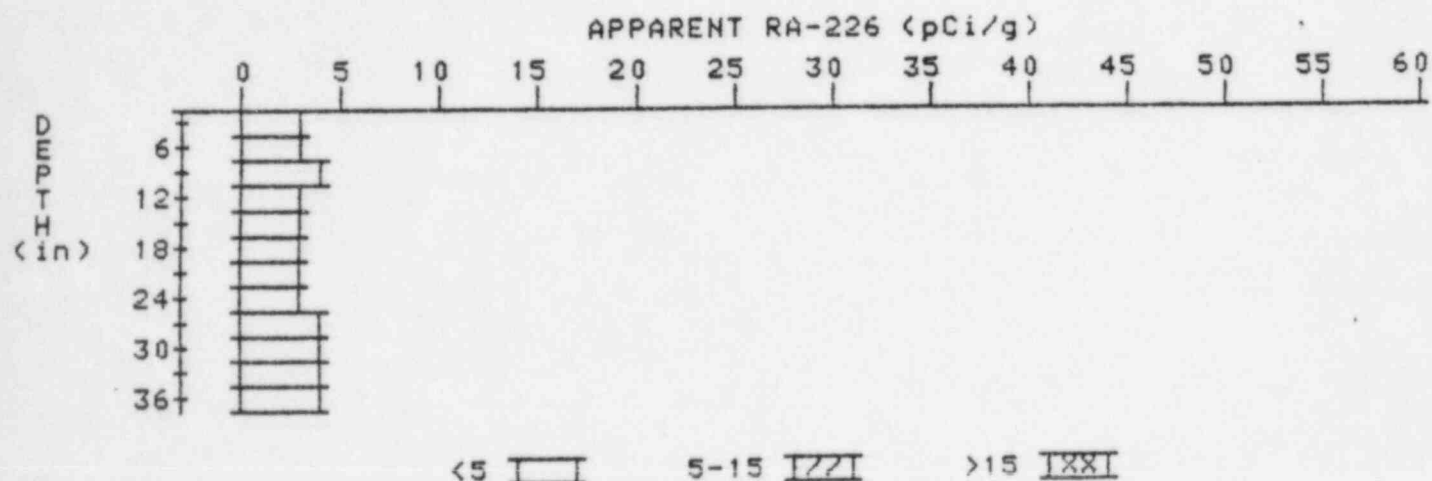
HOLE NUMBER: 7

LOCATION: 185265

Depth (in)	Apparent Radium-226 (pCi/g) Undeconvolved	Apparent Radium-226 (pCi/g) Deconvolved
3	3.1	3.1
6	3.3	3.5
9	3.4	3.6
12	3.4	3.4
15	3.4	3.4
18	3.4	3.4
21	3.4	3.4
24	3.4	3.2
27	3.5	3.7
30	3.5	3.5
33	3.5	3.5
36	3.5	3.5

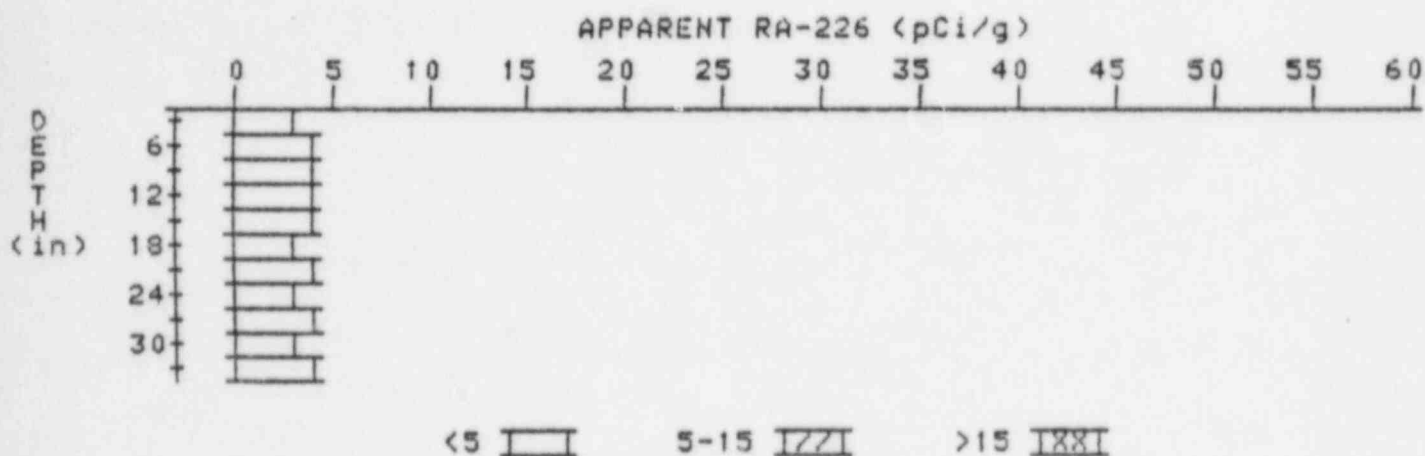
HOLE NUMBER: 15

LOCATION: 225288

Depth (in)	Apparent Radium-226 (pCi/g) Undeconvolved	Apparent Radium-226 (pCi/g) Deconvolved
3	3.2	3.2
6	3.4	3.6
9	3.5	3.7
12	3.5	3.5
15	3.5	3.5
18	3.5	3.3
21	3.6	4.0
24	3.5	3.3
27	3.5	3.5
30	3.5	3.1
33	3.7	3.7

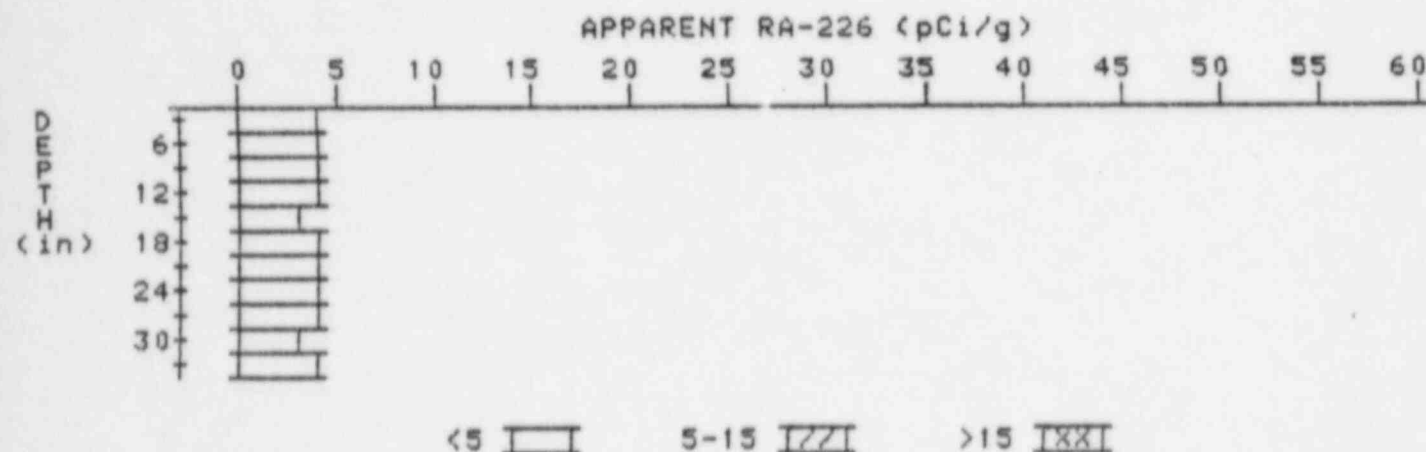
HOLE NUMBER: 16

LOCATION: 230230

Depth (in)	Apparent Radium-226 (pCi/g) Undeconvolved	Apparent Radium-226 (pCi/g) Deconvolved
3	4.1	4.1
6	4.1	4.3
9	4.0	4.0
12	3.9	4.1
15	3.7	3.3
18	3.7	3.5
21	3.8	4.0
24	3.8	3.6
27	3.9	4.3
30	3.8	3.4
33	3.9	3.9

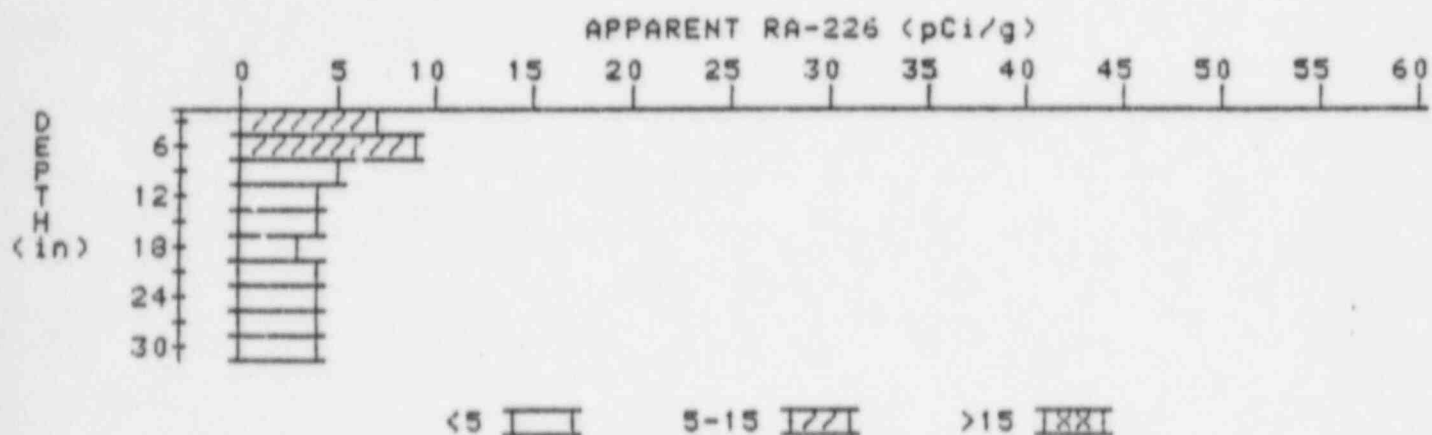
HOLE NUMBER: 19

LOCATION: 239259

Depth (in)	Apparent Radium-226 (pCi/g) Undeconvolved	Apparent Radium-226 (pCi/g) Deconvolved
3	7.0	7.0
6	6.9	8.9
9	5.7	5.0
12	4.9	4.4
15	4.4	4.2
18	4.0	3.3
21	4.0	4.2
24	3.9	3.7
27	3.9	3.7
30	4.0	4.0

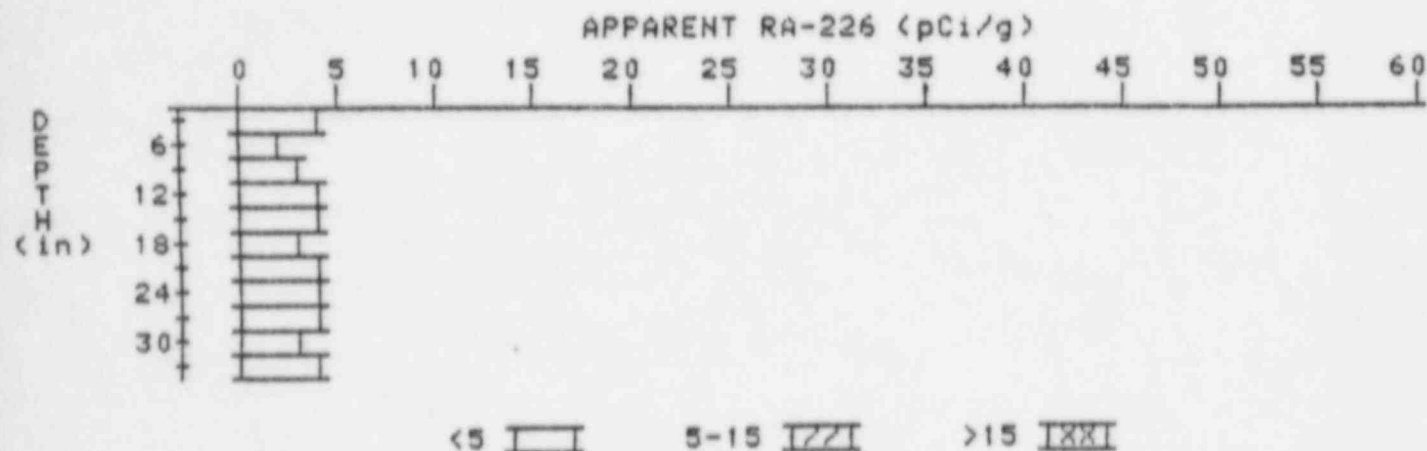
PROPERTY NUMBER: GJ-00316-RS
HOLE NUMBER: 21
LOCATION: 240287

Depth (in)	Apparent Radium-226 (pCi/g) Undeconvolved	Apparent Radium-226 (pCi/g) Deconvolved
3	3.8	3.8
6	3.3	2.2
9	3.4	3.4
12	3.5	3.5
15	3.6	3.8
18	3.6	3.4
21	3.7	3.9
24	3.7	3.7
27	3.7	3.9
30	3.6	3.1
33	3.8	3.8

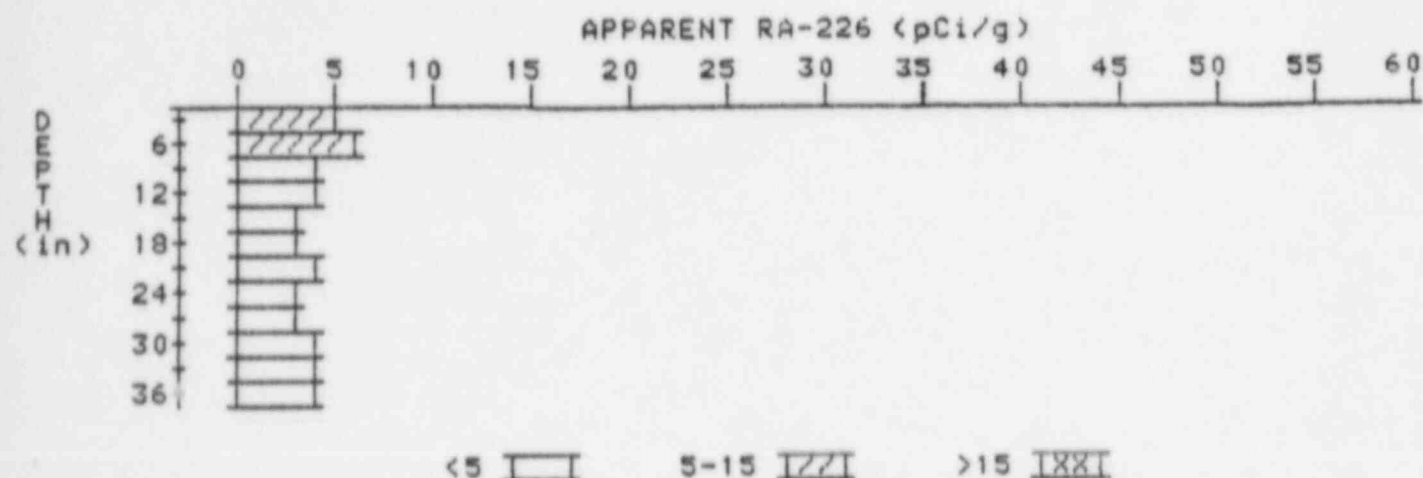
HOLE NUMBER: 23

LOCATION: 260234

Depth (in)	Apparent Radium-226 (pCi/g) Undeconvolved	Apparent Radium-226 (pCi/g) Deconvolved
3	5.4	5.4
6	5.3	6.4
9	4.6	4.2
12	4.1	3.9
15	3.7	3.3
18	3.5	2.8
21	3.7	4.2
24	3.6	3.4
27	3.6	3.4
30	3.7	3.9
33	3.7	3.9
36	3.6	3.6
