RADIOLOGIC AND ENGINEERING ASSESSMENT

DOE ID NO.: GJ-12375-RM  
ADDRESS: 2890 ORCHARD AVENUE

AUGUST 1985

BENDIX FIELD ENGINEERING CORPORATION  
P.O. Box 1569  
Grand Junction, Colorado 81502

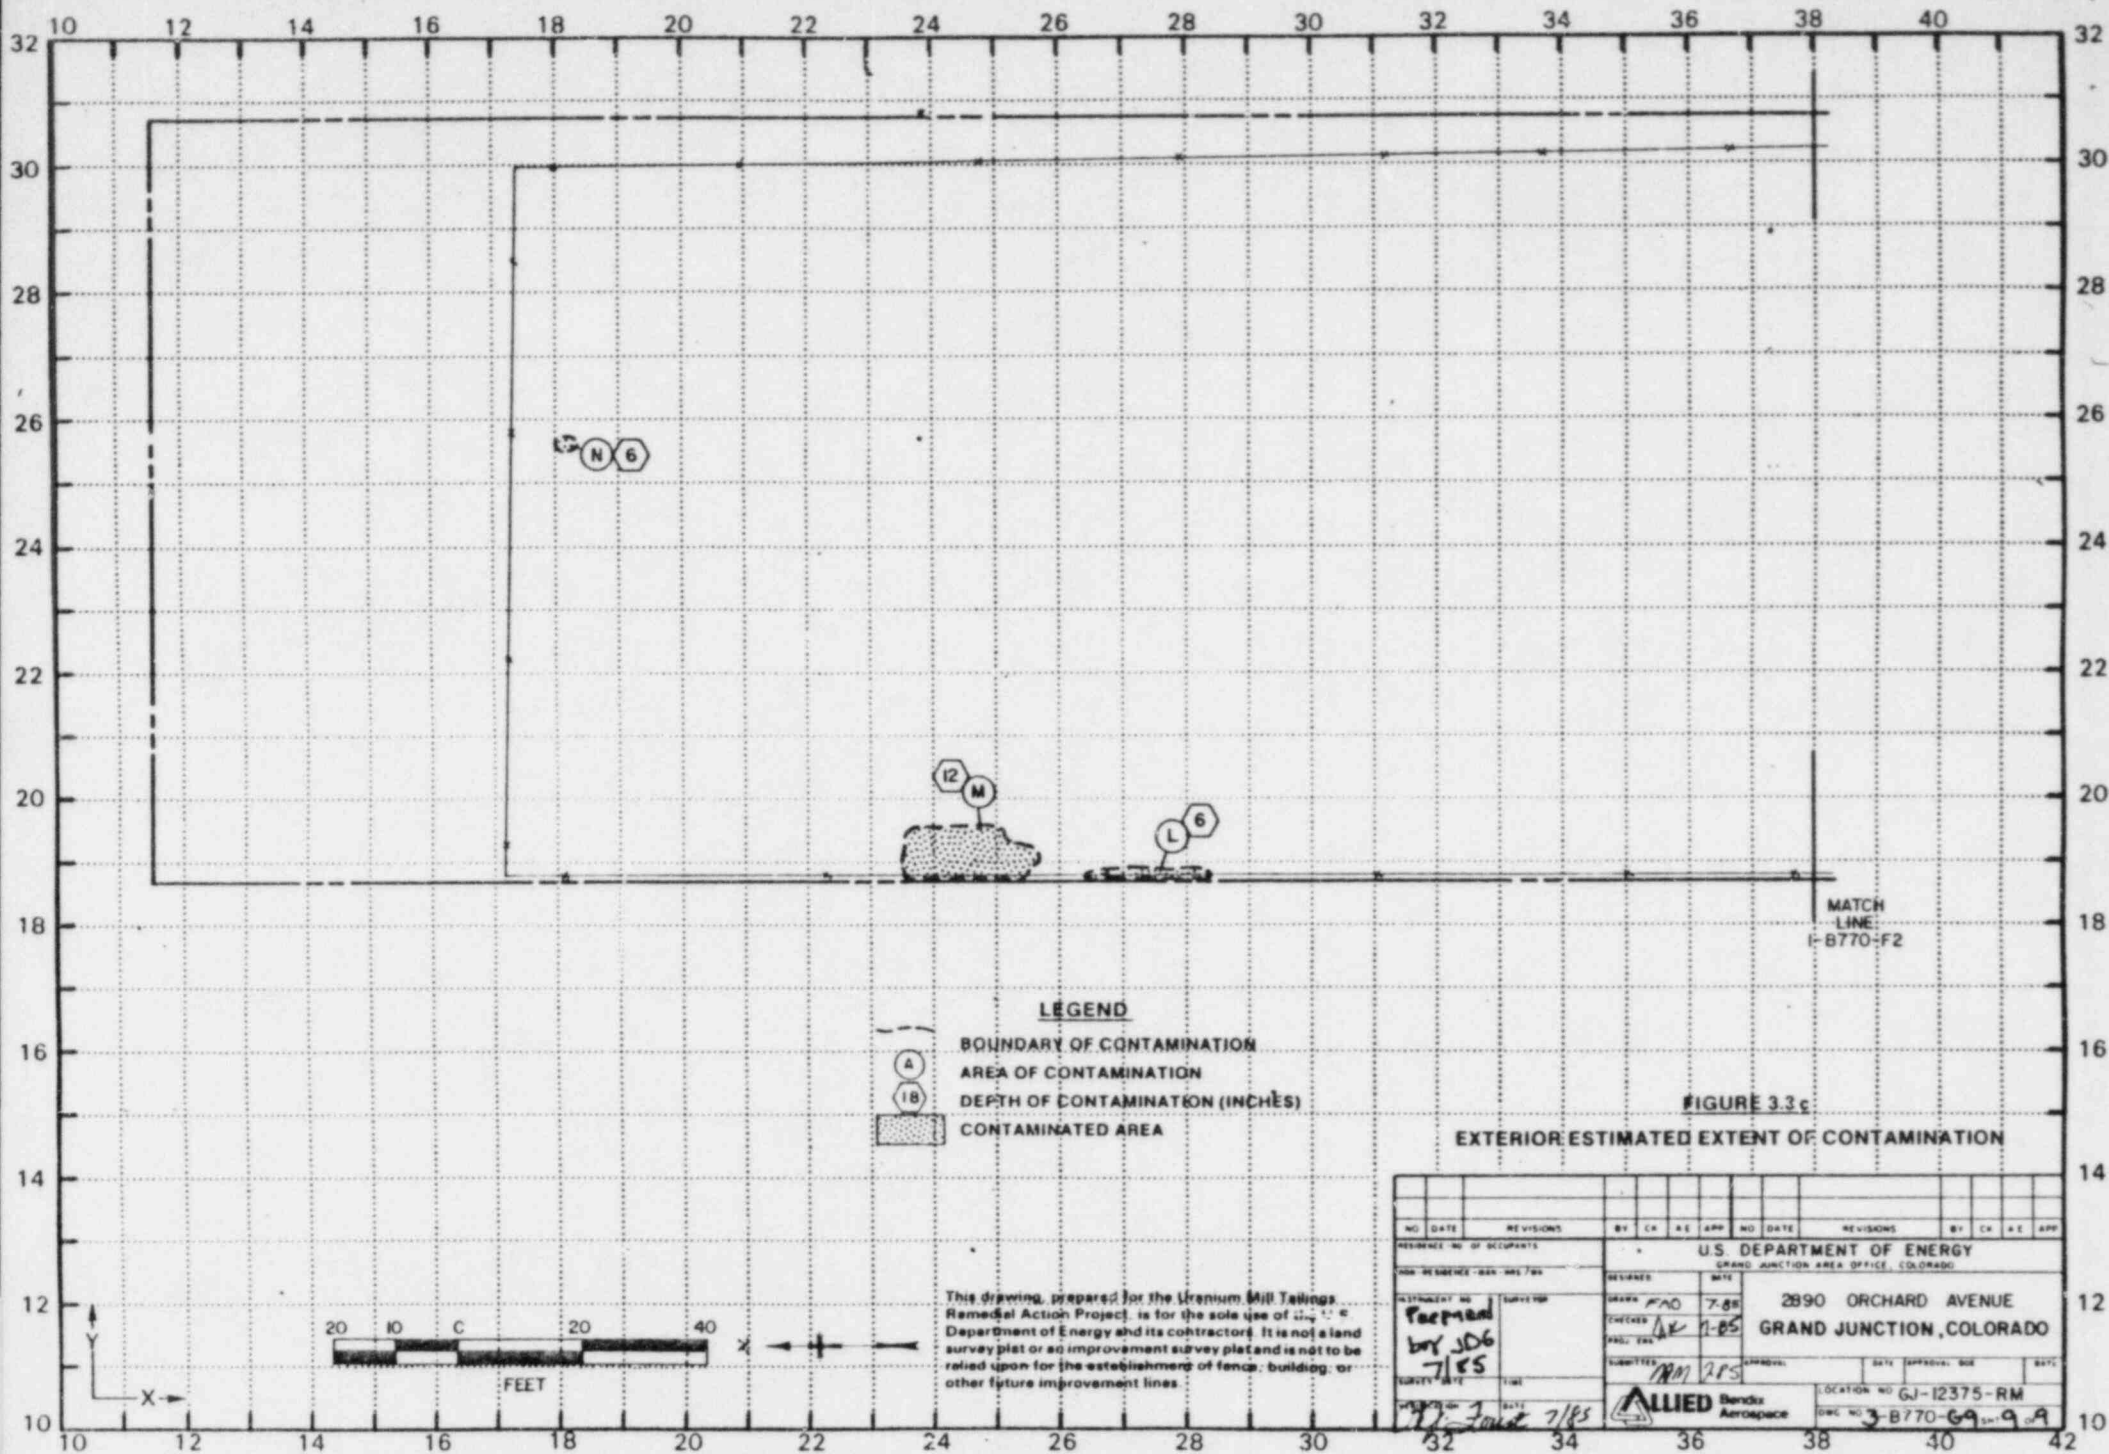
Appendix Figures 3.3a, 3.3b, and 3.3c show identified areas and estimated depths of contamination on this property, based on assessments of all measurements taken. As noted in these figures, areas recommended for remedial action that contain identified residual radioactive materials are:

The recommended remedial action for this property, DOE ID No. GJ-12375-RM, includes removal of all areas identified as containing radioactive material (as discussed in Section 3.5 and shown in Appendix Figures 3.3a, 3.3b, and 3.3c) and transport of removed material to the disposal site.
