RADIOLOGIC AND ENGINEERING ASSESSMENT

DOE ID NO.: GJ-02172-RS
ADDRESS: 1320 NORTH 17TH STREET

AUGUST 1985

BENDIX FIELD ENGINEERING CORPORATION
P.O. Box 1569
Grand Junction, Colorado 81502

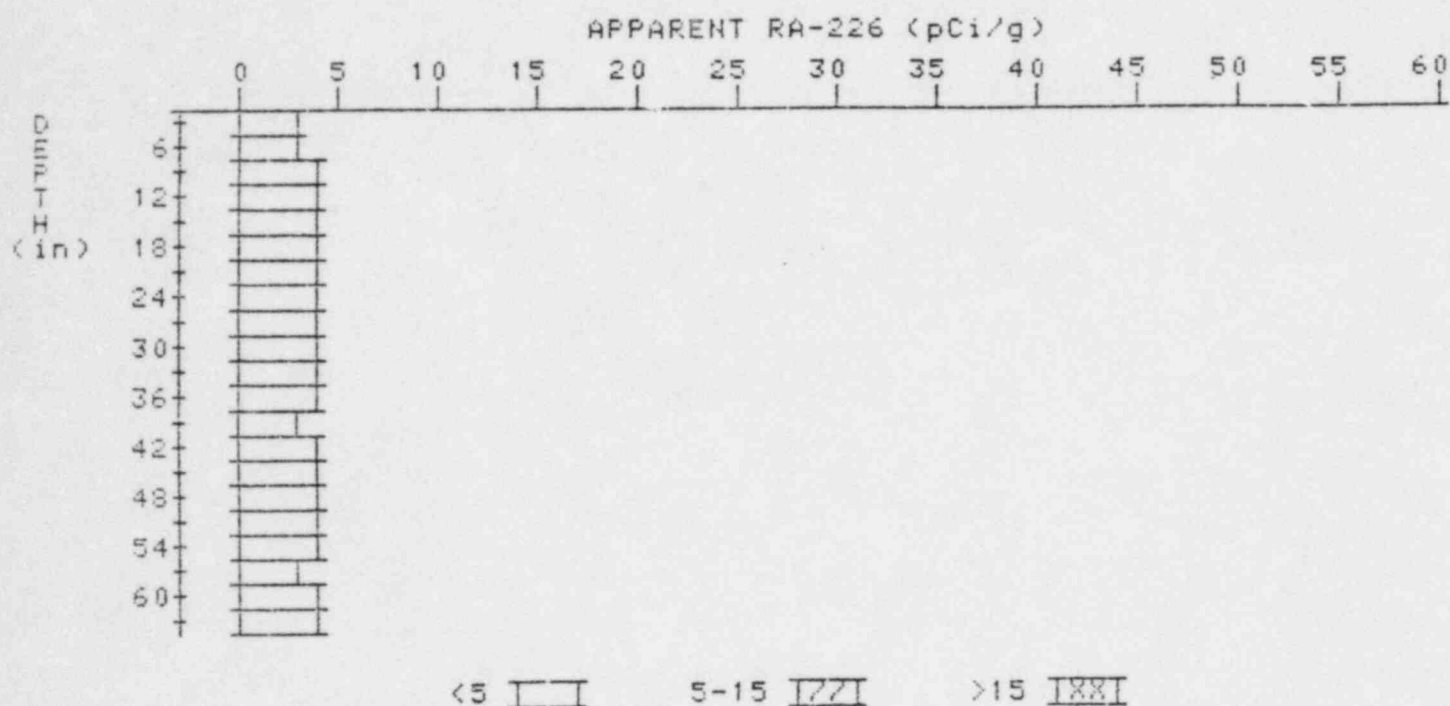
PROPERTY NUMBER: GJ-02172-RS
HOLE NUMBER: 9
LOCATION: 174242

Loc #	Grid Location	Depth (in.)	Meas. Type	In Situ Ra-226 (pCi/g)		Chem Ra-226 (pCi/g)	Comments
				Tot. Ct	Spectr.		
9	174242	48	TC	3.7		*	
		51	TC	3.7		*	
		54	TC	3.7		*	
		57	TC	3.6		*	
		60	TC	3.6		*	
		63	TC	3.6		*	
10	196240	00	DS	1.1		*	
		03	TC	3.2		*	West foundation
		06	TC	3.3		*	
		09	TC	3.5		*	
		12	TC	3.4		*	DC = 0 inches
		15	TC	3.5		*	
		18	TC	3.4		*	
		21	TC	3.4		*	
		24	TC	3.5		*	
		27	TC	3.5		*	
		30	TC	3.6		*	
		33	TC	3.5		*	
11	210225	03	TC	3.1		*	South foundation
		06	TC	3.4		*	
		09	TC	3.7		*	
		12	TC	3.5		*	DC = 0 inches
		15	TC	3.5		*	
		18	TC	3.5		*	
		21	TC	3.5		*	
		24	TC	3.4		*	
		27	TC	3.4		*	
		30	TC	3.4		*	
12	210271	03	TC	3.0		*	North foundation
		06	TC	3.2		*	
		09	TC	3.3		*	
		12	TC	3.5		*	DC = 0 inches
		15	TC	3.4		*	
		18	TC	3.4		*	
		21	TC	3.4		*	
		24	TC	3.5		*	
		27	TC	3.5		*	
		30	TC	3.5		*	
		33	TC	3.4		*	
		36	TC	3.5		*

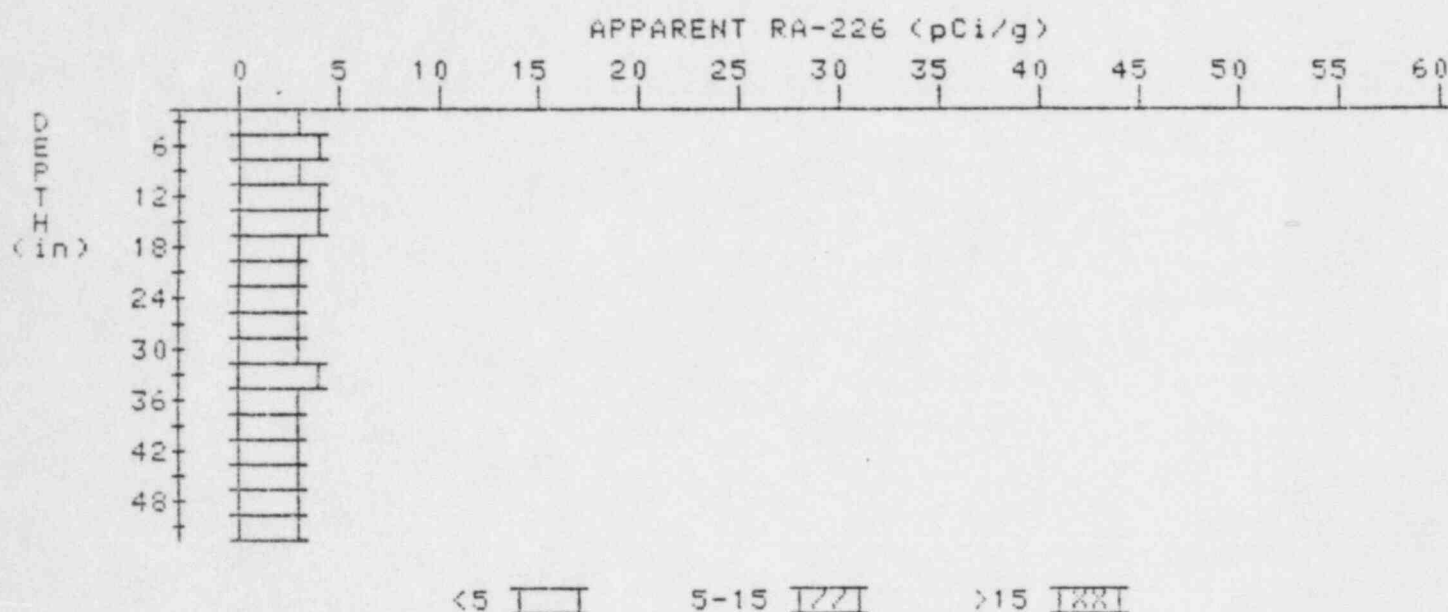
PROPERTY NUMBER: GJ-02172-RS
HOLE NUMBER: 13
LOCATION: 221242

Loc #	Grid Location	Depth (in.)	Meas. Type	In Situ Ra-226 (pCi/g)		Chem Ra-226 (pCi/g)	Comments
				Tot. Ct	Spectr.		
13	221242	03	TC	2.9		*	Sewer and gas lines
		06	TC	3.2		*	
		09	TC	3.3		*	
		12	TC	3.5		*	East foundation
		15	TC	3.5		*	
		18	TC	3.4		*	
		21	TC	3.4		*	
		24	TC	3.4		*	
		27	TC	3.4		*	
		30	TC	3.4		*	
		33	TC	3.5		*	
		36	TC	3.4		*	
		39	TC	3.3		*	
		42	TC	3.3		*	
		45	TC	3.3		*	
		48	TC	3.3		*	
		51	TC	3.2		*	
14	250260	00	DS	<1.0		*	Background
		03	TC	2.9		*	
		06	TC	3.2		*	DC = 0 inches
		09	TC	3.3		*	
		12	TC	3.4		*	
		15	TC	3.4		*	
		18	TC	3.4		*	
		21	TC	3.4		*	
		24	TC	3.4		*	
		27	TC	3.4		*
