RADIOLOGIC AND ENGINEERING ASSESSMENT

DOE ID NO.: GJ-04298-RS  
ADDRESS: 224 OURAY AVENUE

AUGUST 1985

URANIUM MILL TAILINGS REMEDIAL ACTION PROJECT OFFICE

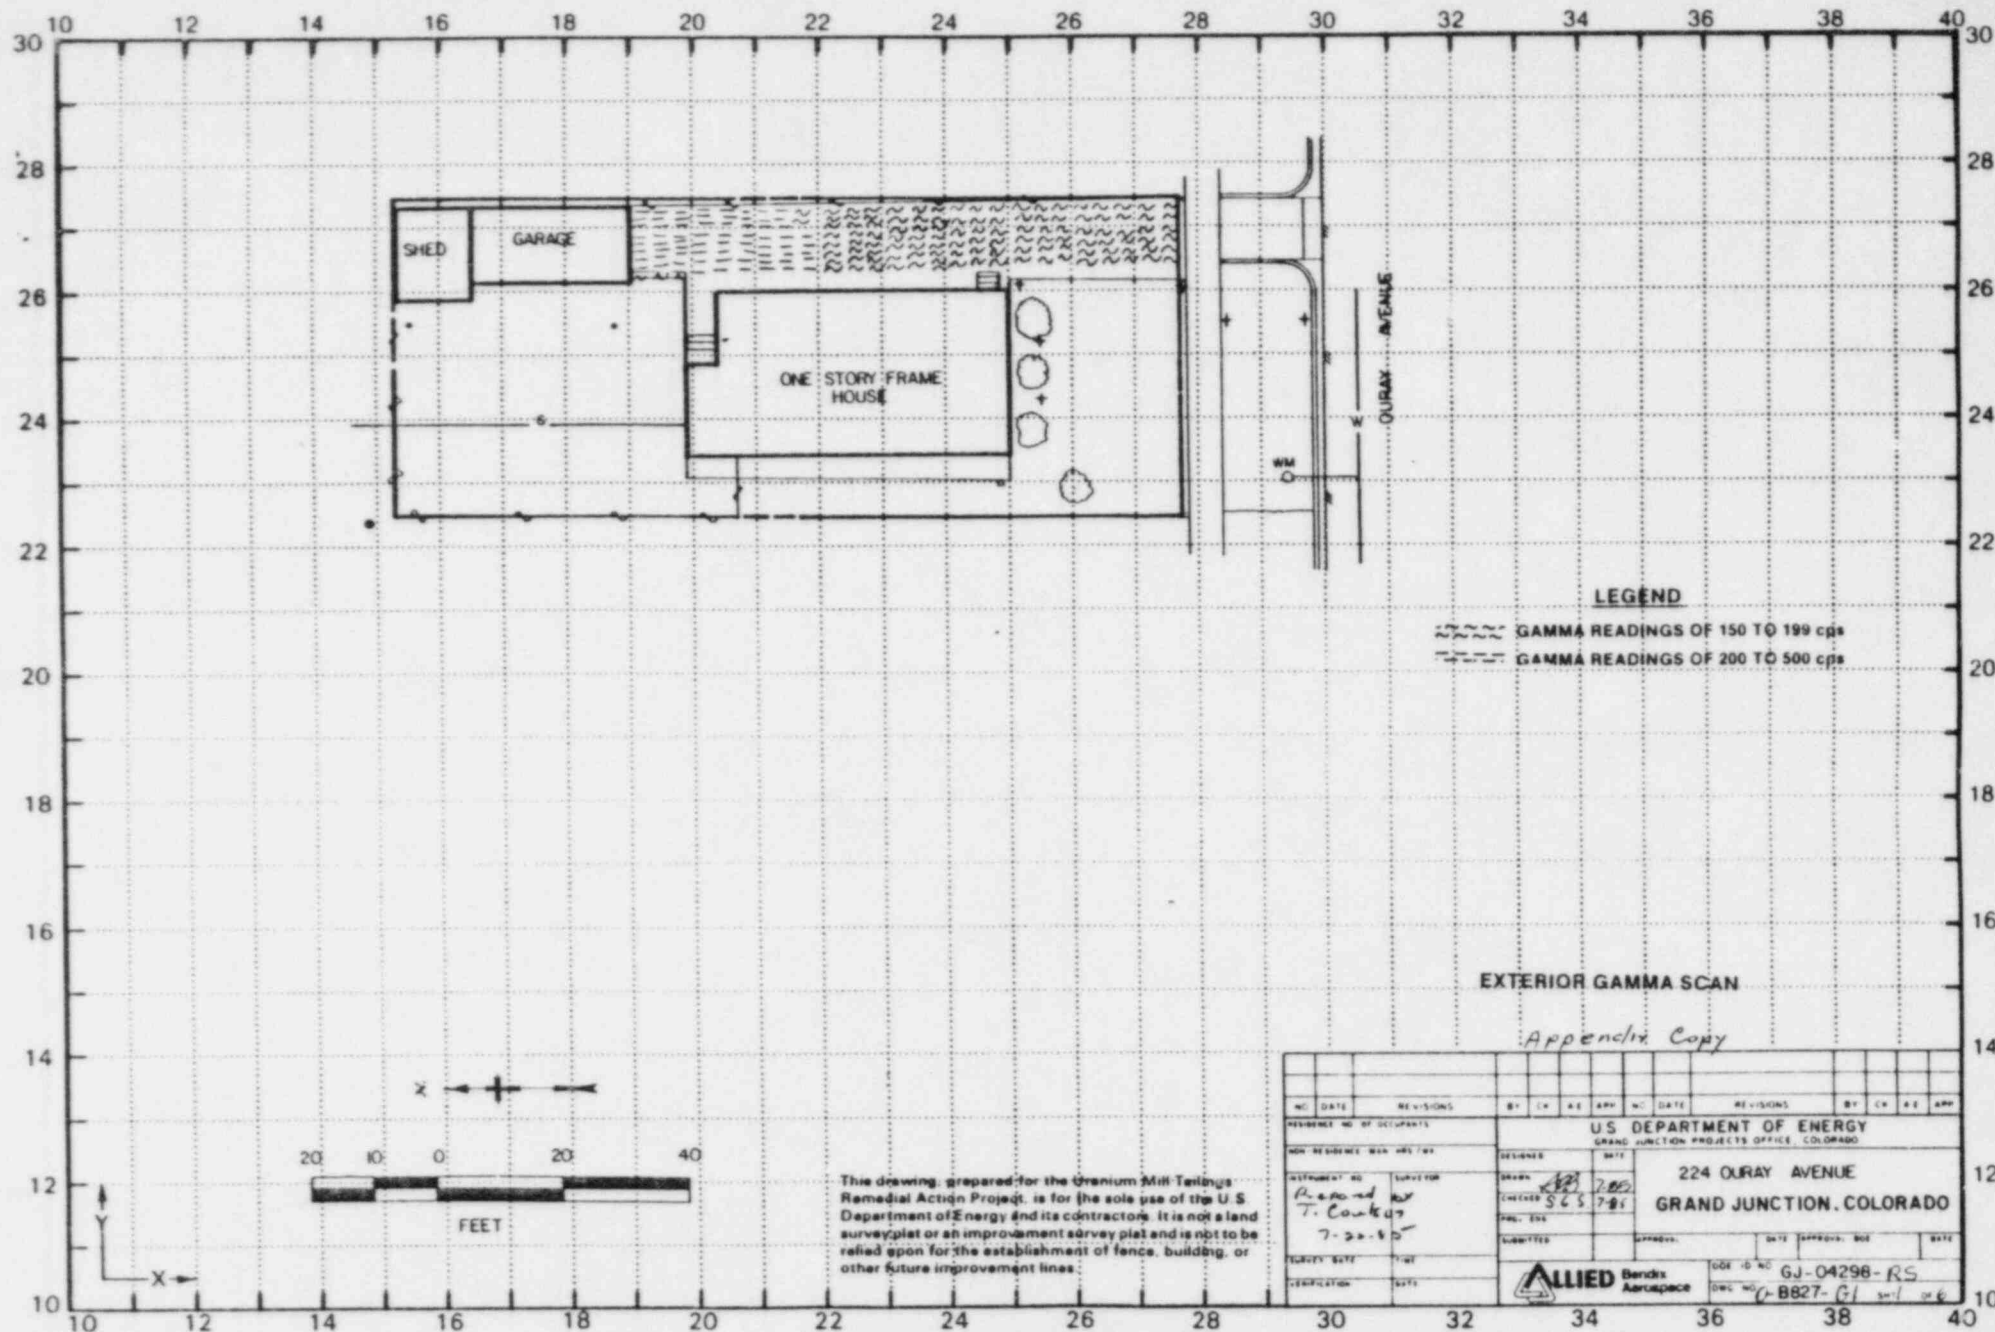
Appendix Figure 3.4 shows identified areas and estimated depths of contamination on this property, based on assessments of all measurements taken. As noted in this figure, areas recommended for remedial action that contain identified residual radioactive materials are:

The recommended remedial action for this property, DOE ID No. GJ-04298-RS, includes removal of all areas identified as containing radioactive material (as discussed in Section 3.5 and shown in Appendix Figure 3.4) and transport of removed material to the disposal site.
