RADIOLOGIC AND ENGINEERING ASSESSMENT

DOE ID NO.: GJ-04153-RS
ADDRESS: 1630 NORTH 17TH STREET

AUGUST 1985

BENJIX FIELD ENGINEERING CORPORATION
P.O. Box 1569
Grand Junction, Colorado 81502

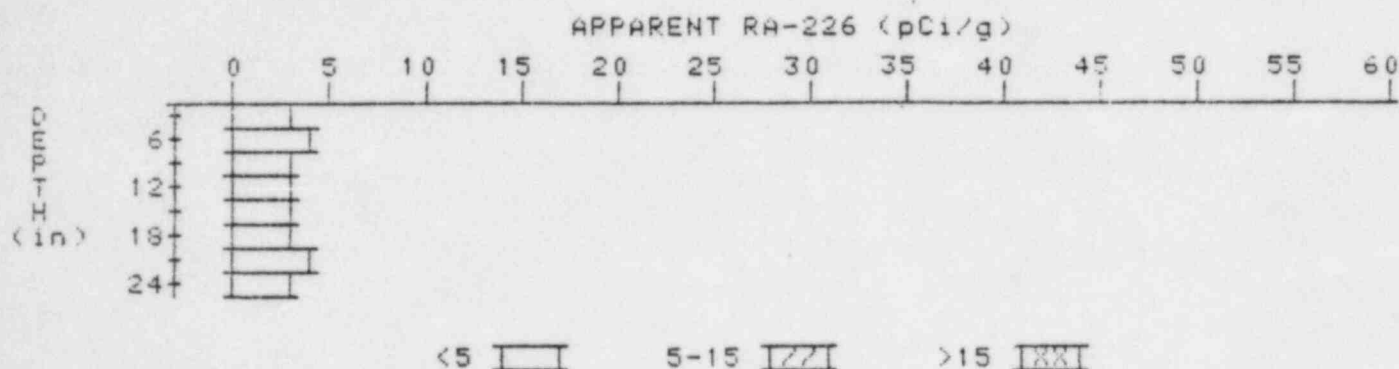
HOLE NUMBER: 7

Depth (in)	Apparent Radium-226 (pCi/g) Undeconvolved	Apparent Radium-226 (pCi/g) Deconvolved
3	3.3	3.3
6	3.4	3.6
9	3.3	3.1
12	3.3	3.5
15	3.2	3.0
18	3.2	3.0
21	3.3	3.7
24	3.2	3.2

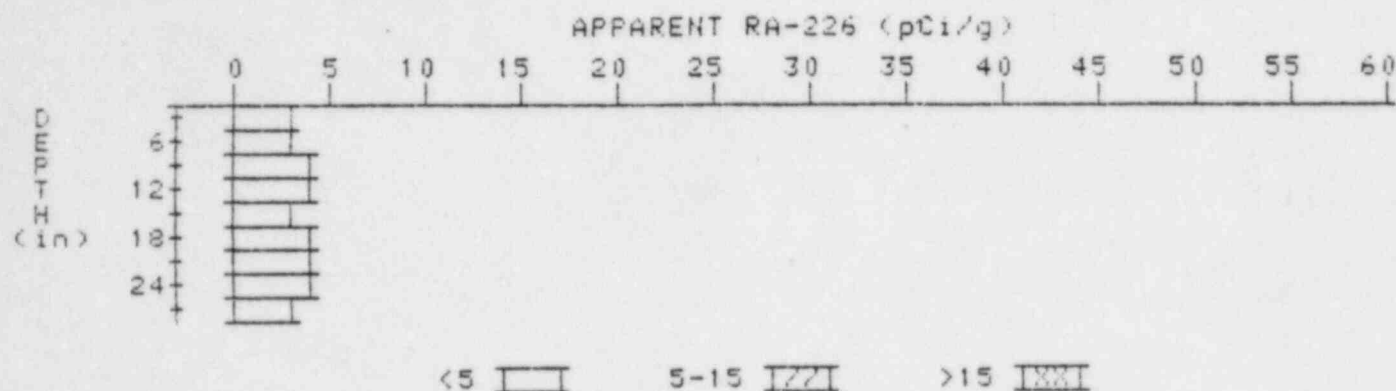
HOLE NUMBER: 14

Depth (in)	Apparent Radium-226 (pCi/g) Undeconvolved	Apparent Radium-226 (pCi/g) Deconvolved
3	2.9	2.9
6	3.2	3.4
9	3.4	3.6
12	3.5	3.7
15	3.5	3.3
18	3.6	3.8
21	3.6	3.8
24	3.8	3.5
27	3.4	3.4

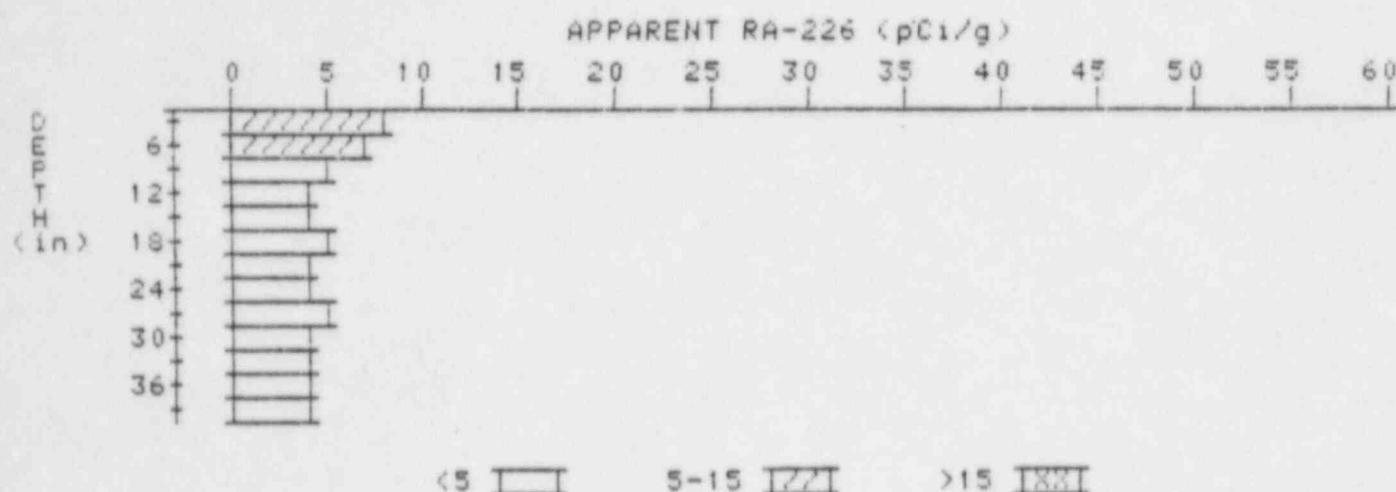
PROPERTY NUMBER: GJ-04153-R3
HOLE NUMBER: 17
LOCATION: 245275

Depth (in)	Apparent Radium-226 (pCi/g) Undeconvolved	Apparent Radium-226 (pCi/g) Deconvolved
3	8.1	8.1
6	6.8	6.6
9	5.6	4.7
12	4.9	4.4
15	4.5	3.8
18	4.5	4.7
21	4.4	4.4
24	4.3	3.8
27	4.4	4.3
30	4.3	4.3
33	4.2	4.0
36	4.2	4.2
39	4.2	4.2
