RADIOLOGIC AND ENGINEERING ASSESSMENT

DOE ID NO.: GJ-11579-RS
ADDRESS: 2508 ELM AVENUE

AUGUST 1985

BENDIX FIELD ENGINEERING CORPORATION
P.O. Box 1569
Grand Junction, Colorado 81502

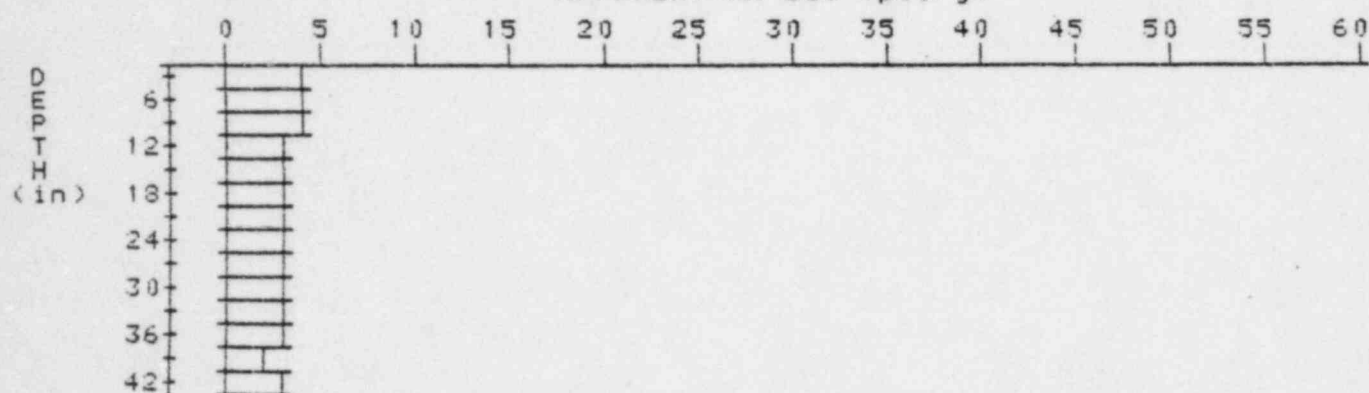
LOCATION: 169251

1. The areas around Grid Points 169251 and 177262 appear to be free of contamination based on all data taken.
2. The Sample Location map that indicates a borehole at Location 197261 is correct. The hole was checked with a downhole scintillometer and found to be clean. In the future I will send a copy of the Downhole Gamma Survey Field Data sheet.
3. The delta reading at Location 19 indicate to me that the concrete is contaminated because there were no visible signs of tailings and the total count at Location 11 showed no contamination.
