RADIOLOGIC AND ENGINEERING ASSESSMENT

DOE ID NO.: GJ-11489-RS
ADDRESS: 523 28 3/4 ROAD

AUGUST 1985

BENDIX FIELD ENGINEERING CORPORATION
P.O. Box 1569
Grand Junction, Colorado 81502

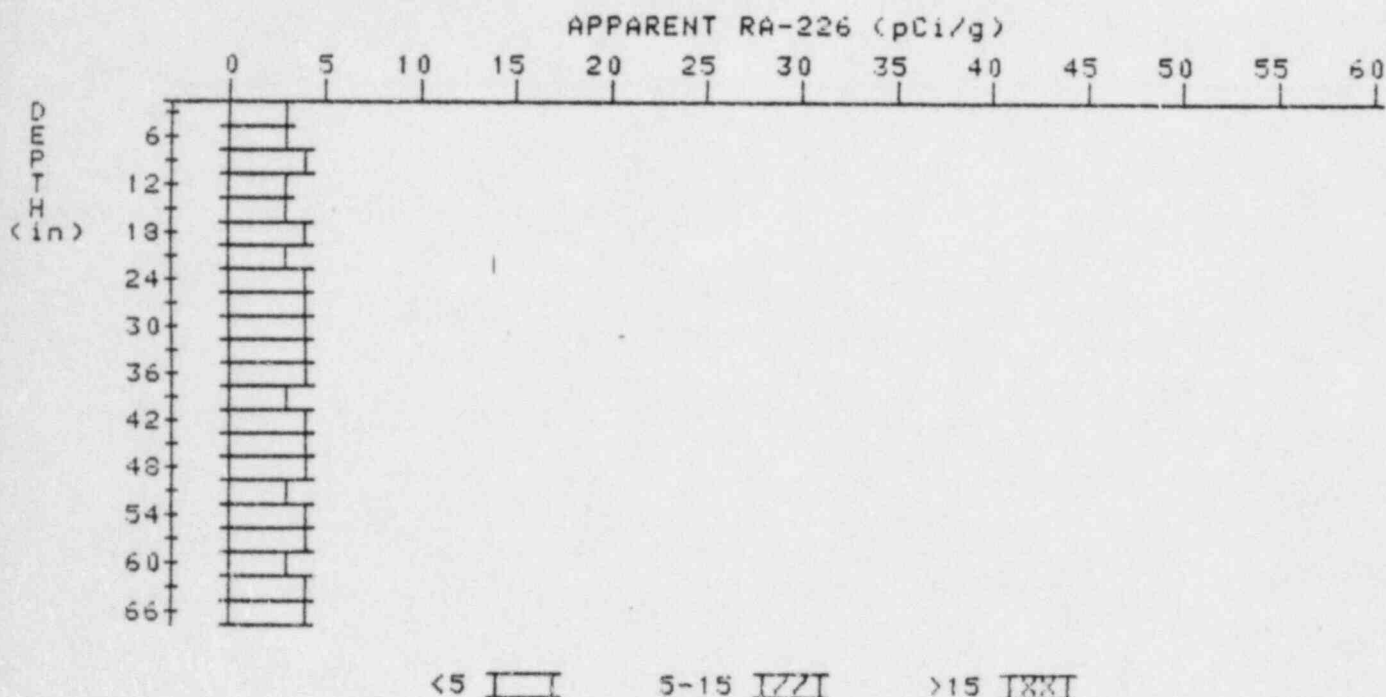
HOLE NUMBER: 2

Depth (in)	Apparent Radium-226 (pCi/g) Undeconvolved	Apparent Radium-226 (pCi/g) Deconvolved
3	2.9	2.9
6	3.2	3.4
9	3.4	3.8
12	3.4	3.4
15	3.4	3.0
18	3.6	4.0
21	3.6	3.4
24	3.7	3.7
27	3.8	4.2
30	3.7	3.5
33	3.7	3.9
36	3.6	3.6
39	3.5	3.3
42	3.5	3.5
45	3.5	3.5
48	3.5	3.5

51	3.5	3.3
54	3.6	3.8
57	3.6	3.6
60	3.6	3.4
63	3.7	4.1
66	3.6	3.6

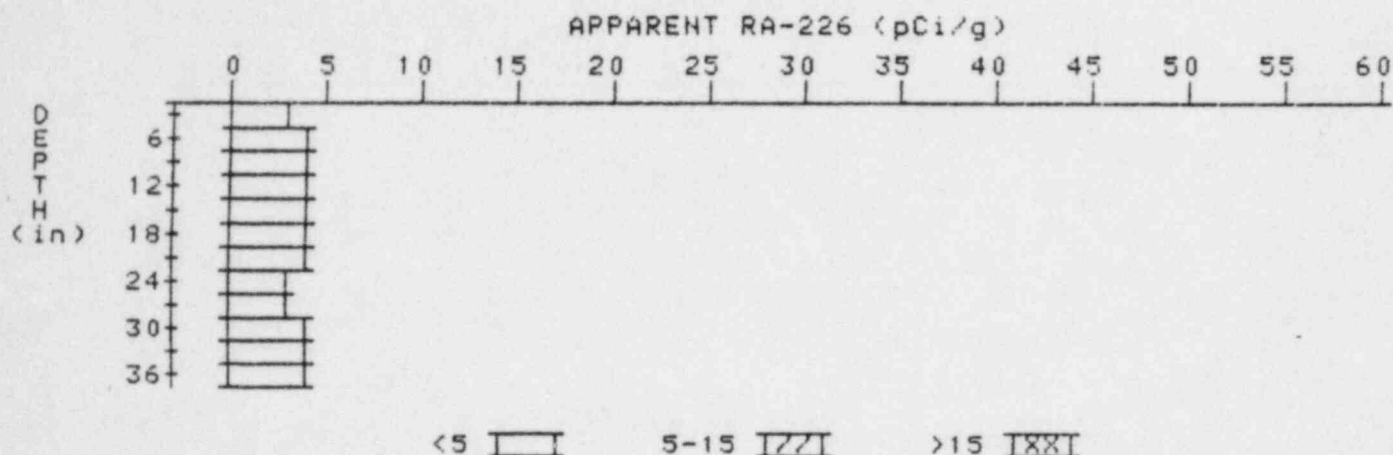
PROPERTY NUMBER: GJ-11489-RS
HOLE NUMBER: 3
LOCATION: 219199

Depth (in)	Apparent Radium-226 (pCi/g) Undeconvolved	Apparent Radium-226 (pCi/g) Deconvolved
3	2.8	2.8
6	3.3	3.8
9	3.5	3.9
12	3.5	3.5
15	3.5	3.5
18	3.5	3.5
21	3.5	3.5
24	3.5	3.3
27	3.6	3.4
30	3.8	4.2
33	3.8	4.0
36	3.7	3.7

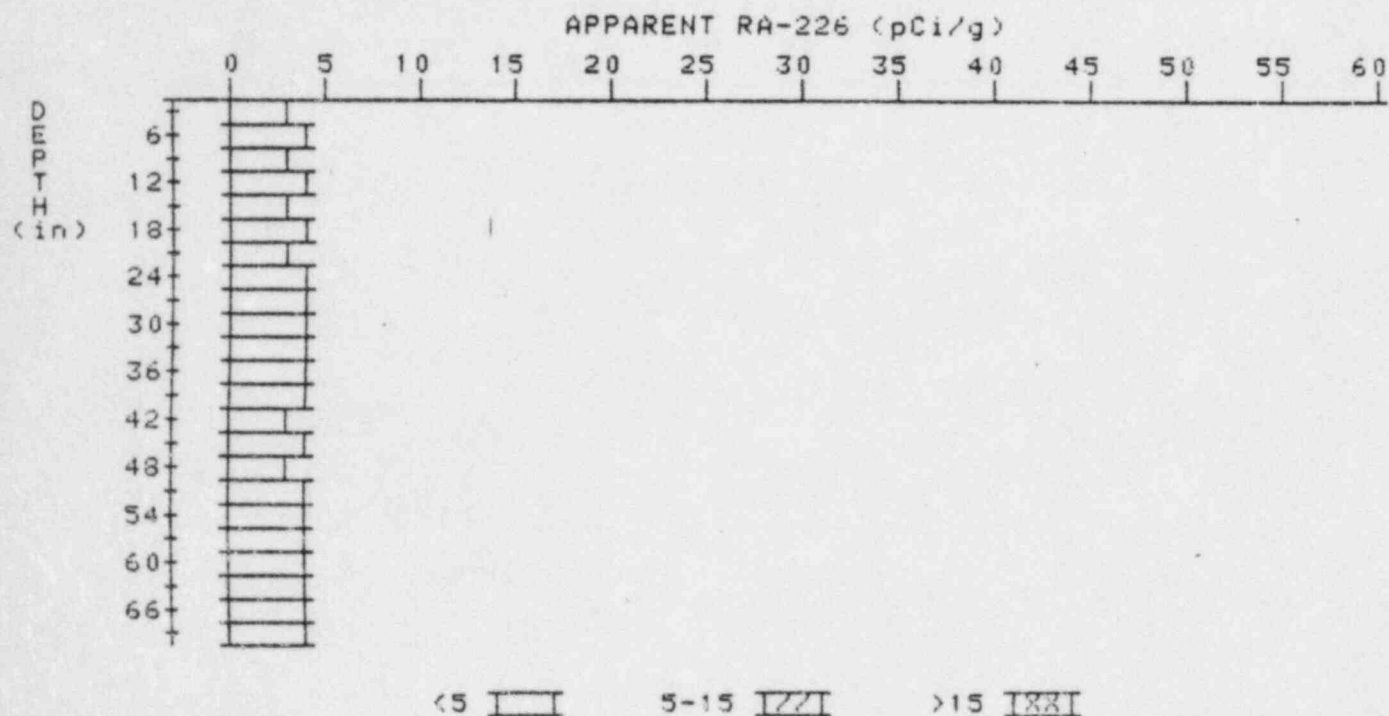
HOLE NUMBER: 7

Depth (in)	Apparent Radium-226 (pCi/g) Undeconvolved	Apparent Radium-226 (pCi/g) Deconvolved
3	3.0	3.0
6	3.4	4.1
9	3.4	3.2
12	3.5	3.9
15	3.4	3.0
18	3.5	3.9
21	3.4	3.0
24	3.5	3.5
27	3.6	3.8
30	3.6	3.6
33	3.6	3.6
36	3.6	3.6
39	3.6	3.8
42	3.5	3.1
45	3.6	3.8

48	3.6	3.4
51	3.7	3.9
54	3.7	3.5
57	3.8	4.0
60	3.8	3.8
63	3.8	3.8
66	3.8	4.0
69	3.7	3.7

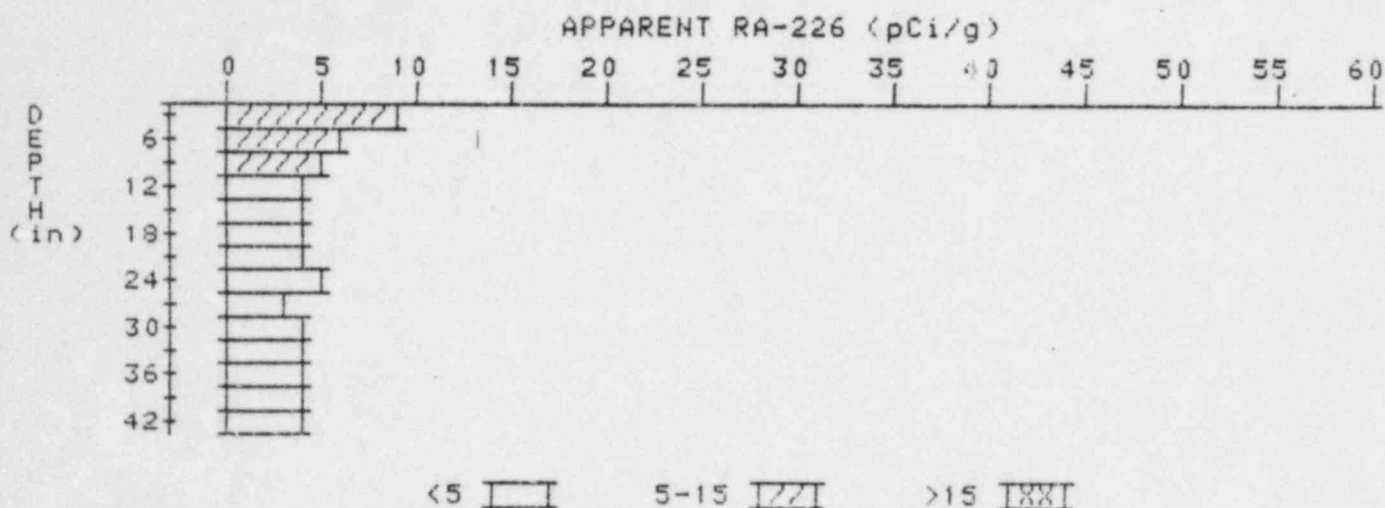
PROPERTY NUMBER: GJ-11489-RS
HOLE NUMBER: 11
LOCATION: 257190

Depth (in)	Apparent Radium-226 (pCi/g) Undeconvolved	Apparent Radium-226 (pCi/g) Deconvolved
3	9.3	9.3
6	7.3	6.2
9	5.9	5.0
12	5.0	4.5
15	4.4	3.7
18	4.2	4.0
21	4.1	3.7
24	4.2	4.9
27	3.9	3.4
30	3.9	3.9
33	3.9	4.1
36	3.8	3.6
39	3.8	4.0
42	3.7	3.7
