RADIOLOGIC AND ENGINEERING ASSESSMENT

DOE ID NO.: GJ-11490-RS
ADDRESS: 537 28 3/4 ROAD

AUGUST 1985

BENDIX FIELD ENGINEERING CORPORATION
P.O. Box 1569
Grand Junction, Colorado 81502

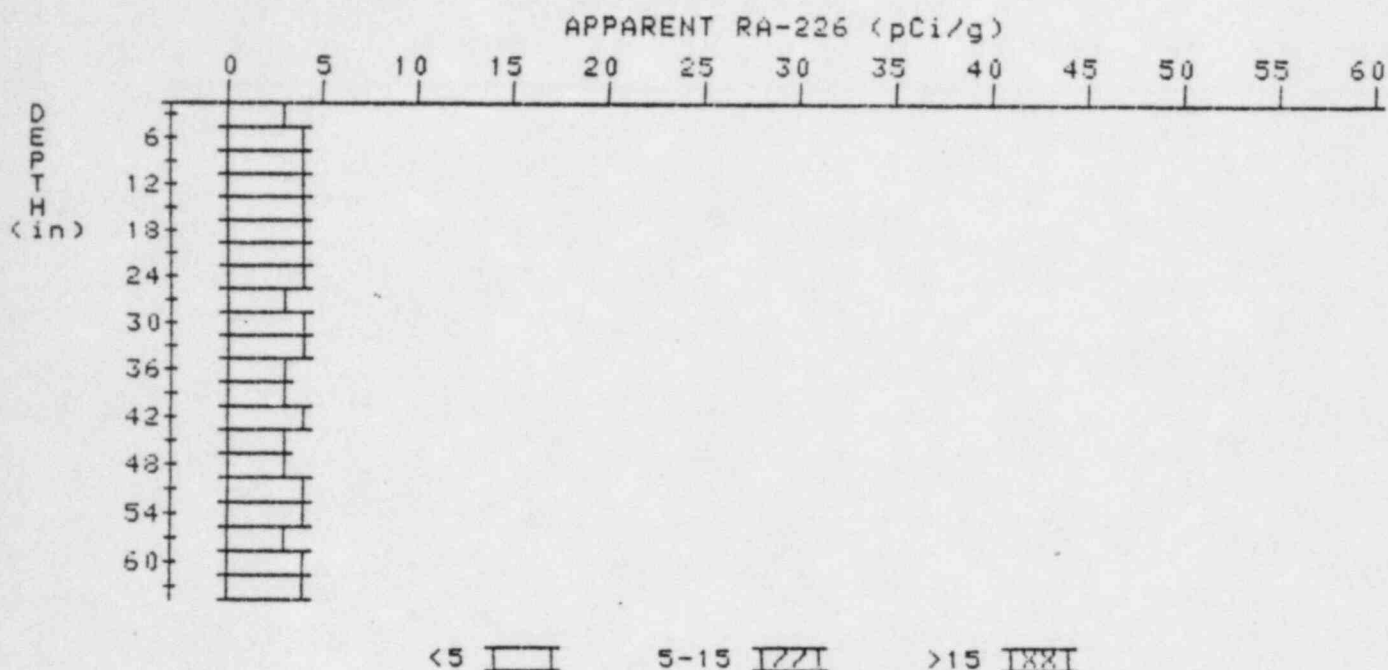
PROPERTY NUMBER: GJ-11490-RS
HOLE NUMBER: 1
LOCATION: 131206

Depth (in)	Apparent Radium-226 (pCi/g) Undeconvolved	Apparent Radium-226 (pCi/g) Deconvolved
3	3.1	3.1
6	3.4	3.8
9	3.5	3.5
12	3.6	3.6
15	3.7	3.9
18	3.7	3.7
21	3.7	3.7
24	3.7	3.9
27	3.6	3.4
30	3.6	3.6
33	3.6	3.8
36	3.5	3.3
39	3.5	3.3
42	3.6	4.0
45	3.5	3.3
48	3.5	3.3
51	3.6	4.0

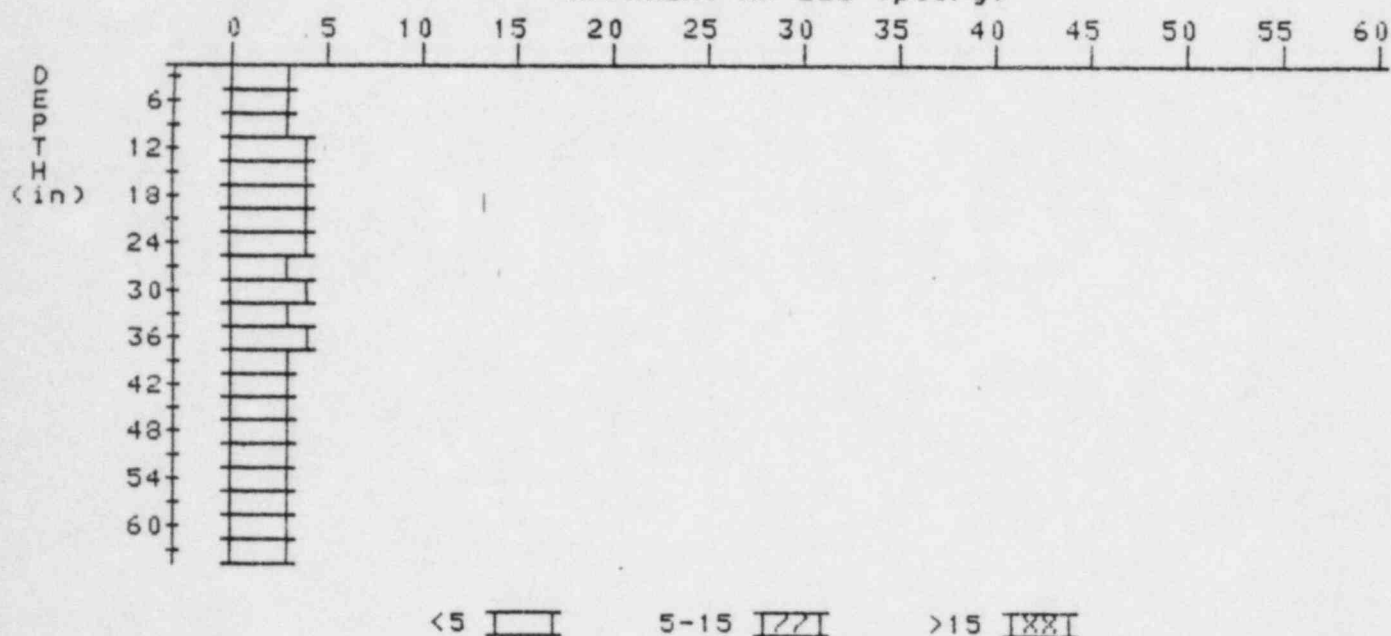
LOCATION: 209230

Depth (in)	Apparent Radium-226 (pCi/g) Undeconvolved	Apparent Radium-226 (pCi/g) Deconvolved
3	3.0	3.0
6	3.1	2.9
9	3.3	3.3
12	3.5	3.9
15	3.5	3.5
18	3.5	3.5
21	3.5	3.5
24	3.5	3.7
27	3.4	3.2
30	3.4	3.6
33	3.3	2.9
36	3.4	3.8
39	3.3	3.1
42	3.3	3.5
45	3.2	3.0
48	3.2	3.2
51	3.2	3.0

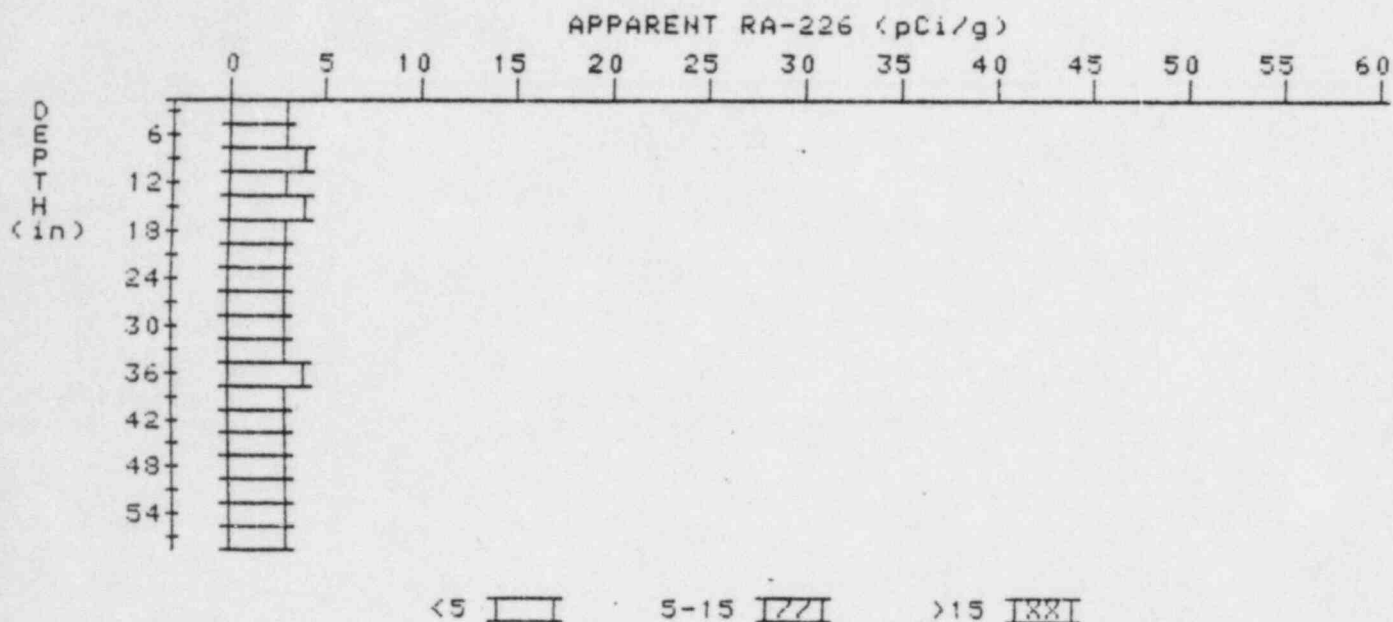
PROPERTY NUMBER: GJ-11490-RS
HOLE NUMBER: 3
LOCATION: 216220

Depth (in)	Apparent Radium-226 (pCi/g) Undeconvolved	Apparent Radium-226 (pCi/g) Deconvolved
3	2.5	2.5
6	2.8	2.6
9	3.2	3.7
12	3.3	3.3
15	3.4	3.6
18	3.4	3.4
21	3.4	3.4
24	3.4	3.4
27	3.4	3.4
30	3.4	3.4
33	3.4	3.2
36	3.5	3.9
39	3.4	3.2
42	3.4	3.4
45	3.4	3.4
48	3.4	3.4
51	3.4	3.4
54	3.4	3.4

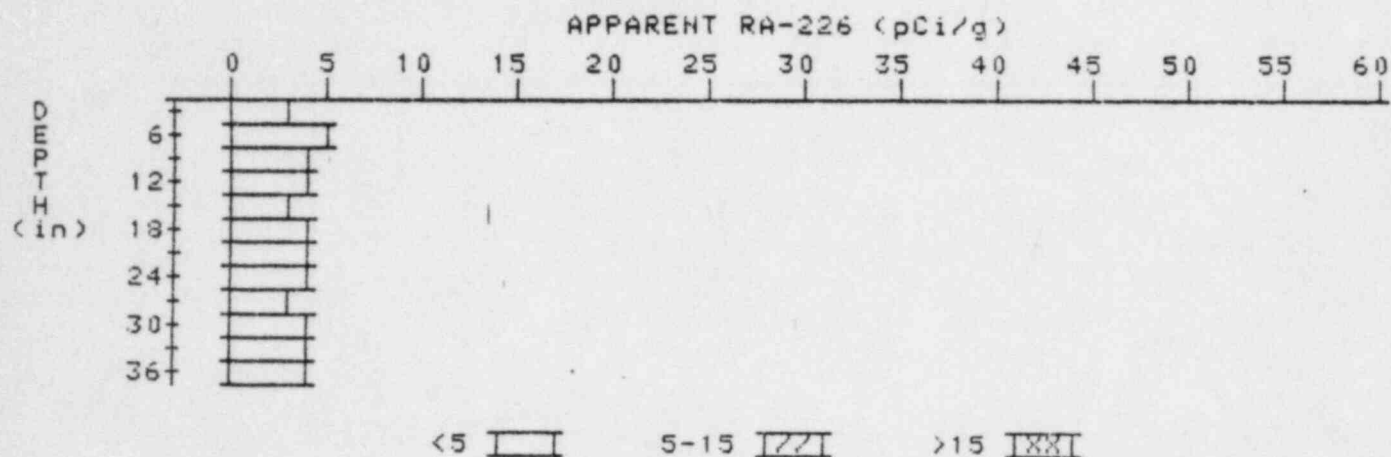
HOLE NUMBER: 4

Depth (in)	Apparent Radium-226 (pCi/g) Undeconvolved	Apparent Radium-226 (pCi/g) Deconvolved
3	3.3	3.3
6	3.8	4.5
9	3.9	4.3
12	3.8	3.8
15	3.7	3.3
18	3.8	4.0
21	3.8	3.6
24	3.9	4.3
27	3.8	3.4
30	3.9	4.1
33	3.9	4.3
36	3.7	3.7

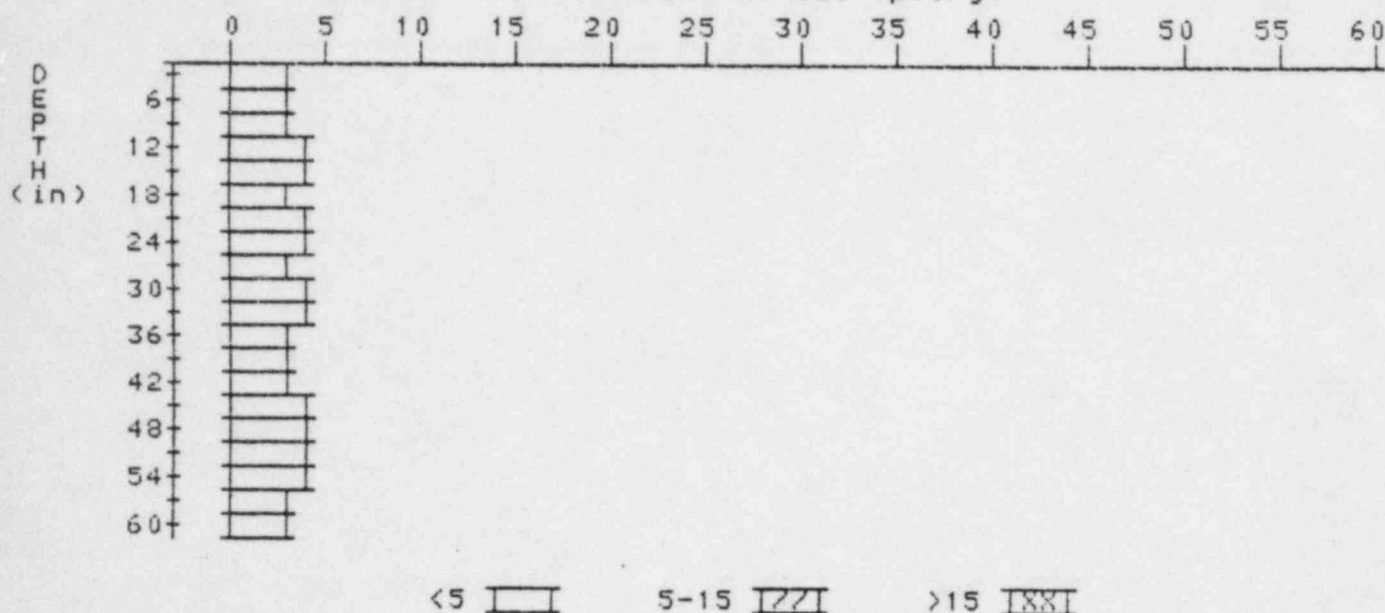
PROPERTY NUMBER: GJ-11490-RS
HOLE NUMBER: 5
LOCATION: 239213

Depth (in)	Apparent Radium-226 (pCi/g) Undeconvolved	Apparent Radium-226 (pCi/g) Deconvolved
3	2.9	2.9
6	3.2	3.4
9	3.4	3.4
12	3.6	3.8
15	3.7	4.1
18	3.6	3.4
21	3.6	3.6
24	3.6	3.8
27	3.5	3.3
30	3.5	3.5
33	3.5	3.7
36	3.4	3.2
39	3.4	3.4
42	3.4	3.2
45	3.5	3.7
48	3.5	3.5
51	3.5	3.5
54	3.5	3.7

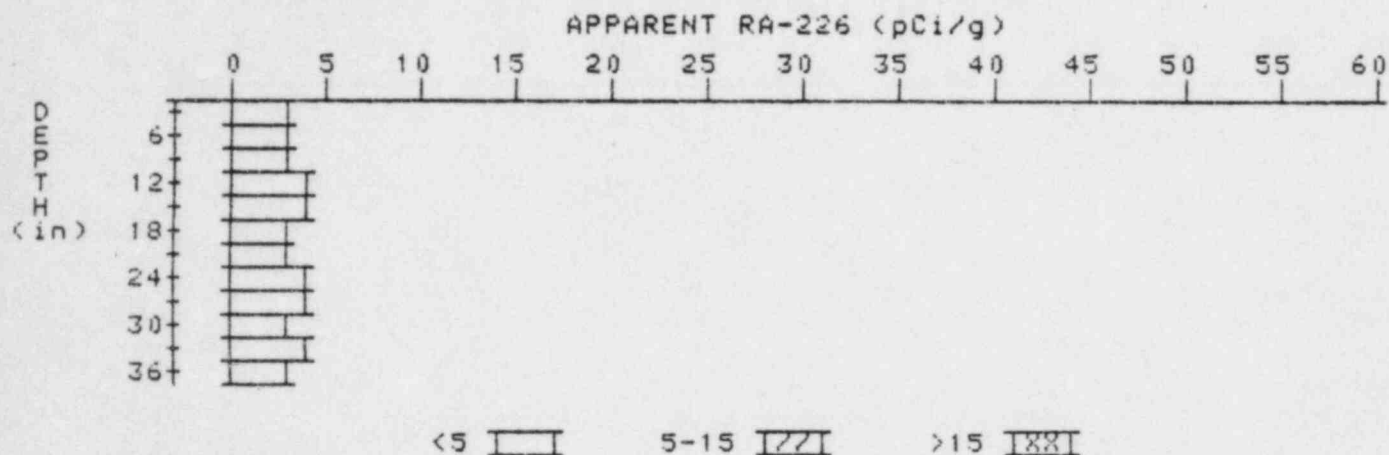
HOLE NUMBER: 7

Depth (in)	Apparent Radium-226 (pCi/g) Undeconvolved	Apparent Radium-226 (pCi/g) Deconvolved
3	2.9	2.9
6	3.1	3.1
9	3.3	3.3
12	3.5	3.7
15	3.6	4.0
18	3.5	3.3
21	3.5	3.3
24	3.6	4.0
27	3.5	3.5
30	3.4	3.0
33	3.5	3.9
36	3.4	3.4
