Department of Energy
Albuquerque Operations Office
P.O. Box 5400
Albuquerque, New Mexico 87185-5400

This concerns the Department of Energy (DOE) Uranium Mill Tailings Remedial Action Green River, Utah, disposal site ground water compliance strategy. As a follow-up to the discussions on July 25 and August 8, 1996, and the Nuclear Regulatory Commission (NRC) letter dated August 29, 1996, enclosed are the "Analysis and Discussion of the Original Ground Water Protection Strategy" and the "Green River Neutron Probe History."

ANALYSIS AND DISCUSSION OF THE ORIGINAL GROUND WATER PROTECTION STRATEGY (MCLs/BACKGROUND), GREEN RIVER SITE, UTAH

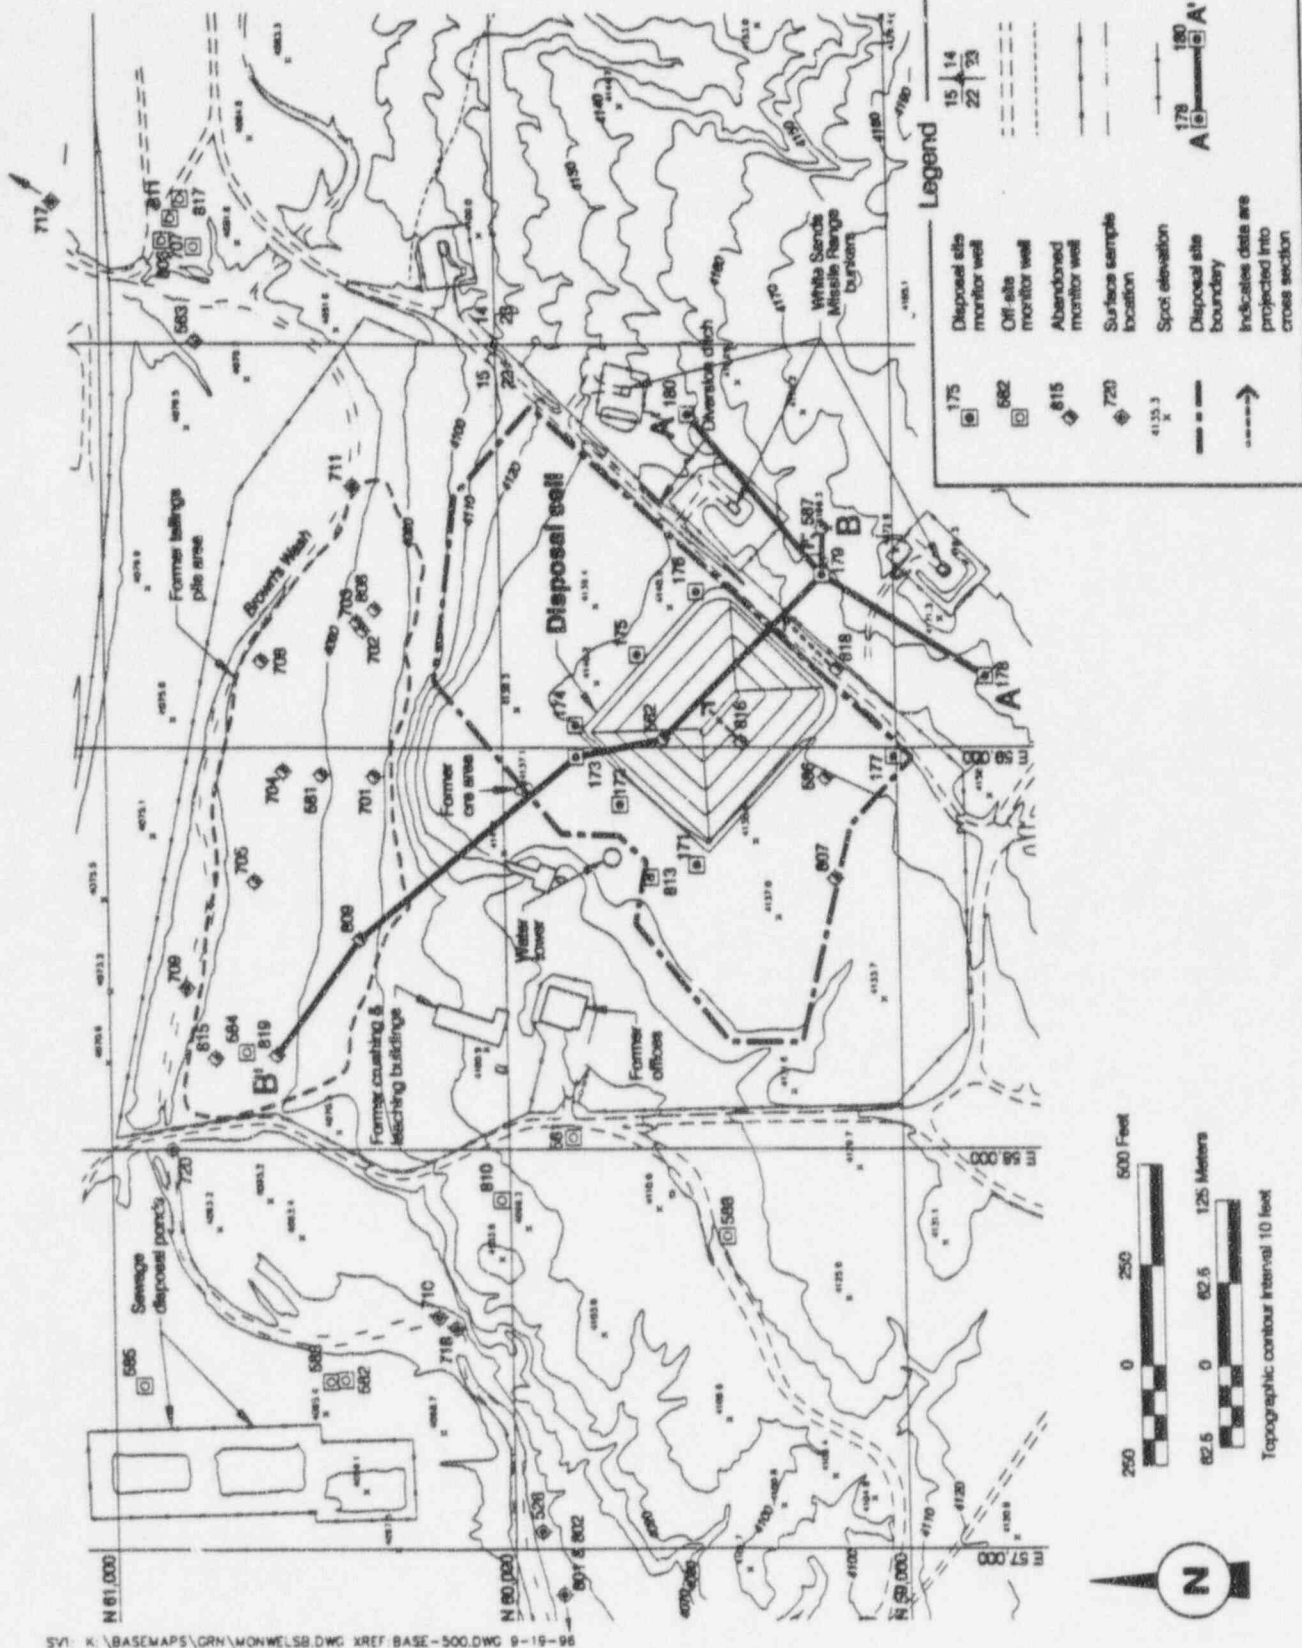
Figure 1
Monitor Wells
Green River, Utah, Disposal Site

The complexities of contaminant concentrations in monitor wells are illustrated in Figures 1-5, showing nitrate, sulfate, TDS, uranium, and selenium in monitor wells 0171-0176, 0179, and 0813. These wells are located around the apron of the disposal cell (Figure 1) and were point-of-compliance wells under the initial ground water protection strategy. Under the strategy being proposed in the forthcoming Appendix E of the Remedial Action Plan, they will be simply monitor wells.
