U.S. NUCLEAR REGULATORY COMMISSION
REGION I

REPORT NUMBER: 50-309/96-09

FACILITY: Maine Yankee Atomic Power Station

Maine Yankee Atomic Power Station NRC Inspection Report 50-309/96-09

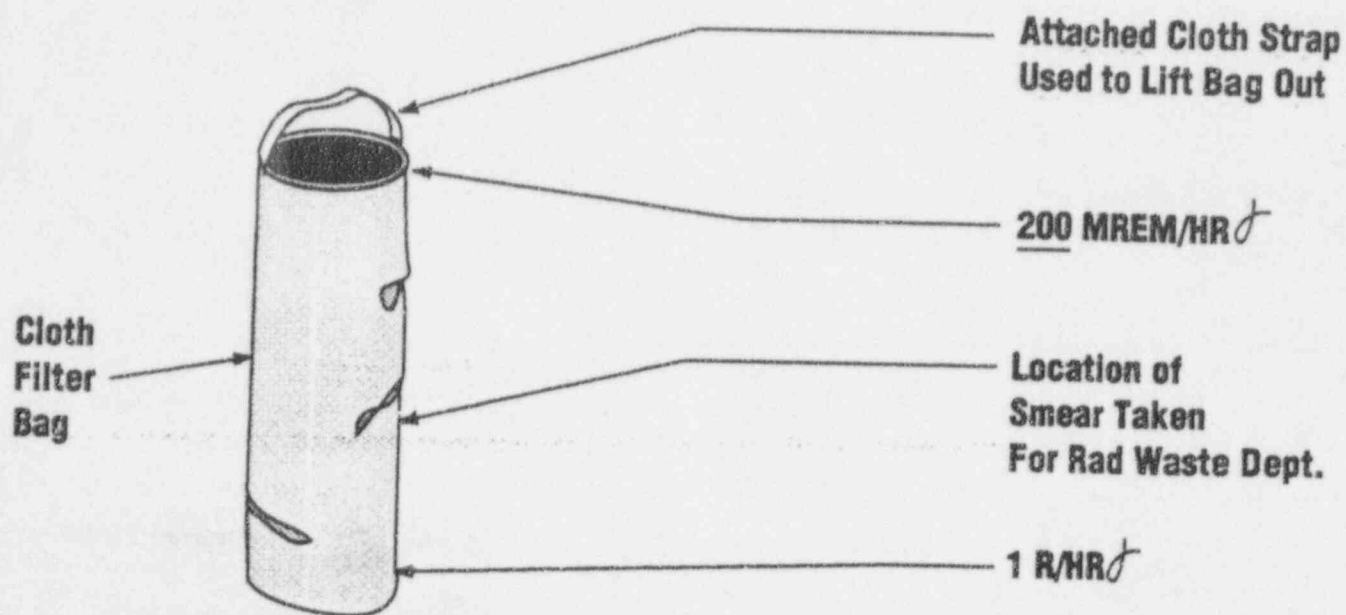
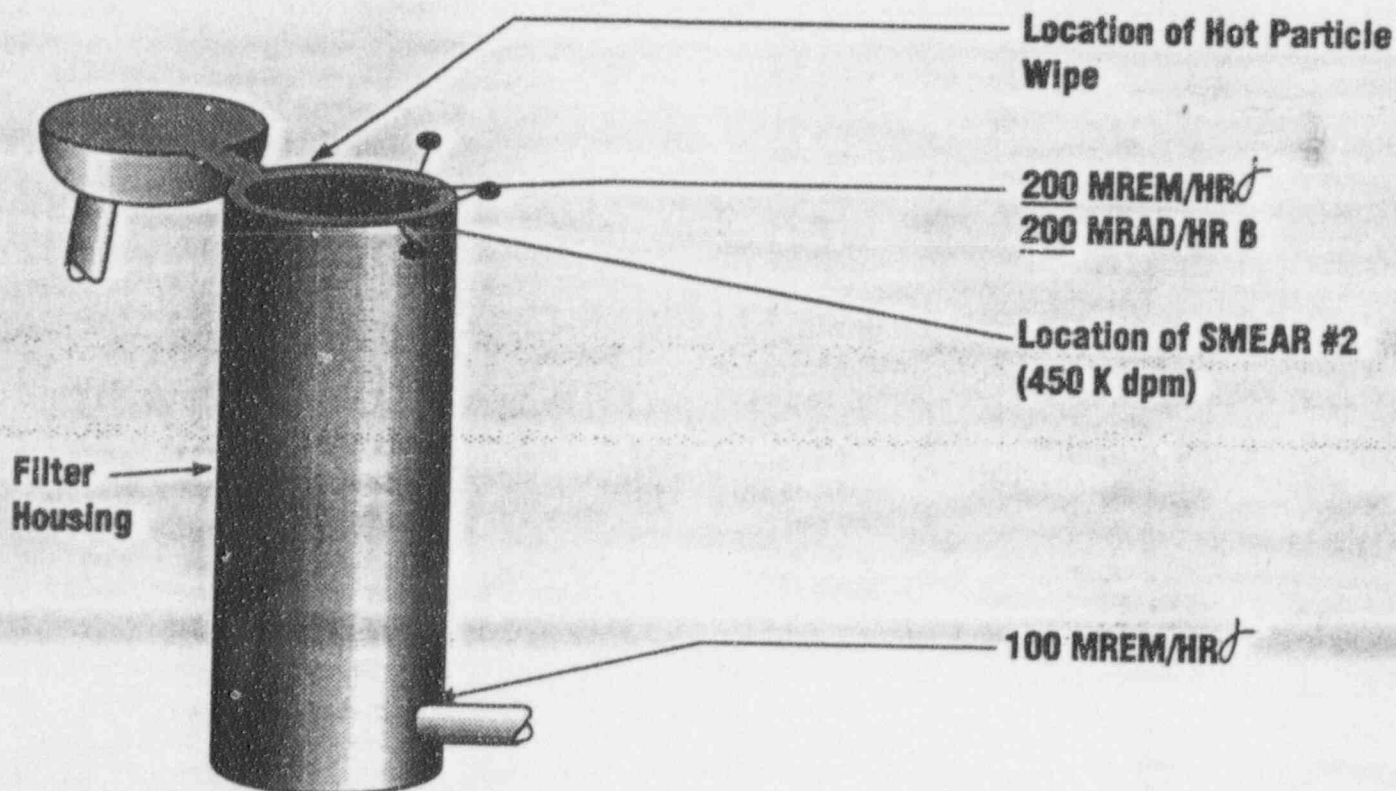
Pre-Filter

- Review of extensive filter handling experience at Maine Yankee verified the non-typical nature of this level of exposure.
- April 16, 1996, change out of Duratek ion-exchange pre-filter (RWP-96-098) was worked to change "Pre" and "Post" filter. (Worked 6 times prior)

- ▶ Pre-filter change-out occurred in about 4 minutes.
- ▶ Remaining scope of work (replacement, closure, post-filter change, system fill, hydro, line-up) was completed in 45 minutes.
