RADIOLOGIC AND ENGINEERING ASSESSMENT

DOE ID NO.: GJ-00154-CS
ADDRESS: 1121 NORTH AVENUE

AUGUST 1985

BENDIX FIELD ENGINEERING CORPORATION
P.O. Box 1569
Grand Junction, Colorado 81502

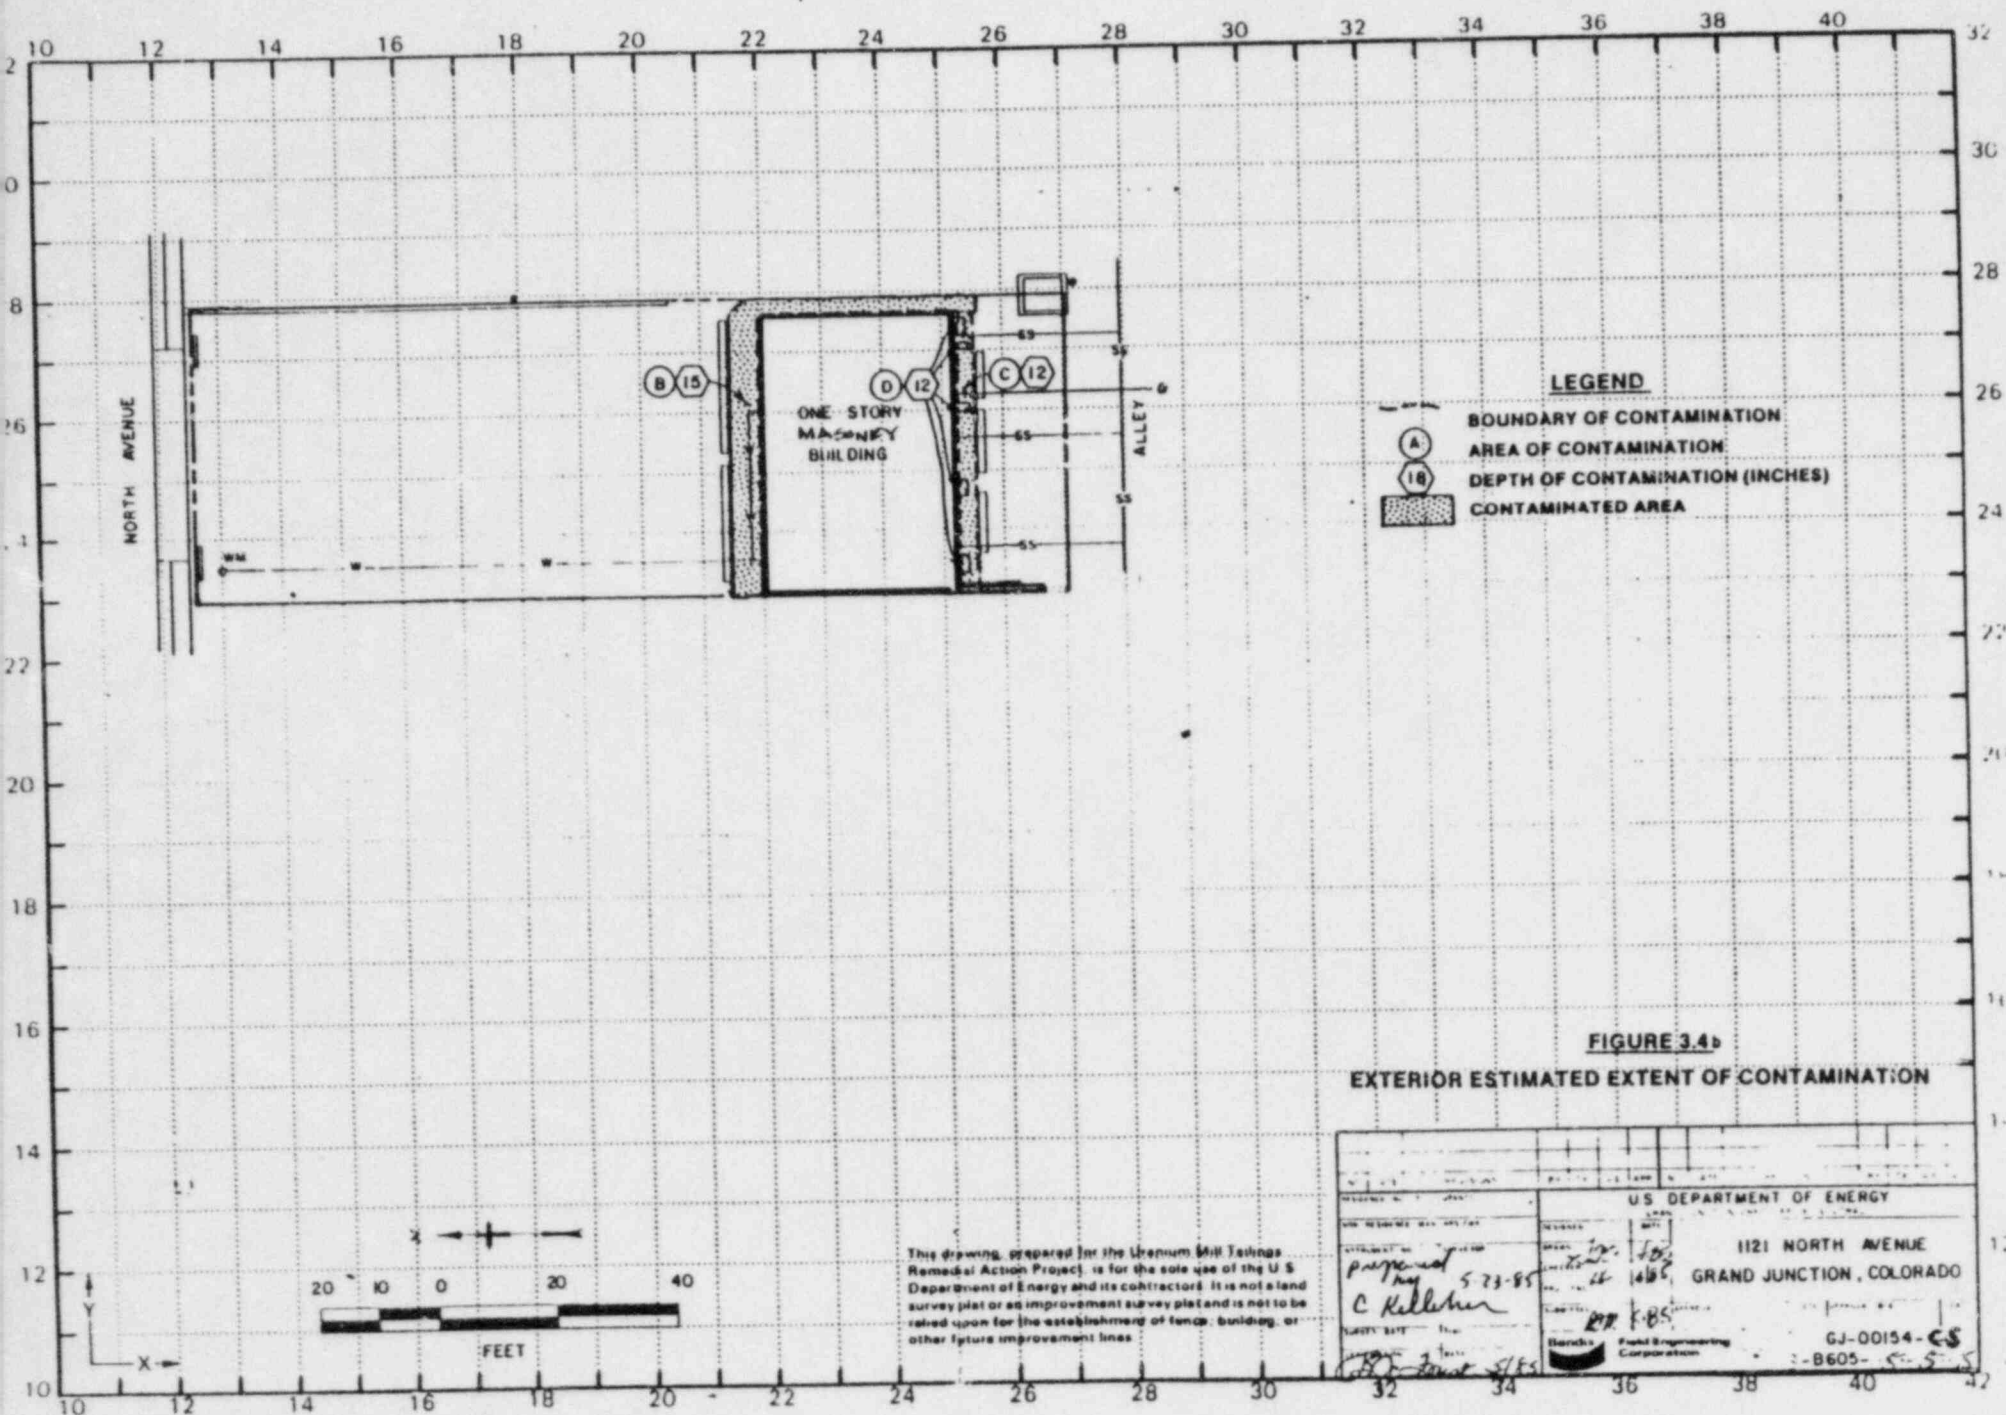
FIGURE 3.40

Appendix Figures 3.4a and 3.4b show identified areas and estimated depth of contamination on this property, based on assessments of all measurements taken. As noted in these figures, areas recommended for remedial action that contain identified residual radioactive materials are:

INTERIOR ESTIMATED EXTENT OF CONTAMINATION

The recommended remedial action for this property, DOE ID No. GJ-00154-CS, includes removal of all areas identified as containing radioactive material (as discussed in Section 3.5 and shown in Appendix Figures 3.4a and 3.4b) and transport of removed material to the disposal site.
