RADIOLOGIC AND ENGINEERING ASSESSMENT

DOE ID NO.: GJ-02246-RS
ADDRESS: 1370 NORTH 20TH STREET

AUGUST 1985

BENDIX FIELD ENGINEERING CORPORATION
P.O. Box 1569
Grand Junction, Colorado 81502

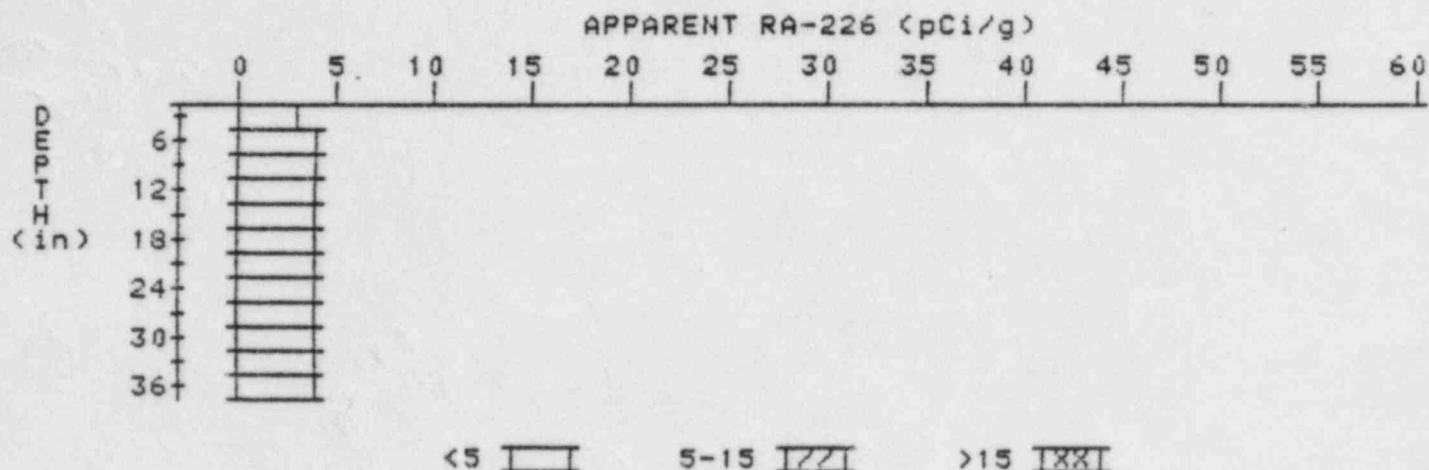
HOLE NUMBER: 3

LOCATION: 190271

Depth (in)	Apparent Radium-226 (pCi/g) Undeconvolved	Apparent Radium-226 (pCi/g) Deconvolved
3	3.3	3.3
6	3.5	3.5
9	3.7	3.9
12	3.8	4.0
15	3.8	3.8
18	3.8	3.8
21	3.8	3.8
24	3.8	3.8
27	3.8	3.8
30	3.8	3.6
33	3.9	4.3
36	3.8	3.8

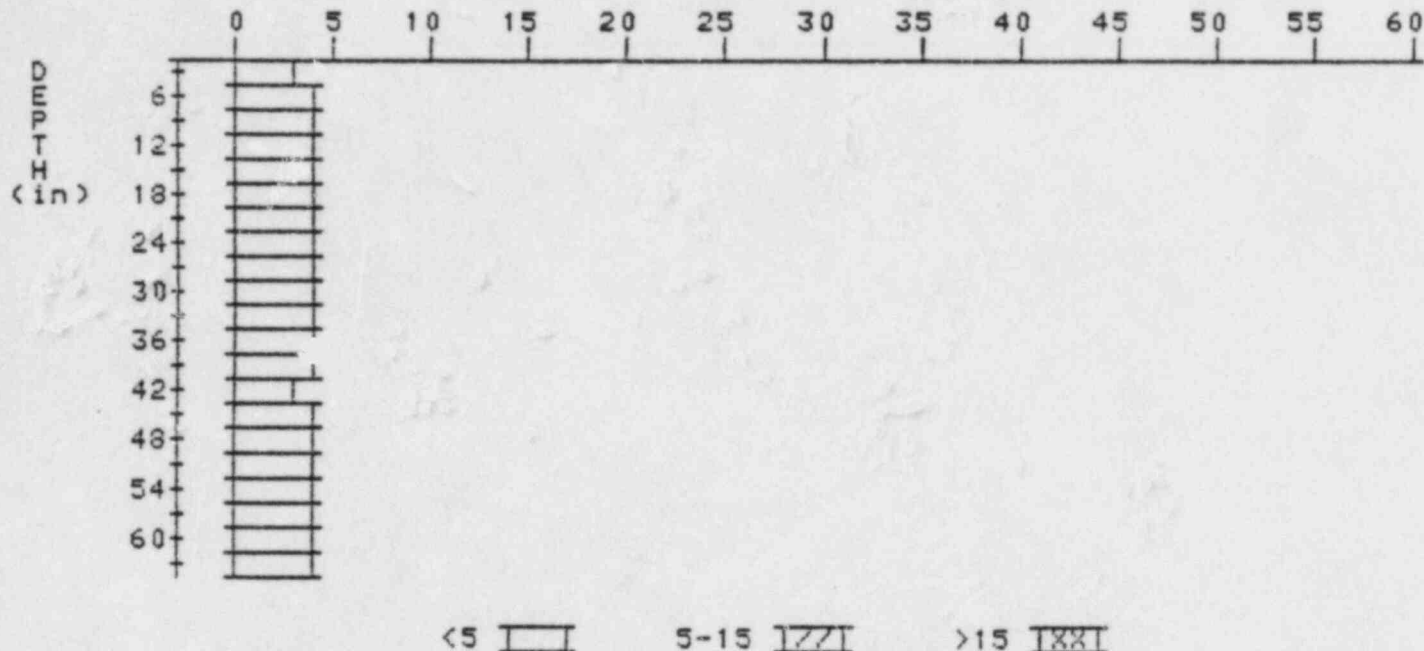
LOCATION: 220253

Depth (in)	Apparent Radium-226 (pCi/g) Undeconvolved	Apparent Radium-226 (pCi/g) Deconvolved
3	3.4	3.4
6	3.6	3.6
9	3.8	4.2
12	3.8	3.6
15	3.9	4.1
18	3.9	3.9
21	3.9	3.7
24	4.0	4.4
27	3.9	3.7
30	3.9	3.9
33	3.9	3.9
36	3.9	3.9
39	3.9	4.1
42	3.8	3.4
45	3.9	4.1
48	3.9	3.7
51	4.0	4.2

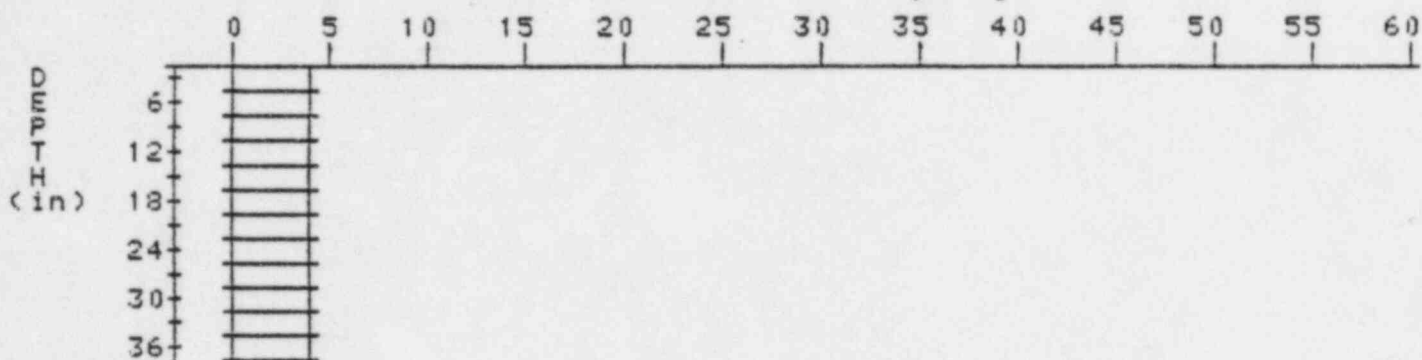
LOCATION: 240240

Depth (in)	Apparent Radium-226 (pCi/g) Undeconvolved	Apparent Radium-226 (pCi/g) Deconvolved
3	3.5	3.5
6	3.7	3.9
9	3.8	3.8
12	3.9	3.9
15	4.0	4.2
18	4.0	3.8
21	4.1	4.3
24	4.1	4.3
27	4.0	4.0
30	3.9	3.7
33	3.9	3.9
36	3.9	3.9
