RADIOLOGIC AND ENGINEERING ASSESSMENT

DOE ID NO.: GJ-01572-RS
ADDRESS: 1933 ELM AVENUE

AUGUST 1985

BENDIX FIELD ENGINEERING CORPORATION
P.O. Box 1569
Grand Junction, Colorado 81502

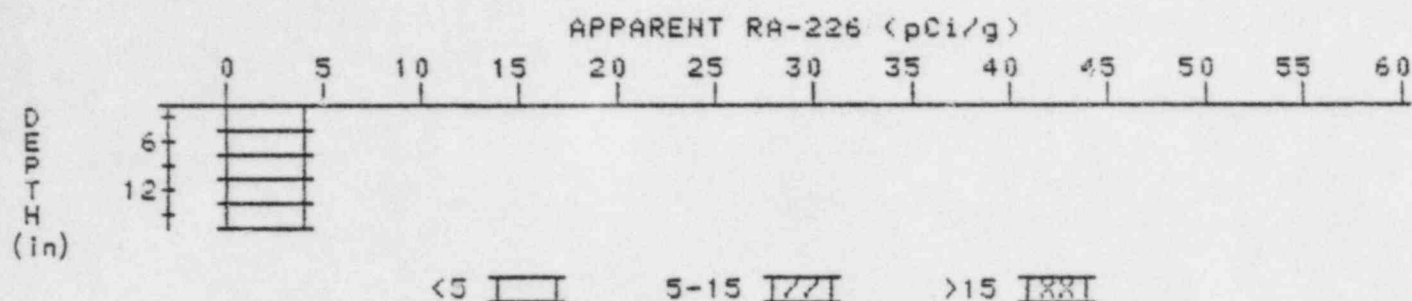
HOLE NUMBER: 6

Depth (in)	Apparent Radium-226 (pCi/g) Undeconvolved	Apparent Radium-226 (pCi/g) Deconvolved
3	4.3	4.3
6	4.2	4.2
9	4.1	3.9
12	4.1	4.1
15	4.1	4.1

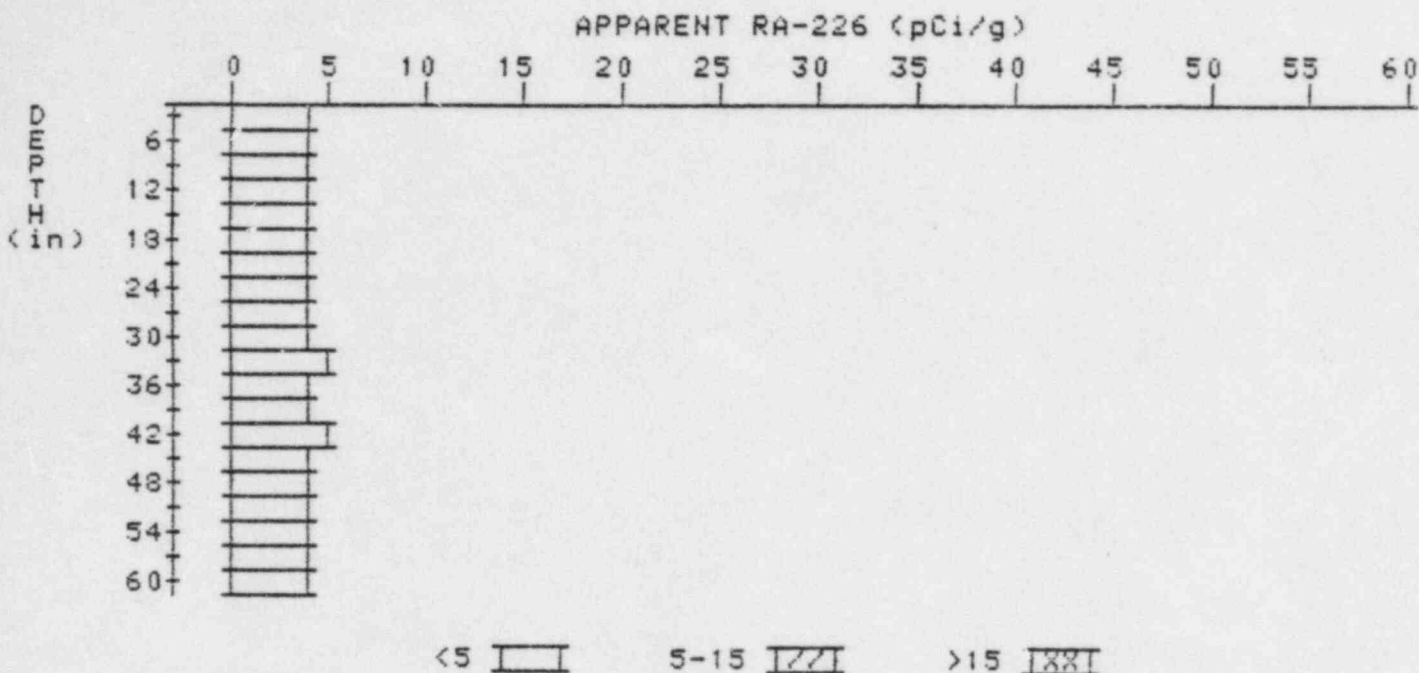
HOLE NUMBER: 9

Depth (in)	Apparent Radium-226 (pCi/g) Undeconvolved	Apparent Radium-226 (pCi/g) Deconvolved
3	3.5	3.5
6	3.6	3.6
9	3.7	3.7
12	3.8	3.8
15	3.9	4.1
18	3.9	3.9
21	3.9	3.9
24	3.9	3.7
27	4.0	4.0
30	4.1	4.1
33	4.2	4.6
36	4.1	3.9
39	4.1	3.9
42	4.2	4.7
45	4.0	3.6
48	4.0	4.2
51	3.9	3.5
54	4.0	4.2

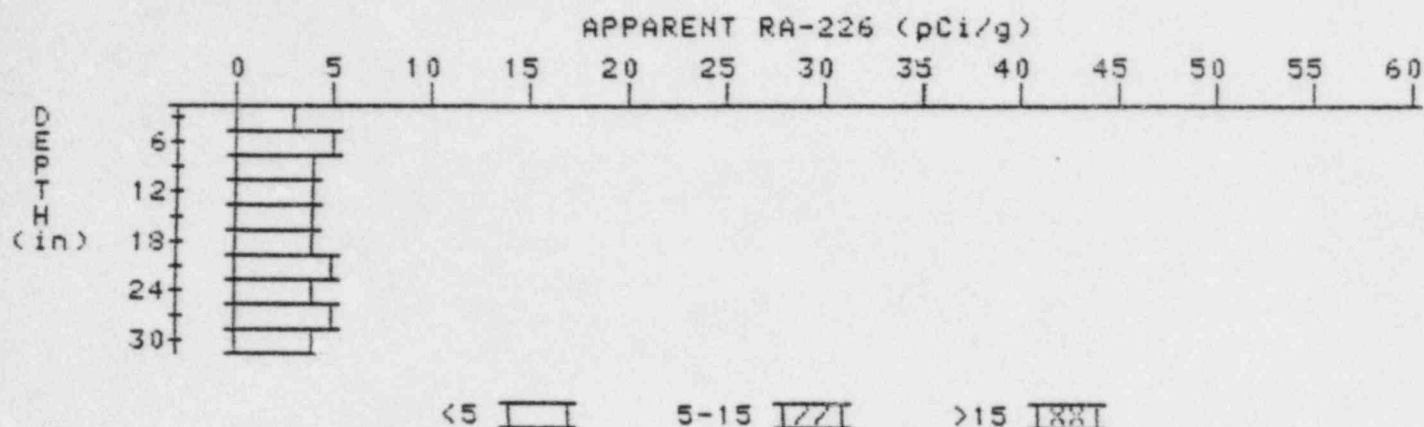
HOLE NUMBER: 16

Depth (in)	Apparent Radium-226 (pCi/g) Undeconvolved	Apparent Radium-226 (pCi/g) Deconvolved
3	2.9	2.9
6	3.7	4.9
9	3.8	3.8
12	3.9	3.9
15	4.0	4.0
18	4.1	4.1
21	4.2	4.6
24	4.1	3.7
27	4.2	4.6
30	4.1	4.1

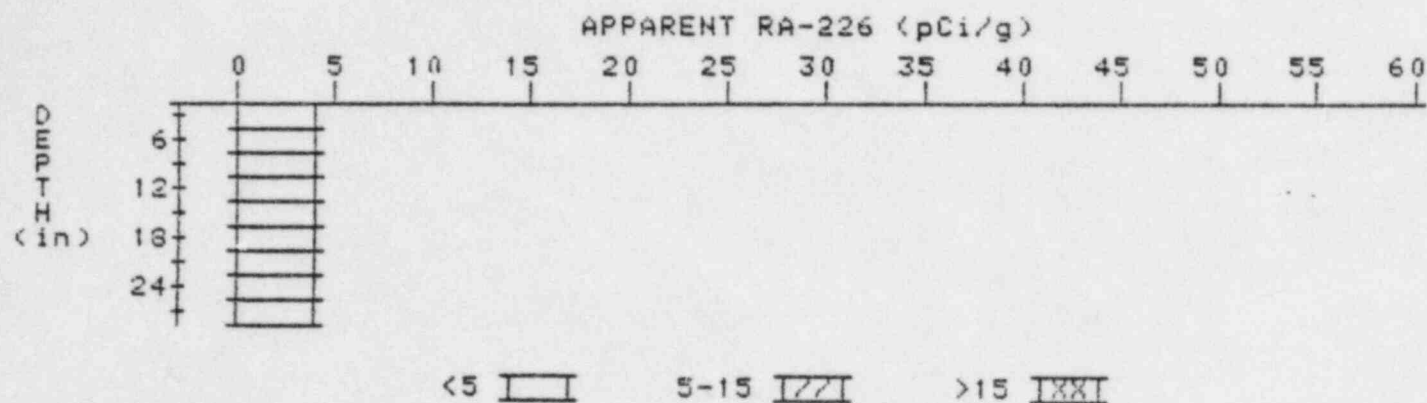
HOLE NUMBER: 20

Depth (in)	Apparent Radium-226 (pCi/g) Undeconvolved	Apparent Radium-226 (pCi/g) Deconvolved
3	4.3	4.3
6	4.3	4.5
9	4.2	4.4
12	4.0	3.6
15	4.0	4.2
18	3.9	3.5
21	4.0	4.2
24	4.0	4.0
27	4.0	4.0
