RADIOLOGIC AND ENGINEERING ASSESSMENT

DOE ID NO.: GJ-05611-RS  
ADDRESS: 211 COUNTRY CLUB PARK ROAD

AUGUST 1985

BENDIX FIELD ENGINEERING CORPORATION  
P.O. Box 1569  
Grand Junction, Colorado 81502

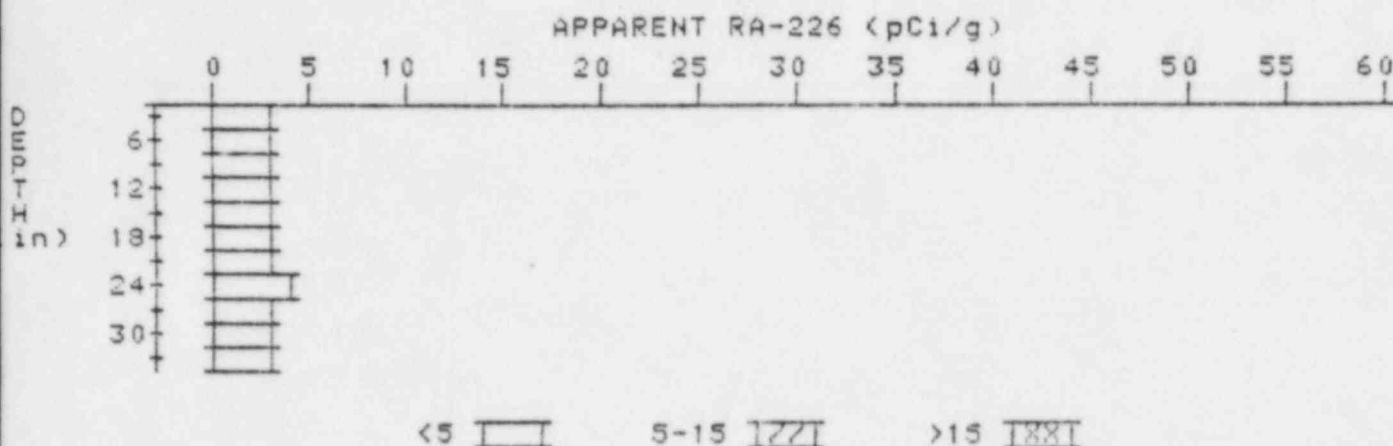
HOLE NUMBER: 7

Depth (in)	Apparent Radium-226 (pCi/g) Undeconvolved	Apparent Radium-226 (pCi/g) Deconvolved
3	2.7	2.7
6	3.0	3.4
9	3.1	3.5
12	3.0	3.0
15	2.9	2.7
18	2.9	2.7
21	3.0	2.8
24	3.2	3.6
27	3.2	3.2
30	3.2	3.2
33	3.2	3.2

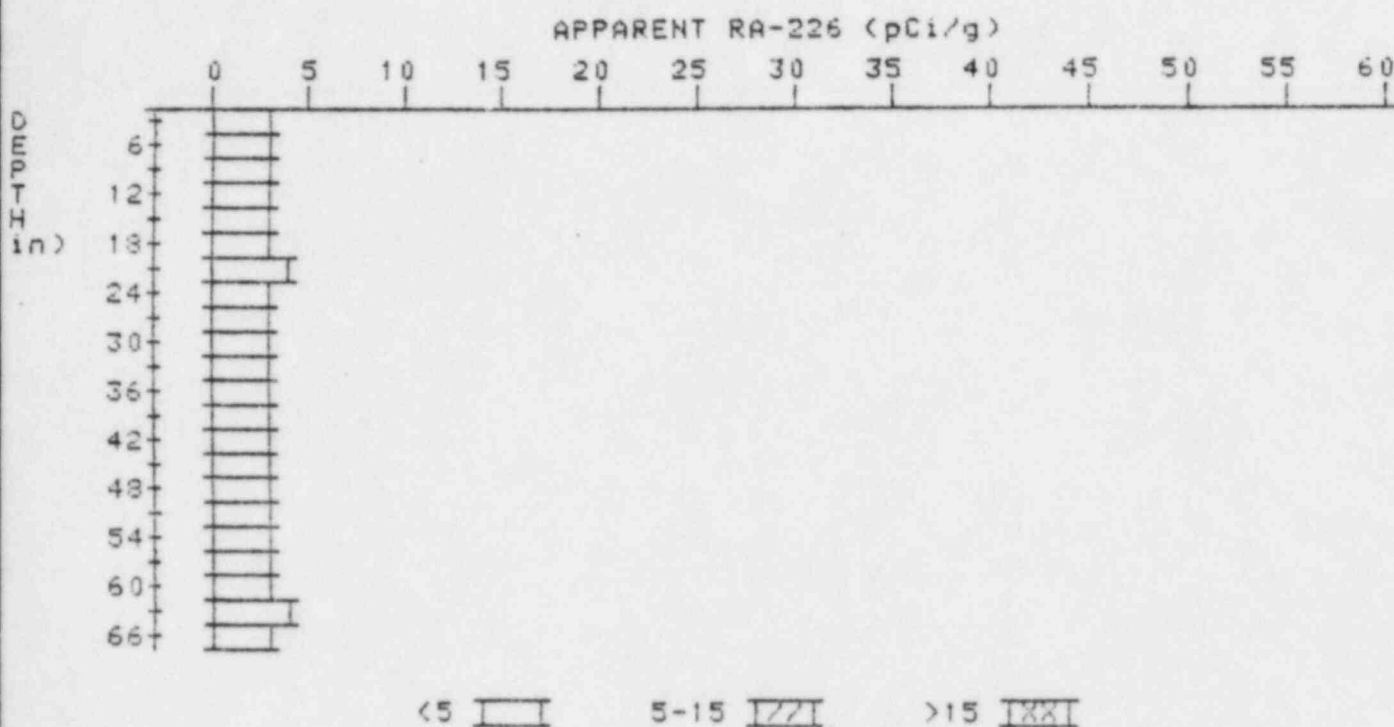
PROPERTY NUMBER: GJ-05611-RS  
HOLE NUMBER: 12  
LOCATION: 285341

Depth (in)	Apparent Radium-226 (pCi/g) Undeconvolved	Apparent Radium-226 (pCi/g) Deconvolved
3	2.8	2.8
6	2.9	3.1
9	2.9	2.7
12	3.0	3.2
15	3.0	2.8
18	3.1	2.7
21	3.4	4.1
24	3.3	3.3
27	3.2	3.2
30	3.1	3.1
33	3.0	2.8
36	3.0	3.0
39	3.0	3.0
42	3.0	3.0
45	3.0	2.8
48	3.1	3.3

51	3.1	2.9
54	3.2	3.4
57	3.2	3.4
60	3.1	2.6
63	3.3	3.7
66	3.3	3.3

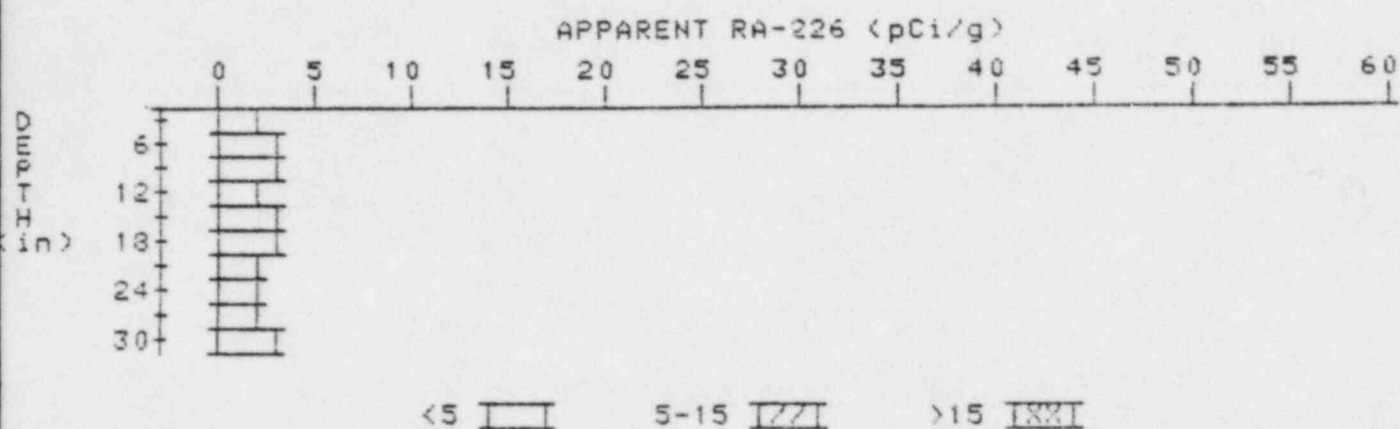
HOLE NUMBER: 15

Depth (in)	Apparent Radium-226 (pCi/g)	Apparent Radium-226 (pCi/g)
	Undeconvolved	Deconvolved
3	2.1	2.1
6	2.5	3.2
9	2.5	2.5
12	2.5	2.3
15	2.6	3.0
18	2.5	2.5
21	2.4	2.2
24	2.4	2.4
27	2.4	2.2
30	2.5	2.5
